December 14, 2023

# **Seaside Groundwater Basin 2023 Seawater Intrusion Analysis Report**

Seaside Groundwater Basin Watermaster

Montgomery & Associates

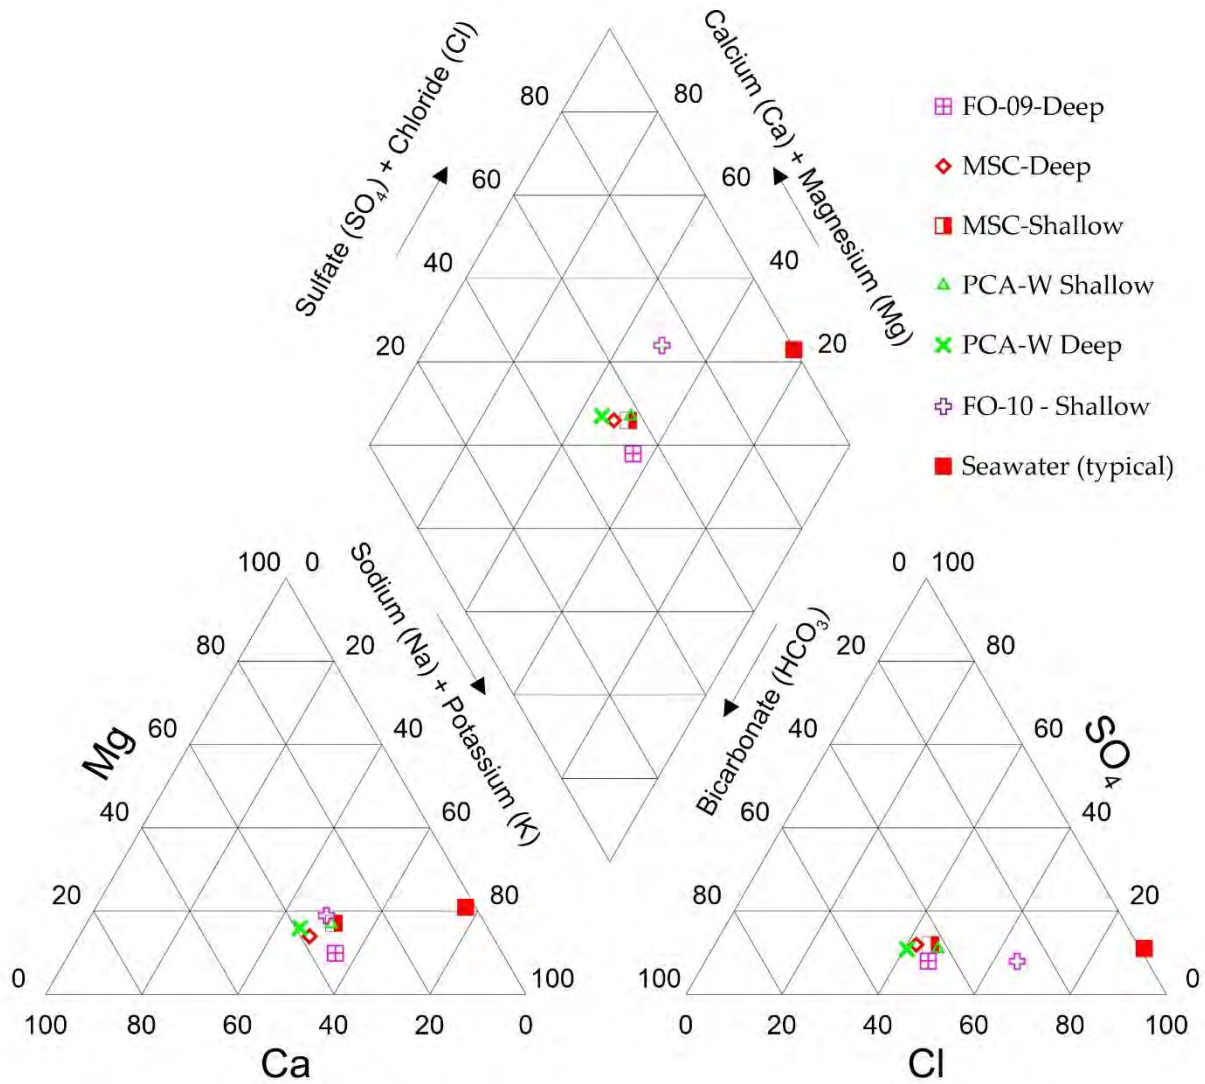
Figure 11. Piper Diagram for Seaside Groundwater Basin Monitoring Wells, Second Quarter Water Year 2023 (January-March 2023)

A Piper diagram plotting 6 monitoring wells in the Northern Coastal subarea for the second quarter WY 2023 (January-March 2023) is shown on Figure 11. Analyses from only 6 wells are shown because the Sentinel Wells are only used for induction logging and are no longer sampled, and most of the monitoring well pairs are only sampled in the fourth quarter. Further, monitoring well FO-09 Shallow was destroyed 2 years ago due to a compromised casing. It has since been replaced and data from the replacement well will be included in future SIARs. Appendix C includes individual Piper diagrams for each well to track their anions and cations over time. Note that bicarbonate ( $\text{HCO}_3$ ) presented on Piper and Stiff diagrams is derived from Total Alkalinity (as  $\text{CaCO}_3$ ).

As noted in the previous 3 SIARs (M&A, 2020; M&A, 2021; M&A, 2022) and shown on Figure 11, monitoring well FO-10 Shallow plots differently than the other wells on the Piper diagram and has exhibited a marked increase in chloride over the past 3 years, departing significantly from its historical trends (Appendix D: Figure D-9). This year FO-10 Shallow continues to plot differently than other wells due to elevated chloride, though the trends do not appear to have worsened from the previous year (Appendix D: Figure D-10). Downhole logging at the FO-10 site and subsequent historical record search identified a 1,300 foot, 2-inch steel tremie pipe that has been left in the FO-10 borehole since the well's construction (Feeney, 2021; Feeney 2022). While comparison of WY 2021 resistivity at the well with a historical log does show increased conductivity in the well, which may be a sign of seawater intrusion, the presence of the steel pipe obfuscates water quality determinations by muting the induction log response. Further, this steel pipe may act as a conduit allowing flow between overlying intruded Dune Sands sediments and the underlying aquifer. In WY 2023, FO-10 Shallow's anions and cations on the Piper diagram plot similarly to the previous year while FO-10 Deep's anions and cations shifted slightly from the path towards seawater (Appendix D: Figure D-12)

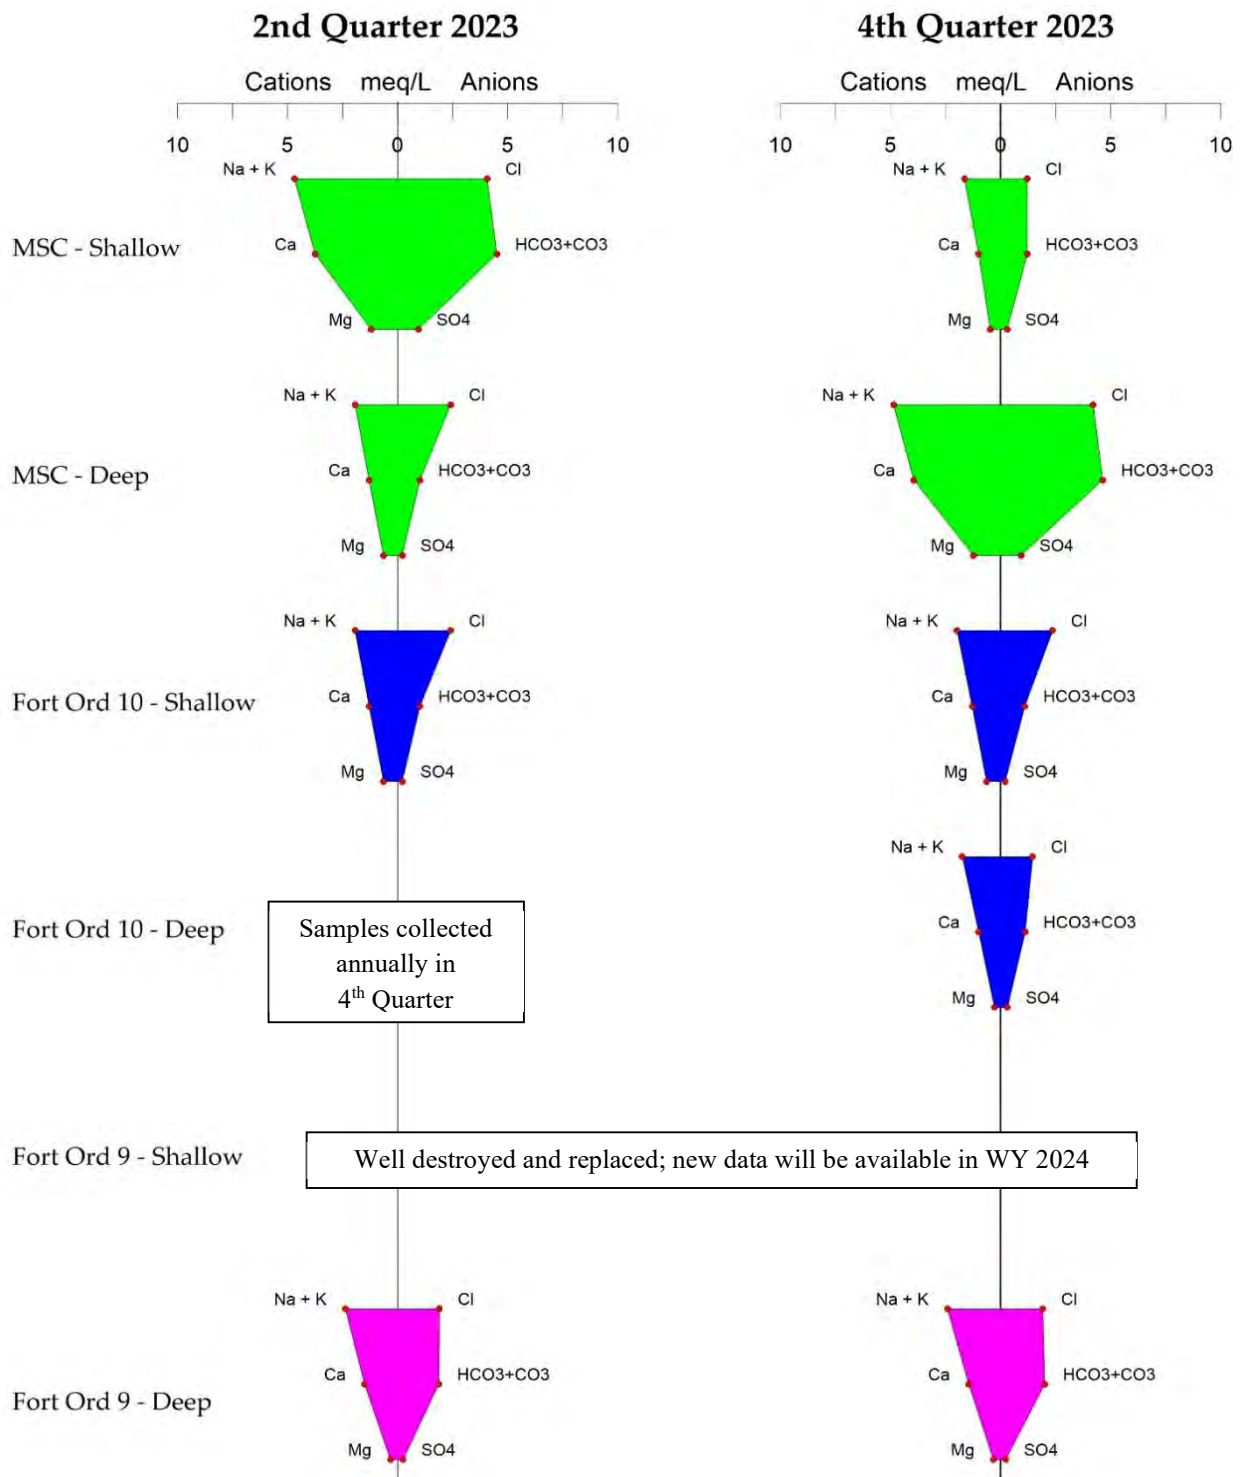
Figure 12. Stiff Diagrams for Monterey Sand Company (MSC), Fort Ord 9, and Fort Ord 10 Wells

than other shallow wells because of elevated chloride. In WY 2023, the shape of FO-10 Deep's stiff diagram is more similar to shallow wells than how it plotted in WY 2022. The mechanism behind the evolving shape of FO-10 Deep and FO-10 Shallow on the stiff diagrams is not currently known, and it is recommended that the nested well pair be destroyed and replaced.

Stiff diagrams for 11 monitoring wells sampled during the fourth quarter of WY 2023 are shown in the right column on Figure 12 through Figure 14. The shapes of the Stiff diagrams for the paired monitoring wells are similar to the shapes of Stiff diagrams for most prior years, with the exception of FO-10 Shallow which has a greater chloride equivalent concentration than  $\text{HCO}_3$  compared to other shallow coastal wells.

- It is recommended that FO-10 Shallow and FO-10 Deep be destroyed and replaced to maintain continuous water quality monitoring and to prevent cross contamination between the Paso Robles and Santa Margarita aquifers, and the overlying Dune Sands. These wells are located outside of the Basin, so destruction would need to be performed by the well owner, MPWMD, and replacement wells would need to be installed by the MCWD GSA.

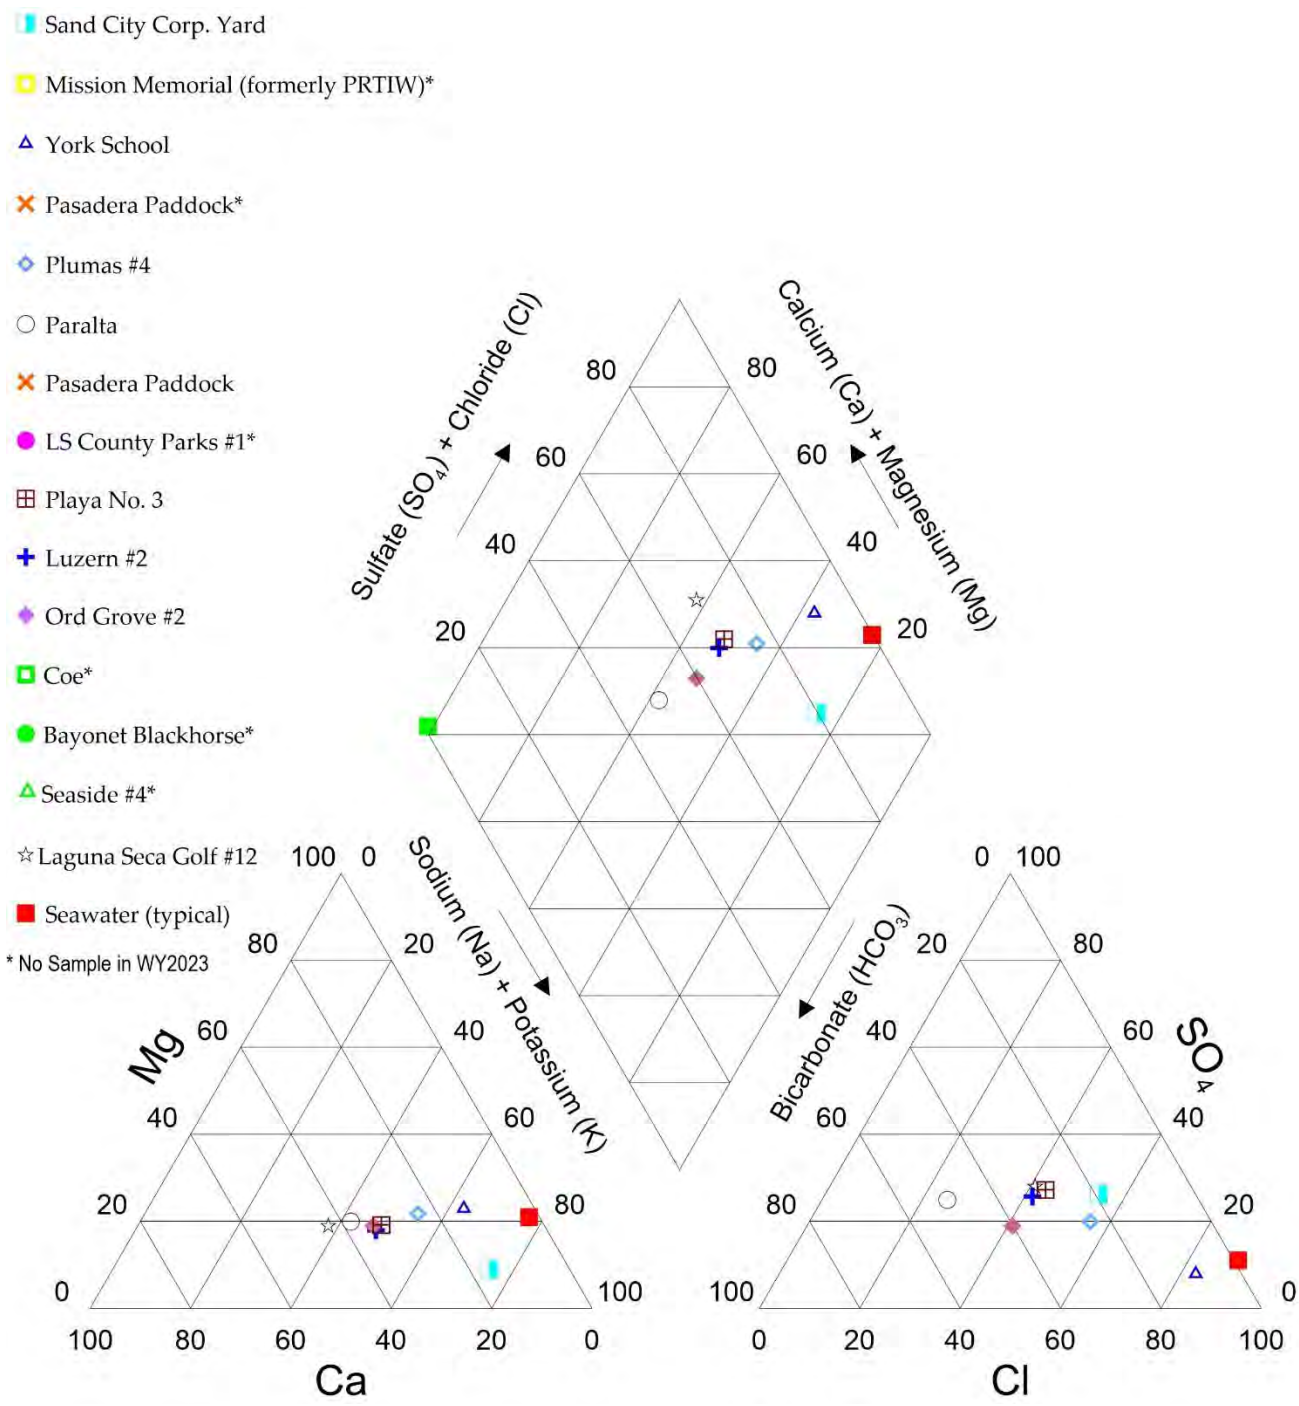
Figure 16. Piper Diagram for Seaside Groundwater Basin Production Wells, Fourth Quarter Water Year 2023 (July-September 2023)

Figure 16 presents a Piper diagram for fourth quarter groundwater from production wells. The production wells plot in roughly the same location on the Piper diagram as most monitoring wells on Figure 15. The variation of the plot location on the Piper diagram for production wells is due to higher sulfate and chloride anions than in the monitoring wells. Groundwater from these wells is characterized as sodium-sulfate-chloride type waters. The York School well plots closest to typical seawater on this diagram; however, its inland location precludes seawater intrusion as the cause for its observed water chemistry. Overall, the Piper diagrams show no indication of seawater intrusion at any of the production wells.

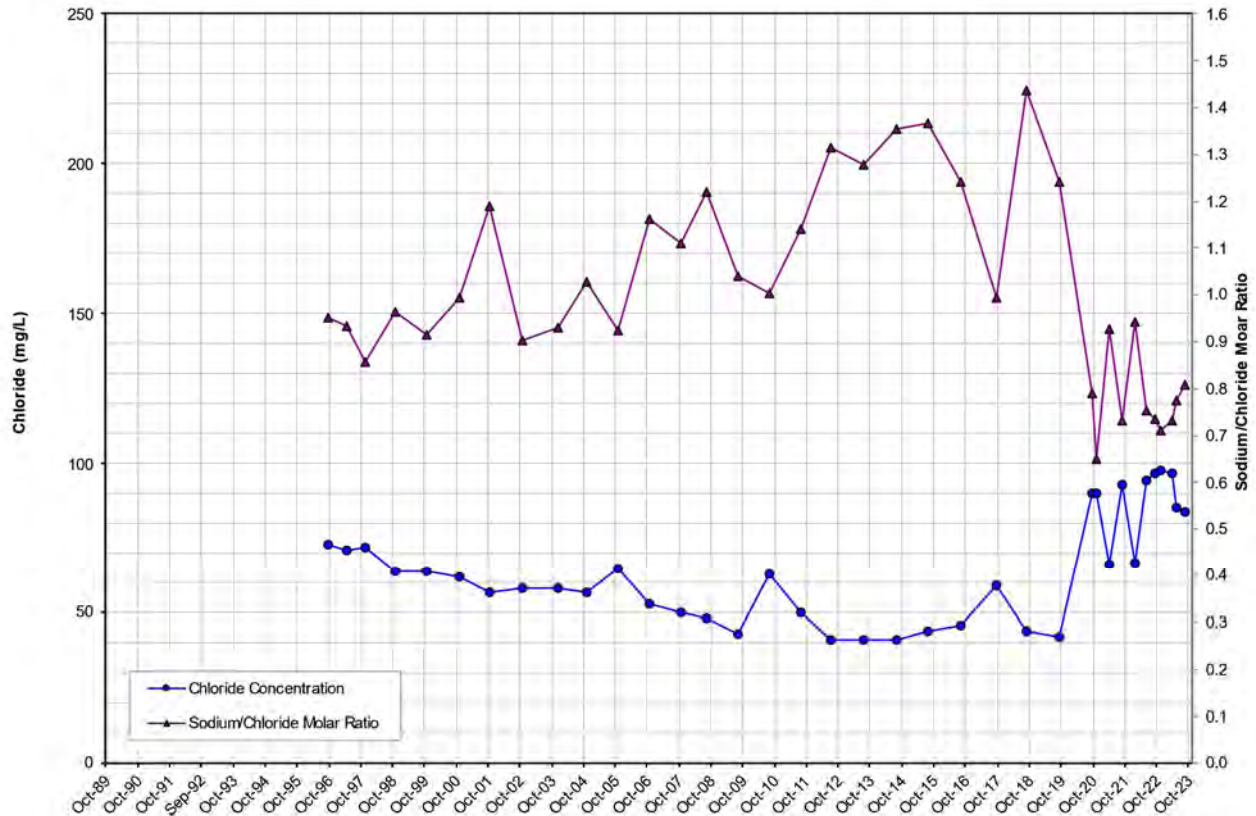
Figure 22. Historical Chloride and Sodium/Chloride Molar Ratios, FO-10 Shallow

construction. As the presence of this steel pipe clouds interpretation of groundwater quality results and may act as a conduit for groundwater in overlying sediments to enter underlying aquifers, it is recommended that both FO-10 Shallow and FO-10 Deep be destroyed and replaced to maintain a consistent water quality record in the area.

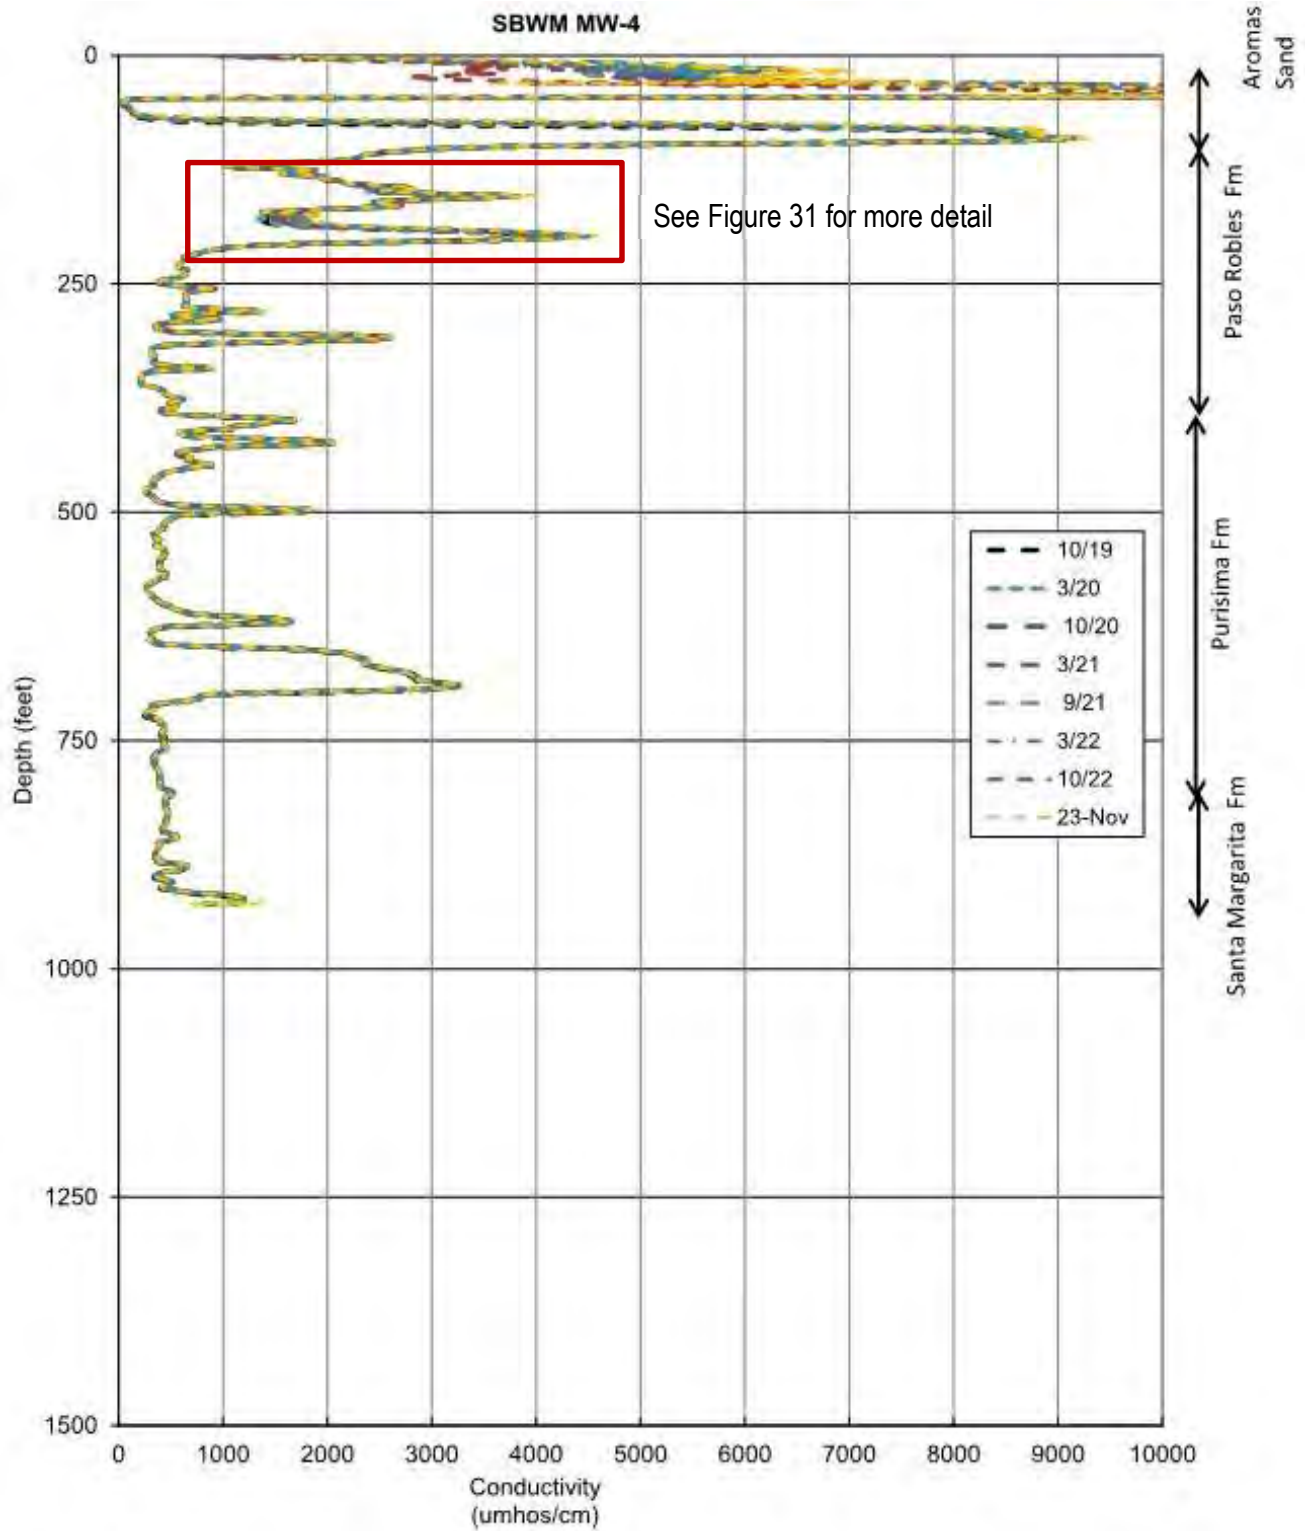
Figure 28. Sentinel Well SBWM MW-4 Induction Log

It will not be feasible to directly measure chloride in the zone of increasing conductivity in SBWM-4, because that would require construction of a new monitoring well targeting that zone. Since SBWM-4 is in the coastal zone and within the Fort Ord Dunes State Park, it would likely not be possible to obtain permission from the Coastal Commission and the State Department of Parks and Recreation to construct a new well at that location. Because of this, ways to use existing wells should be explored. It is recommended that options should be evaluated in WY 2024 for ways to determine if chloride is increasing in the Paso Robles Formation within the Basin.

- It is recommended that options for verifying seawater intrusion occurring in the Paso Robles Formation at or near SBWM-4 be evaluated in WY 2024. This may involve finding a site for a new monitoring well, adapting an existing well, induction logging a nearby monitoring well, or some other solution. If the fall 2024 induction logging results

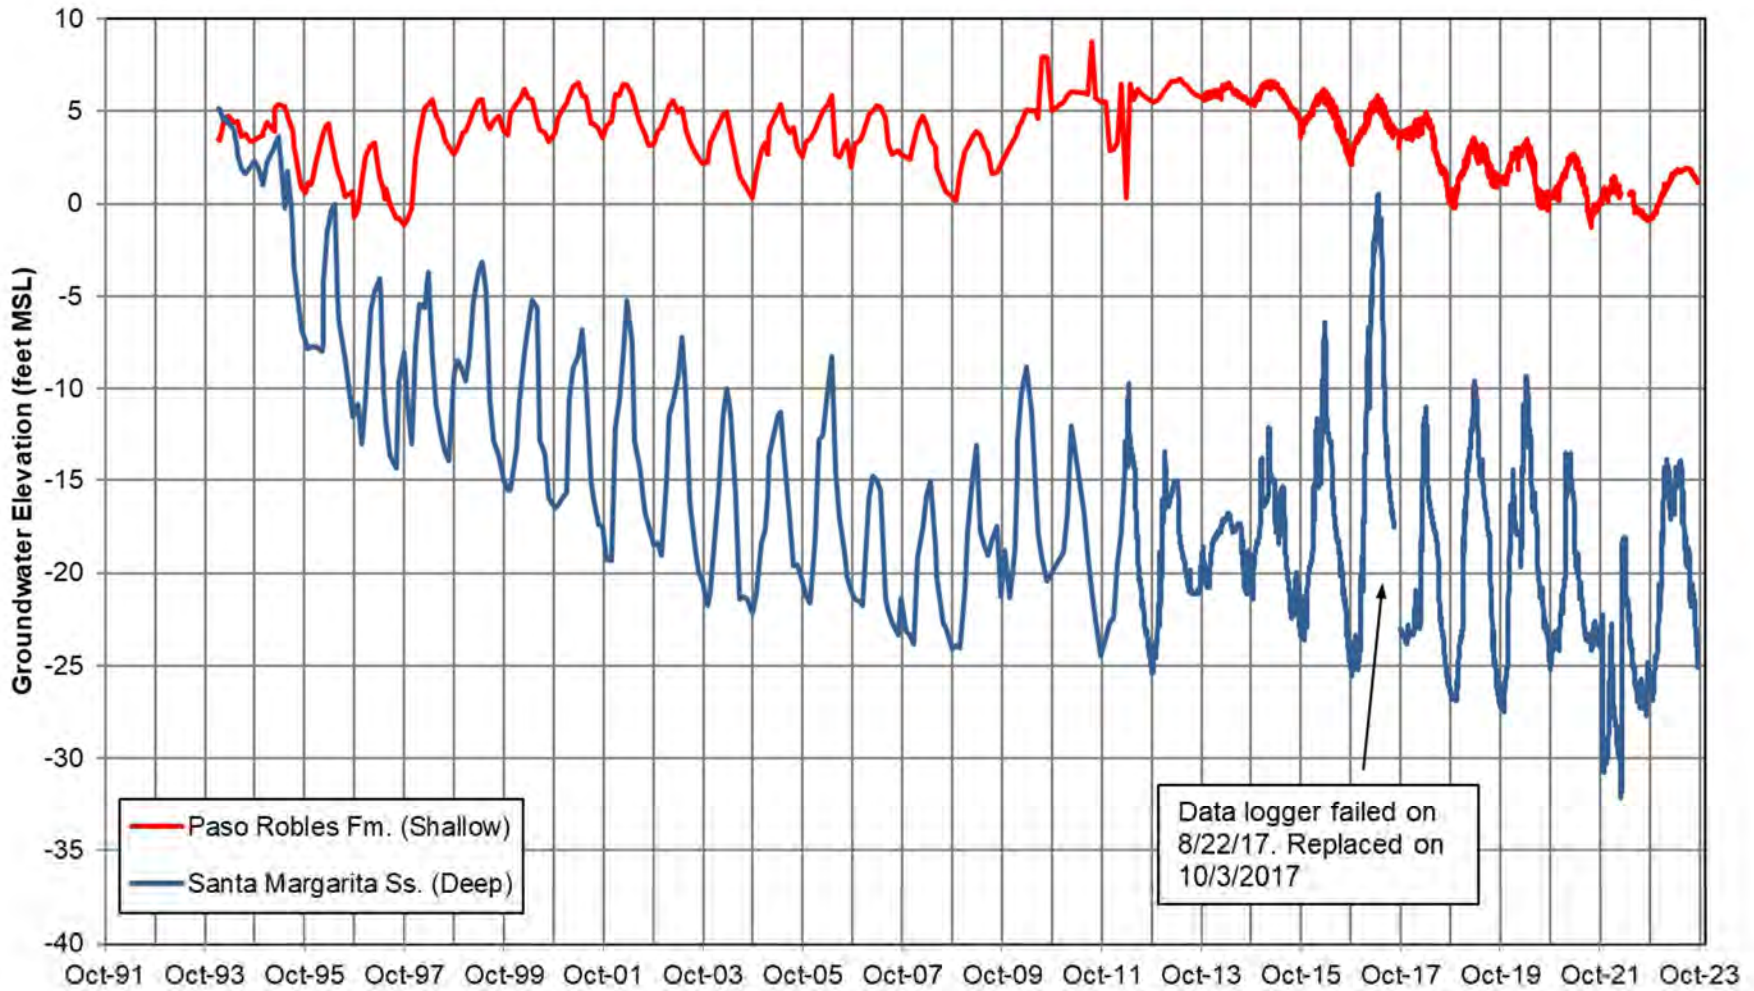
Figure 33. PCA-East Deep and Shallow Monitoring Well Hydrograph

Groundwater levels measured at the PCA-East well are generally representative of groundwater levels in the Northern Coastal subarea, west of nearby production wells. The hydrograph shows peaks and lows that are strongly influenced by pumping by the nearby CAWC production wells which draw from the deep aquifer, and injection of Carmel River ASR water and Pure Water Monterey (PWM) highly treated recycled water at the eastern boundary of the subarea (Figure 33). Other influences are also recognized, such as tides which can cause up to a 1-foot fluctuation in the deep completion of PCA-East. Because of all the possible influences on groundwater levels, it is difficult to compare the present year to the previous year directly. What is more important is to look at long-term trends.

Seasonal fluctuations are noticeable in the winter season when Santa Margarita groundwater elevations are at their highest for the year. For example, the 2017 winter high in PCA-East Deep increased to a level last seen in 1995, because 2,345 acre-feet of excess Carmel River water was injected as it was a very wet year. As described in Section 2.6.1, WY 2023 was a wet year, resulting in available Carmel River Water for ASR injection. Wet conditions, 3,755 acre-feet of Pure Water Monterey injection, and ASR injection resulted in an increase in the seasonal high elevations shown on Figure 33. This marks a departure from very dry conditions over the previous 2 years; last year both seasonal high and low groundwater elevations were amongst the lowest on record. In WY 2023 both seasonal high and low groundwater elevations increased relative to the previous year and are similar to conditions in WY 2020.

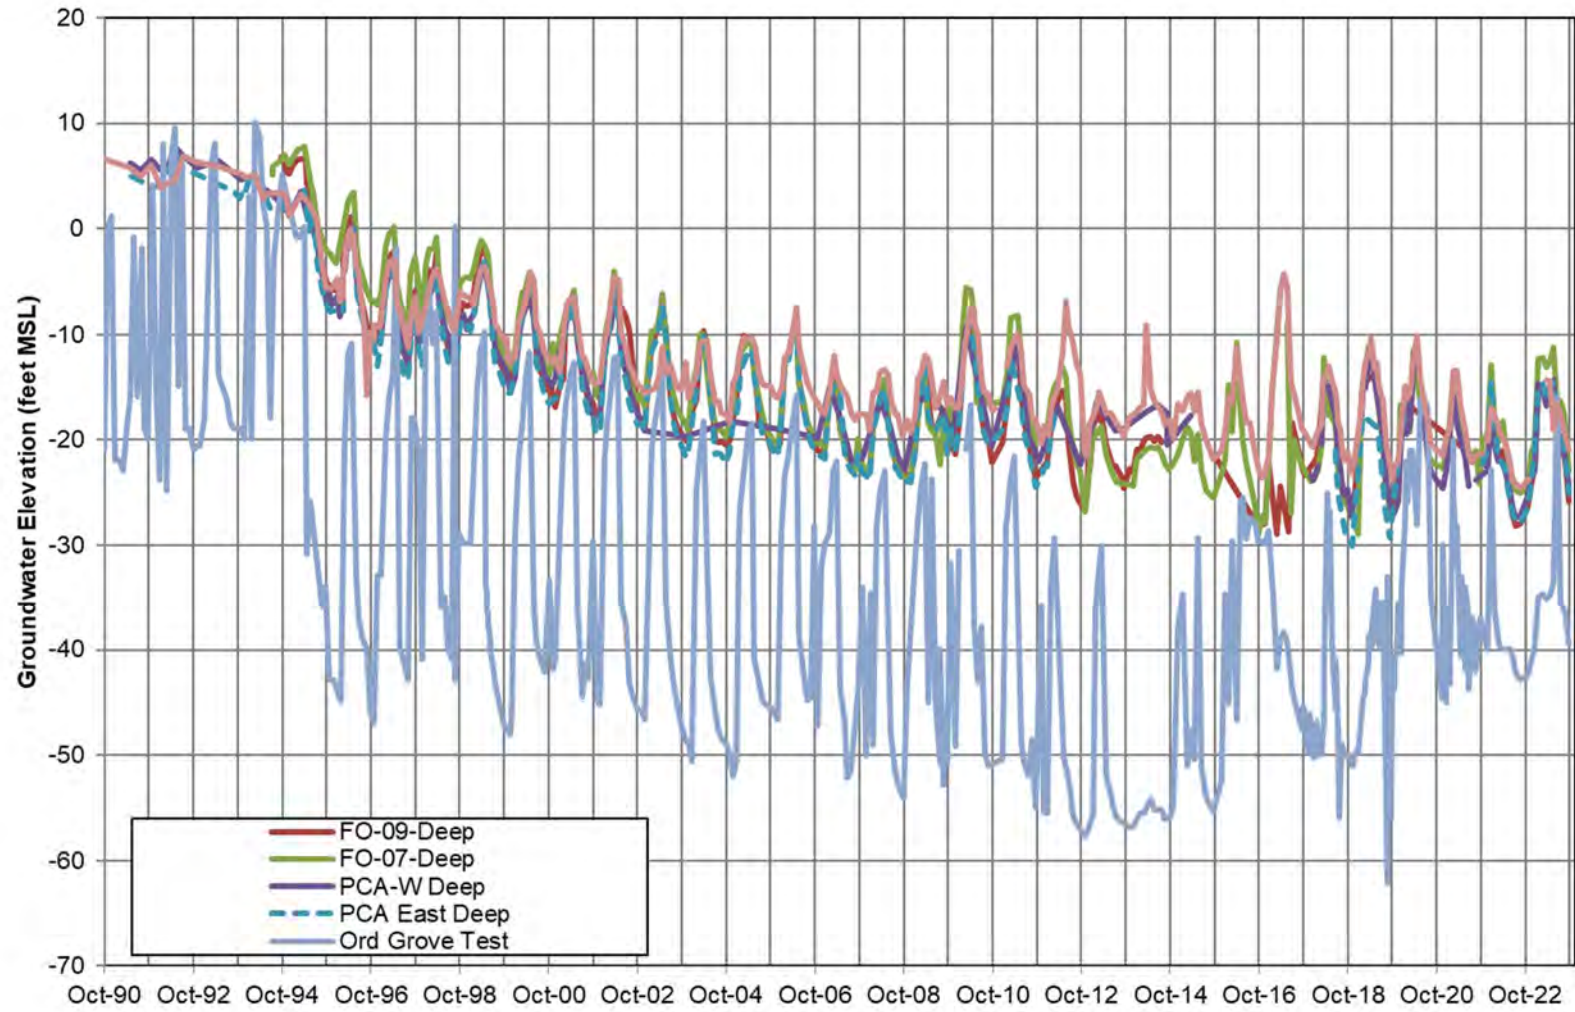
Figure 34. Santa Margarita Aquifer Northern Coastal Subarea Wells

Figure 34 displays groundwater elevations from the deep aquifer in a larger set of Santa Margarita aquifer Northern Coastal subarea wells, including PCA-East. Elevations in all these wells have been below sea level since the late 1990s. The discrepancy between wells near the center of the inland pumping depression (around Ord Grove Test) and more coastal and inland wells helps illustrate the gradient of the deep aquifer's pumping depression over time, shown for WY 2023 on Figure 41 and Figure 43. This discrepancy is illustrative of conditions near the very center of the pumping depression as compared to further from its center. Because the Ord Grove Test well is highly influenced by pumping at the Ord Grove #2 well, it is better to compare seasonal highs between this well and others in the Northern Coastal Subarea. The difference in groundwater elevations at Ord Grove Test and others in the Northern Coastal Subarea tends to increase during dry periods in response to reduced recharge and increased groundwater demand (See October 2012 through October 2016 on Figure 34). Over the past 5 years, the groundwater elevation difference has decreased for 2 reasons. First, elevations in the deeper portion of the pumping depression have risen somewhat over the past 5 years, likely a result of ASR injection in WY 2019, WY 2020, and WY 2023, and PWM injection in WY 2021 through WY 2023 (see October 2018 through October 2023 on Figure 34). Secondly, elevations in some of the wells further from the center of the pumping depression have fallen over the past 5 years (FO-07 Deep, FO-09 Deep, PCA-W Deep, MSC-Deep). Elevations at PCA-East Deep have likewise declined during WY 2021 and WY 2022 though they stabilized in WY 2023. From this it can be concluded that although the pumping depression's depth has decreased in the past few years, its lateral extent continues to grow during dry periods. The pumping depression's extent shrunk somewhat this year, in response to wet conditions, recycled water usage, net ASR injection, and PWM injection. How the shape and gradient of this deep pumping depression evolves over time should continue to be examined in these annual reports to inform projects and sustainability in the Northern Coastal Subarea.

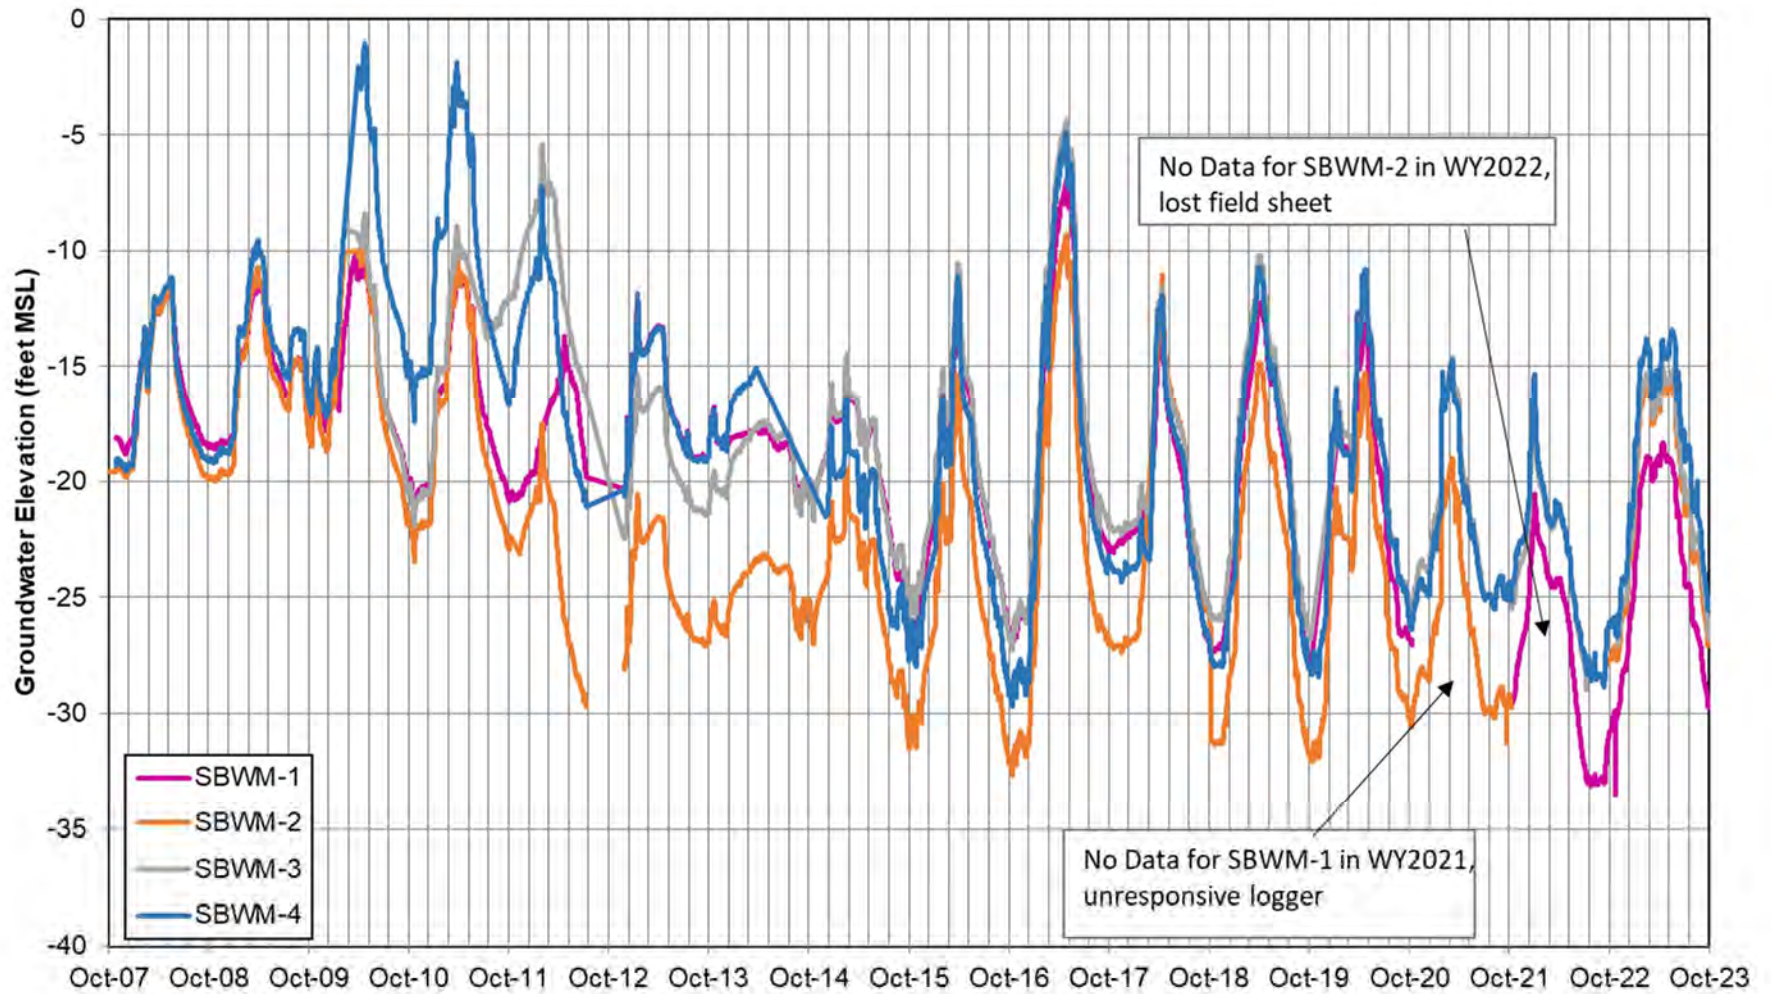
Figure 35. Sentinel Well Hydrographs

Figure 35 includes hydrographs of groundwater elevations for the 4 deep coastal Sentinel Wells. Groundwater elevations on this chart are collected from dataloggers in each well that record levels every 30 minutes. The hydrographs plot daily average elevations, thereby smoothing out the more detailed data which are affected by tidal variations. Hydrographs for the Sentinel Wells are similar to the PCA-East Deep hydrograph and show that groundwater elevations over winter and spring were the highest in WY 2017 because of increased ASR injection. Comparison between WY 2022 and WY 2023 is complicated by a lack of WY 2021 data at SBWM-1 and WY 2022 data at SBWM- 2. Data at SBWM-1 were not available during WY 2021 due to an unresponsive datalogger, but the logger was reinstated in WY 2022. Data at SBWM-2 were not available during WY 2022 due to a lost field sheet.

Following on from WY 2022 where both the seasonal high and low groundwater levels at SBWM-1 were the lowest over its period of record (Figure 35), groundwater levels in SBWM-1 increased slightly but still remain amongst the lowest on record. The modest increases are likely attributed to groundwater augmentation projects (PWM and ASR) and above normal precipitation in WY 2023. In WY 2023, seasonal lows at SBWM-2 were higher than the previous year and similar to WY 2020 and WY 2021. In WY 2023, SBWM-1 groundwater elevations are lower than SBWM-2 elevations. Missing data in WY 2021 and WY 2022 preclude knowing if this also occurred during those years, but in all previous years, SBWM-1 elevations have been higher than SBWM-2's elevations.

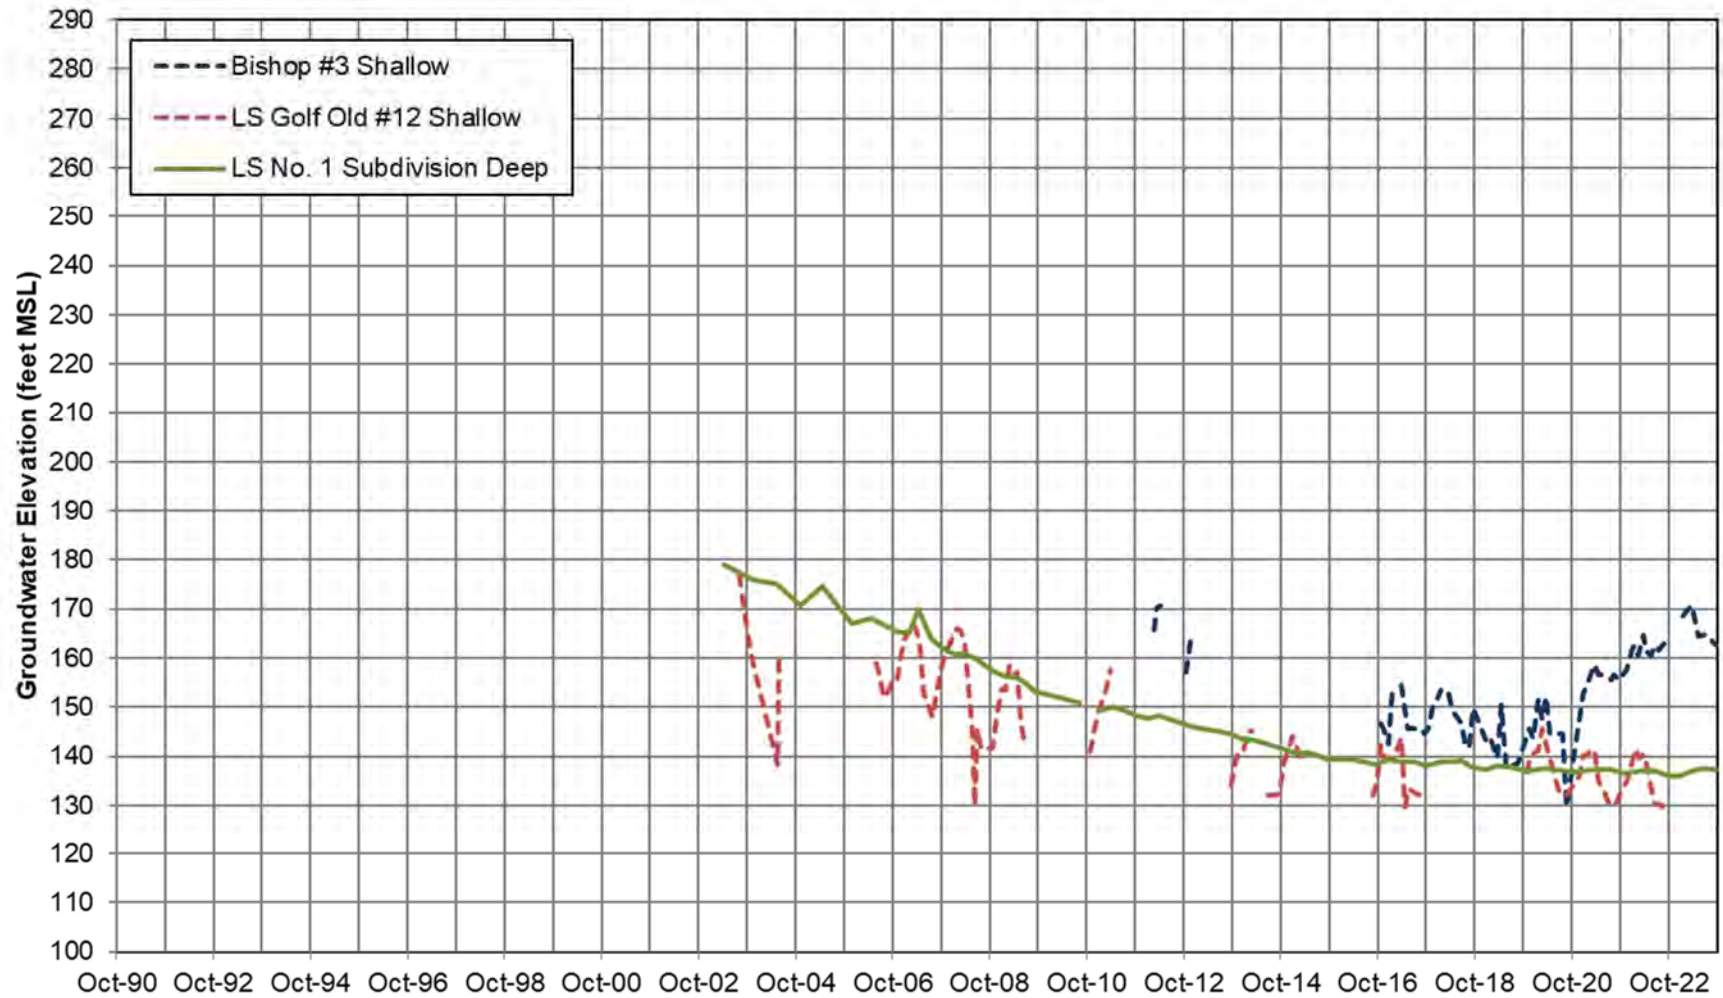
Figure 38. Eastern Laguna Seca Subarea Production Well Hydrographs

In the eastern portion of the subarea between 1999 and 2014, Paso Robles aquifer groundwater levels declined at a rate of approximately 0.6 feet per year and Santa Margarita groundwater levels declined up to 4 feet per year, as shown on Figure 37. Although there was some stabilization between WY 2014 and WY 2016, groundwater levels were declining at a general rate of roughly 0.5 feet per year in both the Paso Robles and Santa Margarita aquifer systems. In WY 2023, the declining trend stabilized at LS No. 1 Subdivision. No data was available in WY 2023 for LS Golf Old #12. In WY 2023, groundwater elevations at the Bishop #3 well continue to rise in response to CAWC ceasing pumping in the Bishop unit. There has been approximately 20 feet of recovery since 2020. Similar trends are present in the central portion of the subarea, as shown on Figure 38.

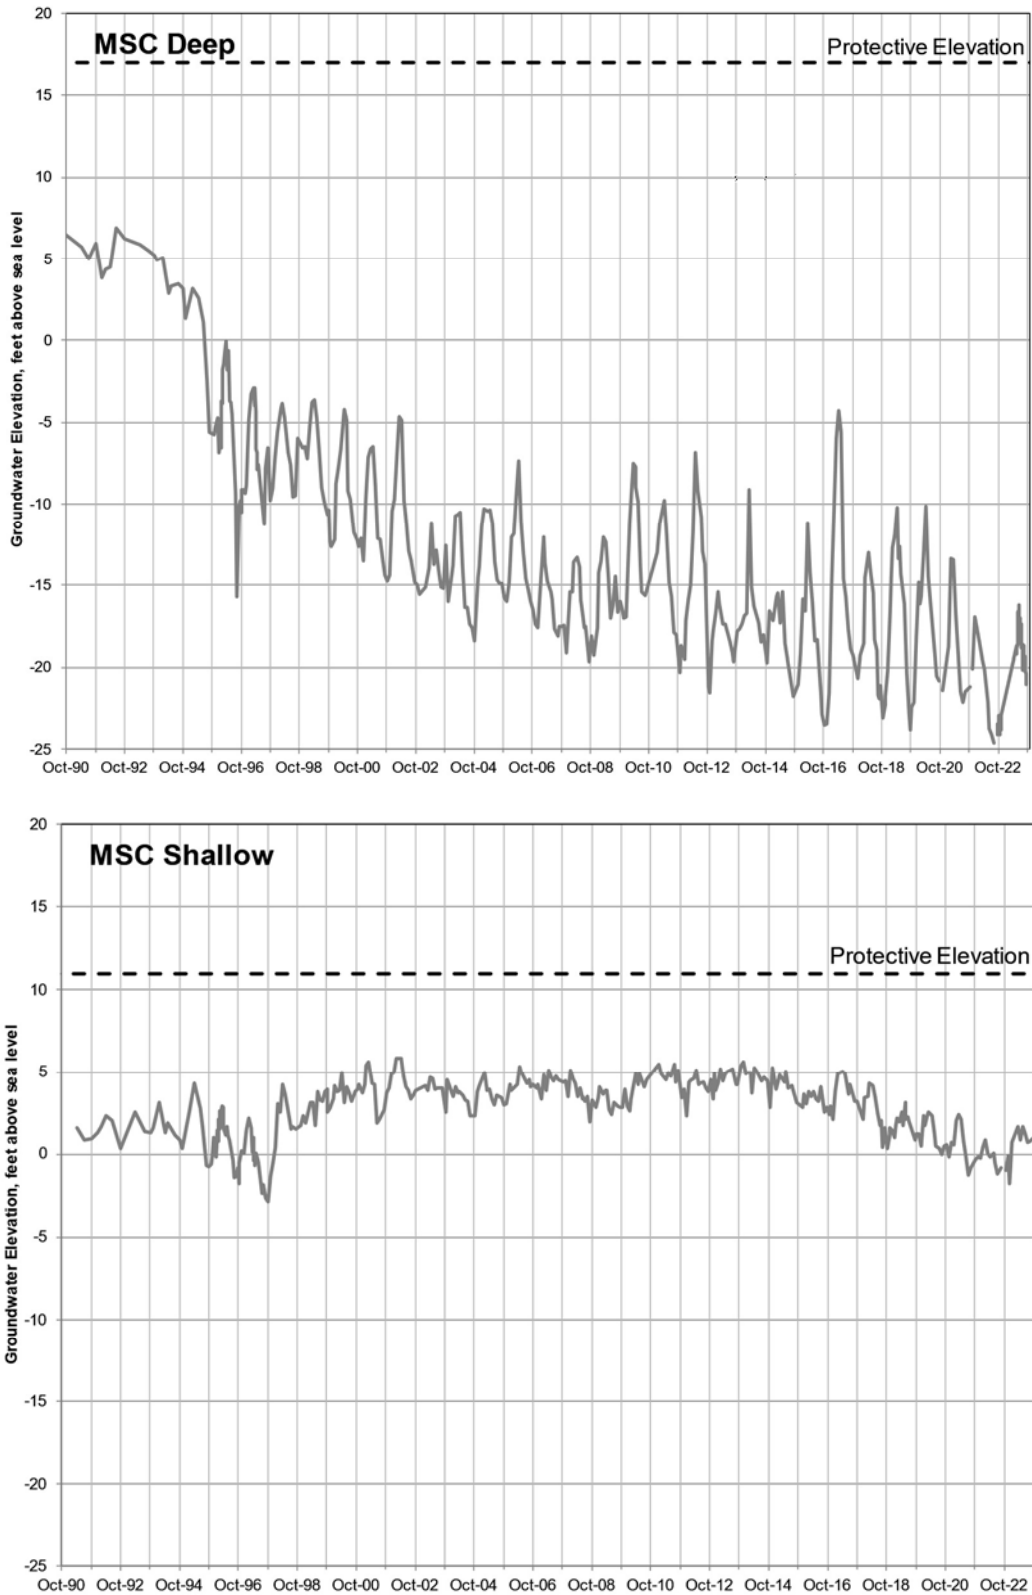
Figure 44. MSC Deep and Shallow Groundwater and Protective Elevations

Figure 44 through Figure 47 show the historical groundwater elevations at each of the target protective elevation monitoring wells. Groundwater levels continue to be below protective elevations in all Santa Margarita target monitoring wells (MSC deep, PCA-West deep, and Sentinel Well 3). Last year, groundwater levels at all 3 Santa Margarita monitoring wells were the lowest over their historical records. In WY 2023, groundwater levels stabilized and are slightly higher than the previous year. Monitoring well CDM-MW4 is the only Paso Robles well (1 of 3 Paso Robles wells total) with groundwater level above its protective elevation. Groundwater levels in the PCA West Shallow well fell below protective elevations in WY 2020 and remained below through WY 2022. In WY 2023 groundwater elevations briefly increased to just below the protective elevation in June. Elevations at this well declined during the summer but the WY 2023 fall elevation remains 1 to 2 feet higher than the 2 previous years. Groundwater levels in the MSC Shallow well continue to be below its protective elevation.
