Subject: Geophysical Investigation Fort Ord Monitoring Wells FO-9 and FO-10 – Preliminary Findings

Fort Ord MW-10 Investigative Geophysics

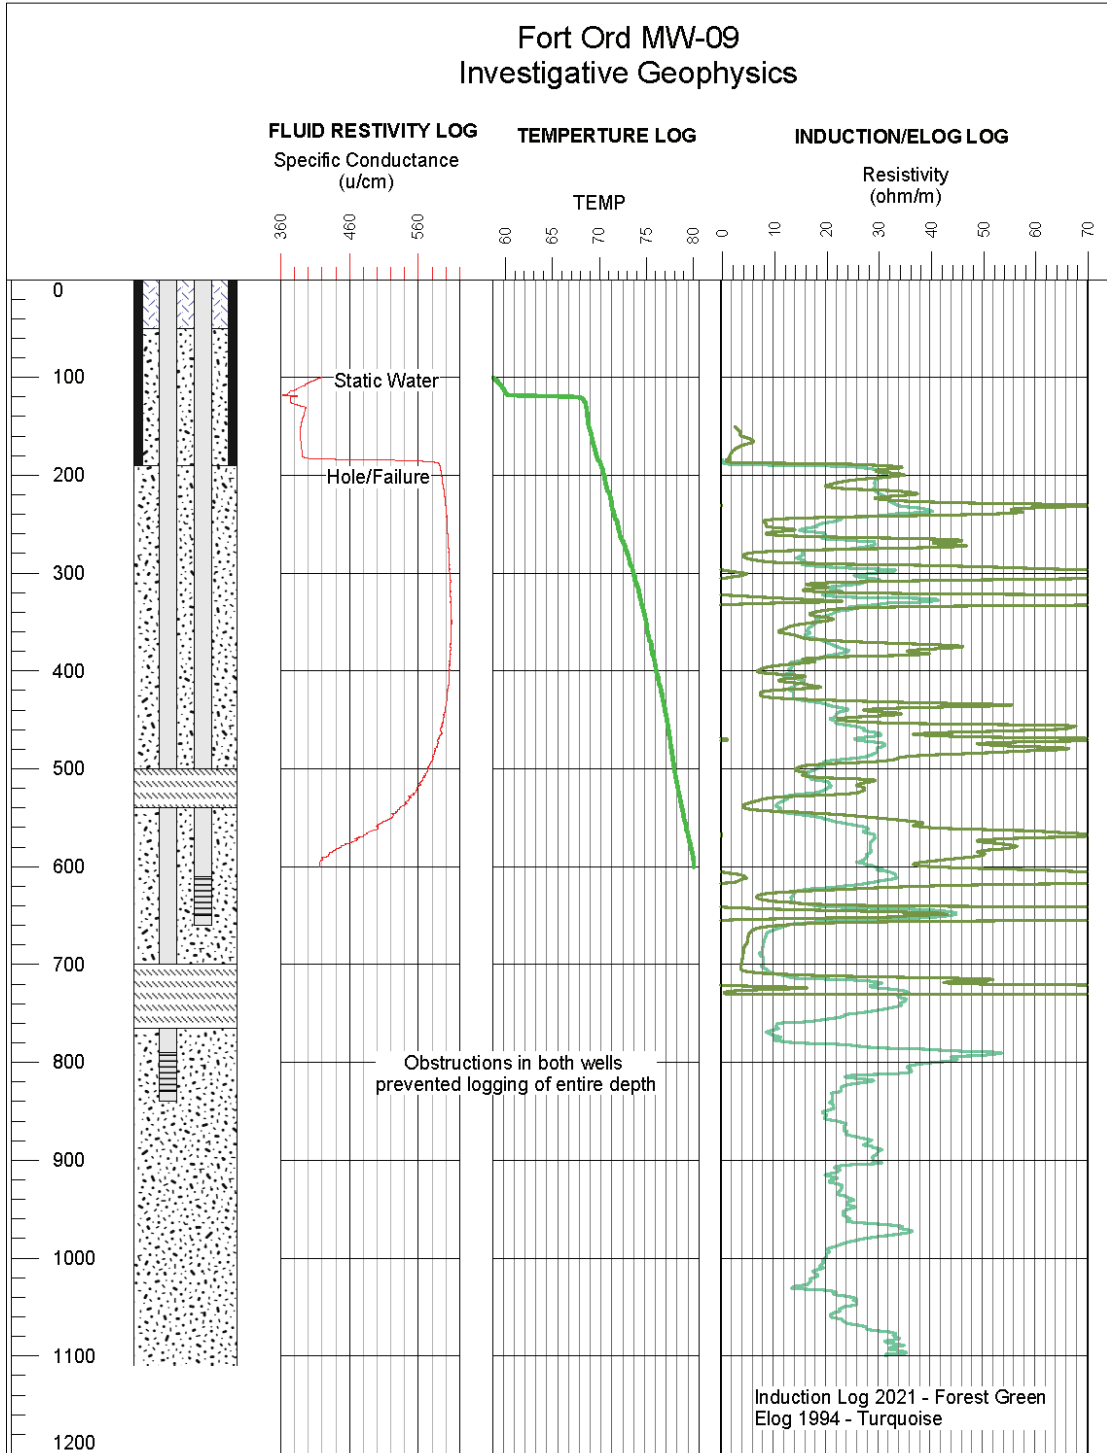
Figure 1

FO-09

- Both of the completions (shallow and deep) at this site have debris (airlift pipe, suction pipe?) in the bottom of the wells so we were not able to get to bottom or even into perforations.

- As can be seen in the Fluid Resistivity log for this well, FO-09 Shallow is leaking poor quality water into the well at about 185 feet bgs (about -40 ft msl). The data suggest the well has a structural flaw (crack, open joint?) at this depth.

- Below this depth, water quality is impacted but as the log approaches the perforations, the quality improves.
- The induction logging matches the original e-log reasonably well. Although the magnitude of the recent trace appears higher than the original, no area looks more conductive than it was in 1994. The higher magnitude of the recent trace is likely a function relating to the legacy e-log to which it is compared, which reflects the higher conductivity fluid in the borehole at the time of original logging. The drilling mud had a conductivity (EC) of about 625 μS at time of drilling whereas now the water (where not impacted by the leak) in the well (and formation) is closer to 400 μS .

- The elevated chloride values in the water quality samples from this well are the result of the entry of water from higher in the casing, not recently advancing SWI.

The two shallow wells were displaying elevated chloride values. The new data confirms that the water quality samples from FO-09 Shallow are impacted by a structural flaw in the casing that is allowing poor quality water to enter the casing and contaminate the perforated area from which samples are taken. The recent samples are not representative of the in-situ aquifer water from the screened interval at this location. It is recommended that this well be video surveyed to assess the nature of the flaw. After confirmation of the nature of the structural flaw, the well should be repaired or destroyed to prevent continued contamination of the Paso Robles Formation at this location.

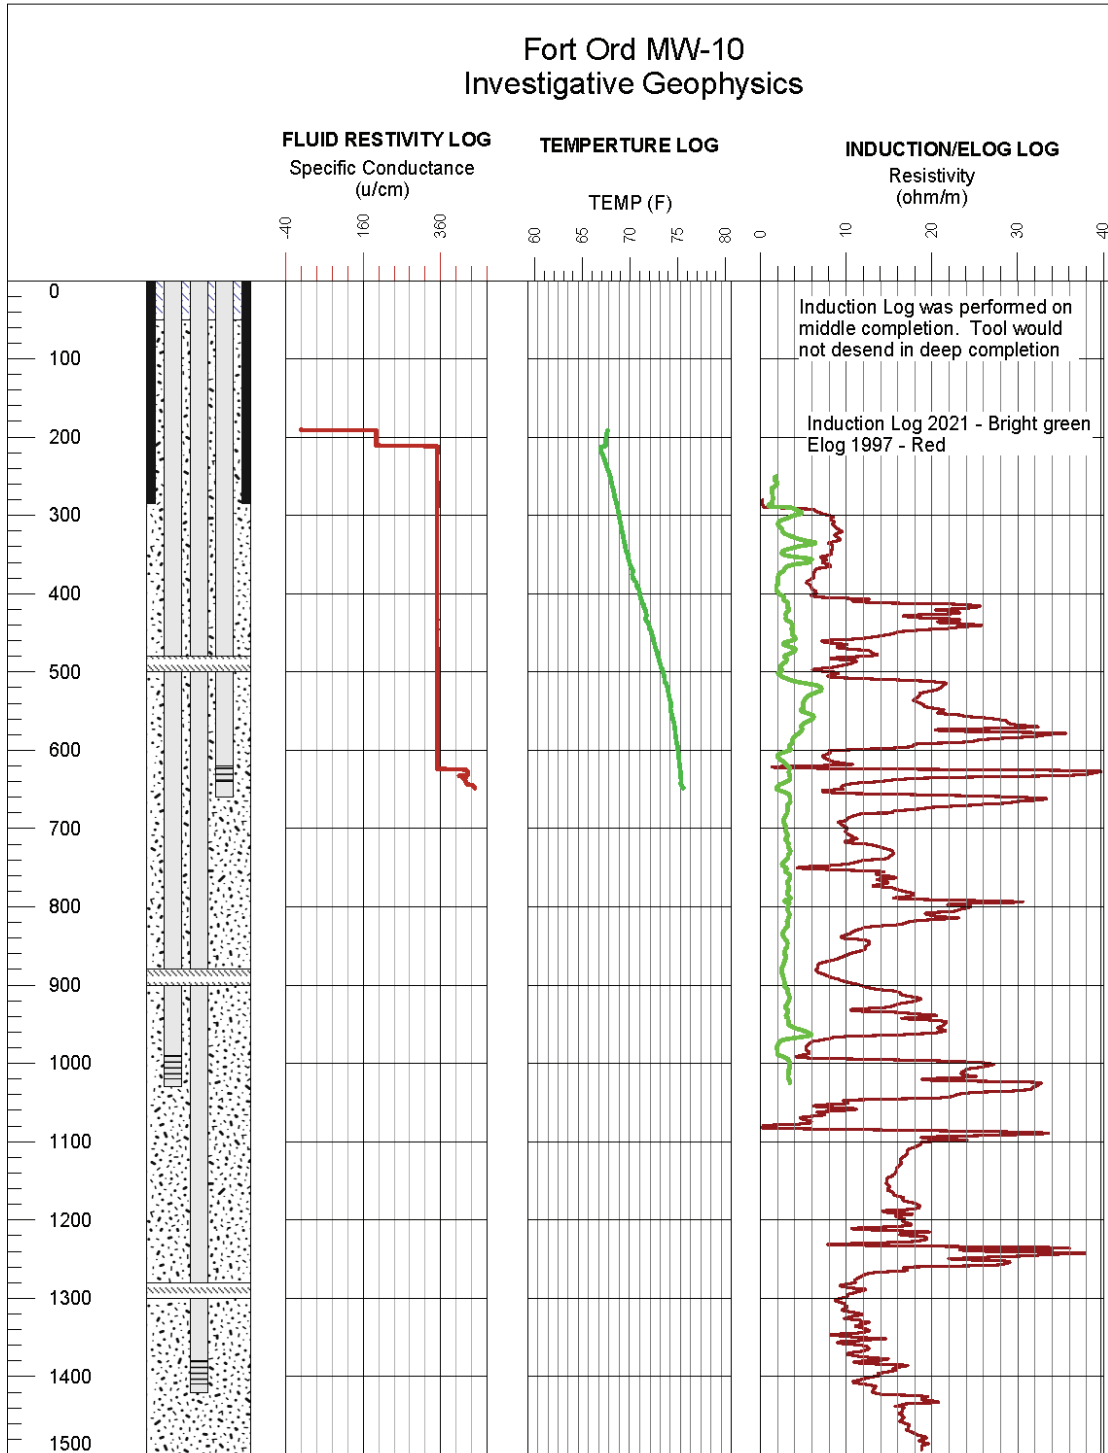
Figure 2

FO-10

- The induction tool was not able to descend in the deep well as the upper section has a bend in the casing that is too tight for passage. The intermediate and shallow wells were successfully logged to bottom.

- The induction log is severely muted when compared with the original e-log. At first glance it looks like seawater intrusion, but on further reflection the shift is along the entire profile, which is considered unlikely. The reason for the muted response is unclear. Discussions with the geophysical contractor suggest that all the intermediate well seals are leaking and allowing poor quality water from above. Whereas that theory would explain the data, it again is considered highly unlikely because water level data from these wells consistently show significant differences between shallow and deep completions.

- The fluid resistivity logs show elevated EC in the screen section relative to the standing water in the casing, suggesting the quality in the screen section may be changing and the water quality samples from this well may be valid.

The data also confirms that the recent increase in chlorides in FO-10 Shallow is representative of the water in the perforations. The reason for the increase is not known. Ongoing routine sampling may assist in better determining water quality trends and any additional well investigative recommendations at this location.

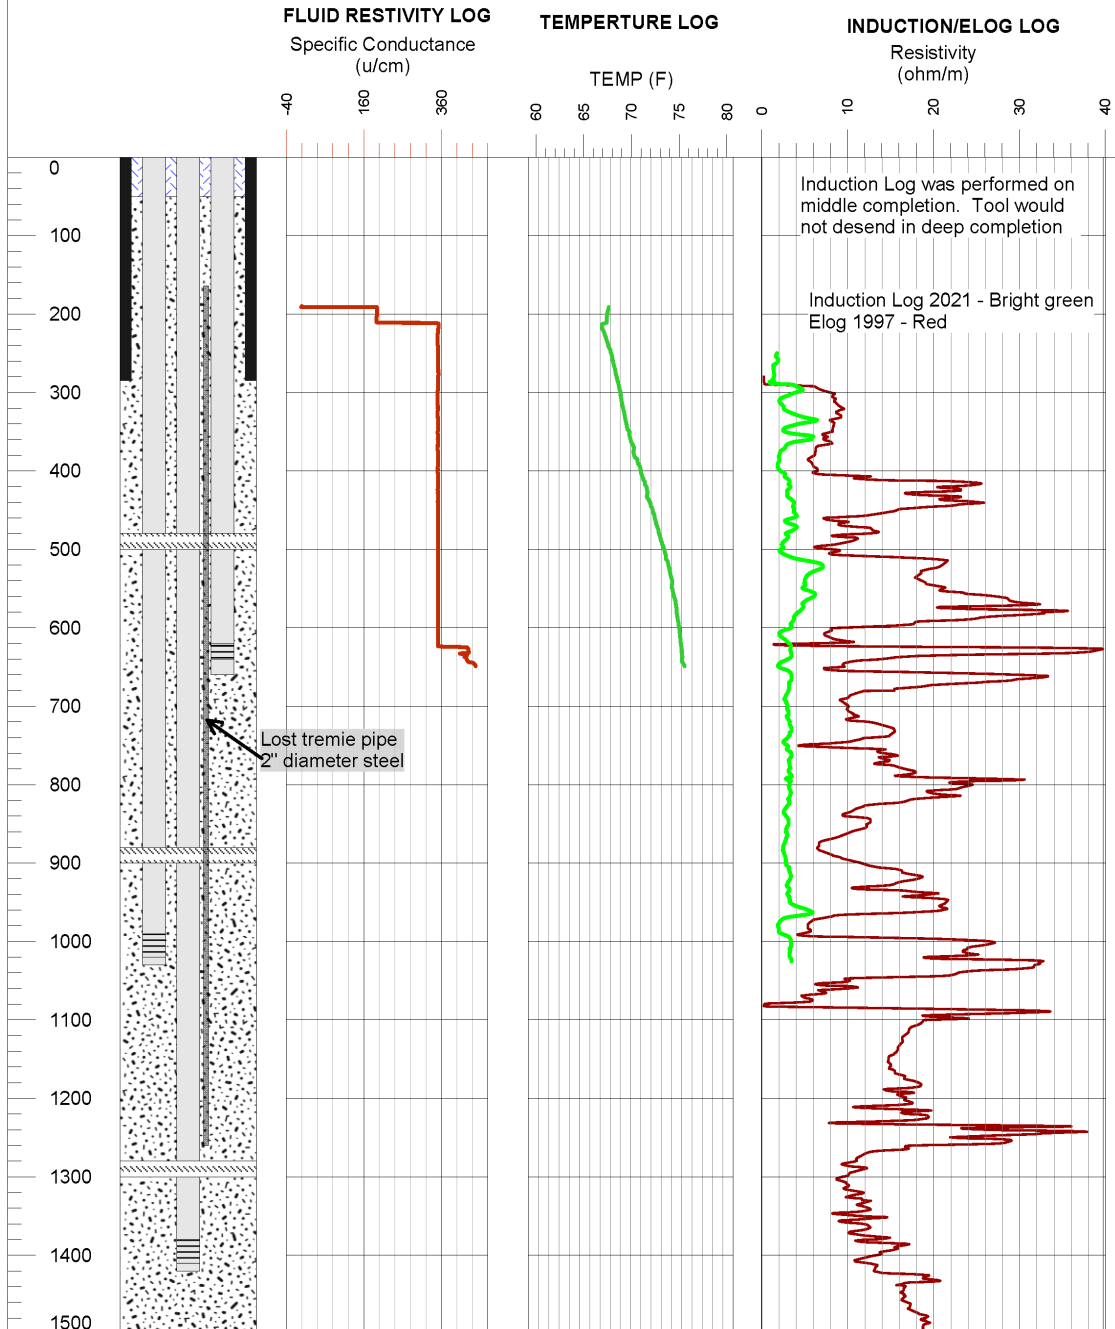
The data collected from FO-10 were more confusing. The EC/Temp showed water similar to that in the perforations throughout the water column. The induction log data were quite confusing. Like FO-9 the original elog was digitized, but the induction log data showed a quite muted signal compared to the original elog. The reason for this response was unknown at the time.

Recently, in discussions with Joe Oliver and review of the field notes that are included in the summary report of the construction of FO-10 (MPWMD TM 97-04), it has been discovered that approximately 1300 feet of 2-inch diameter steel tremie pipe became stuck and had to be abandoned in the hole during construction of this well (see diagram). The presence of this steel pipe now explains the previously unexplained muted response of the induction log. This also could explain the rising chlorides in the FO-10S well. It has been close to 30 years since construction, and the tremie pipe may be corroded and, similar to FO-9S, allowing poorer quality water to move from zone to zone.
