November 25, 2019

# **Seaside Groundwater Basin 2019 Seawater Intrusion Analysis Report**

Seaside Groundwater Basin Watermaster  
Monterey County, California

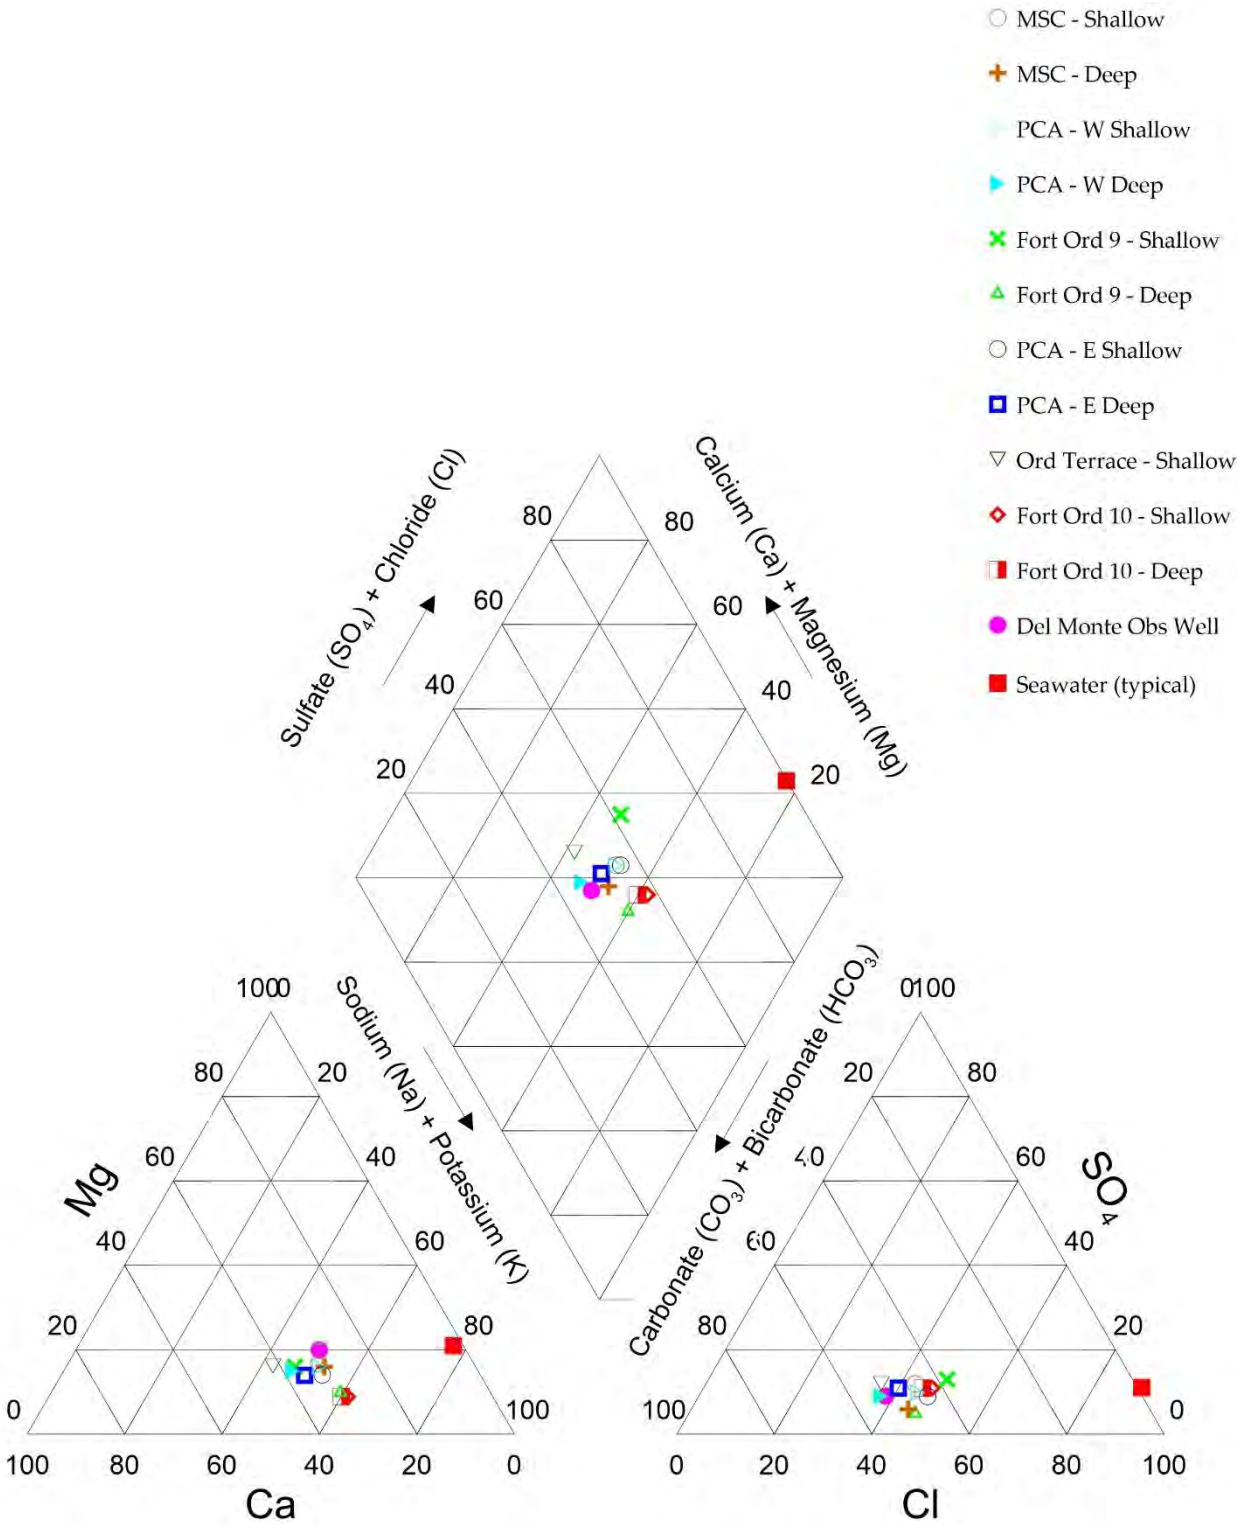
Figure 15. Piper Diagram for Seaside Groundwater Basin Monitoring Wells,  
4<sup>th</sup> Quarter Water Year 2019 (July- September 2019)  
(Data source: Watermaster)

Figure 15 shows groundwater quality data for the monitoring wells clustering generally in a single area on the Piper diagram, which is a pattern similar to that observed in previous SIARs. Groundwater is generally of a sodium-chloride/sodium-bicarbonate type and is not impacted by seawater.

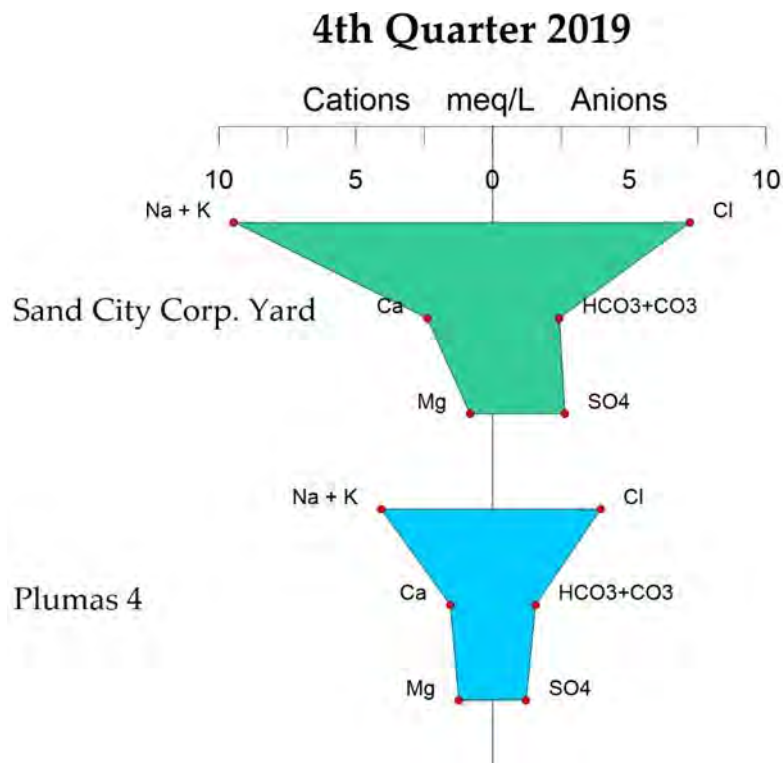
Figure 17. Stiff Diagrams for Southern Coastal Subarea Production Wells  
(Data source: Watermaster)

Stiff diagrams for the 15 production wells sampled during the 4<sup>th</sup> quarter of Water Year 2019 are shown on Figure 17 through Figure 20. These production well Stiff diagrams show no significant changes from the shapes observed in previous years. The Pasadera Paddock production well has a Stiff diagram shape that is different from the other wells' chemistry. The cause of this could be localized mineralization. The Laguna Seca subarea is known to have higher salts in groundwater than the rest of the basin due to the underlying Monterey shale which was deposited in a marine environment. None of the Stiff diagrams for production wells show the high chloride spike shown on Figure 7 that indicates seawater intrusion.

The York School production well, in the Laguna Seca subarea, and Sand City's Public Works Corp Yard production well, in the Southern Coastal subarea both have Stiff diagrams different from most other wells' water quality (Figure 18). Although the shapes are different, they do not display the large chloride spike associated with seawater intrusion as shown on Figure 7. None of the production wells analyzed using Stiff and Piper diagrams show an indication of seawater intrusion.

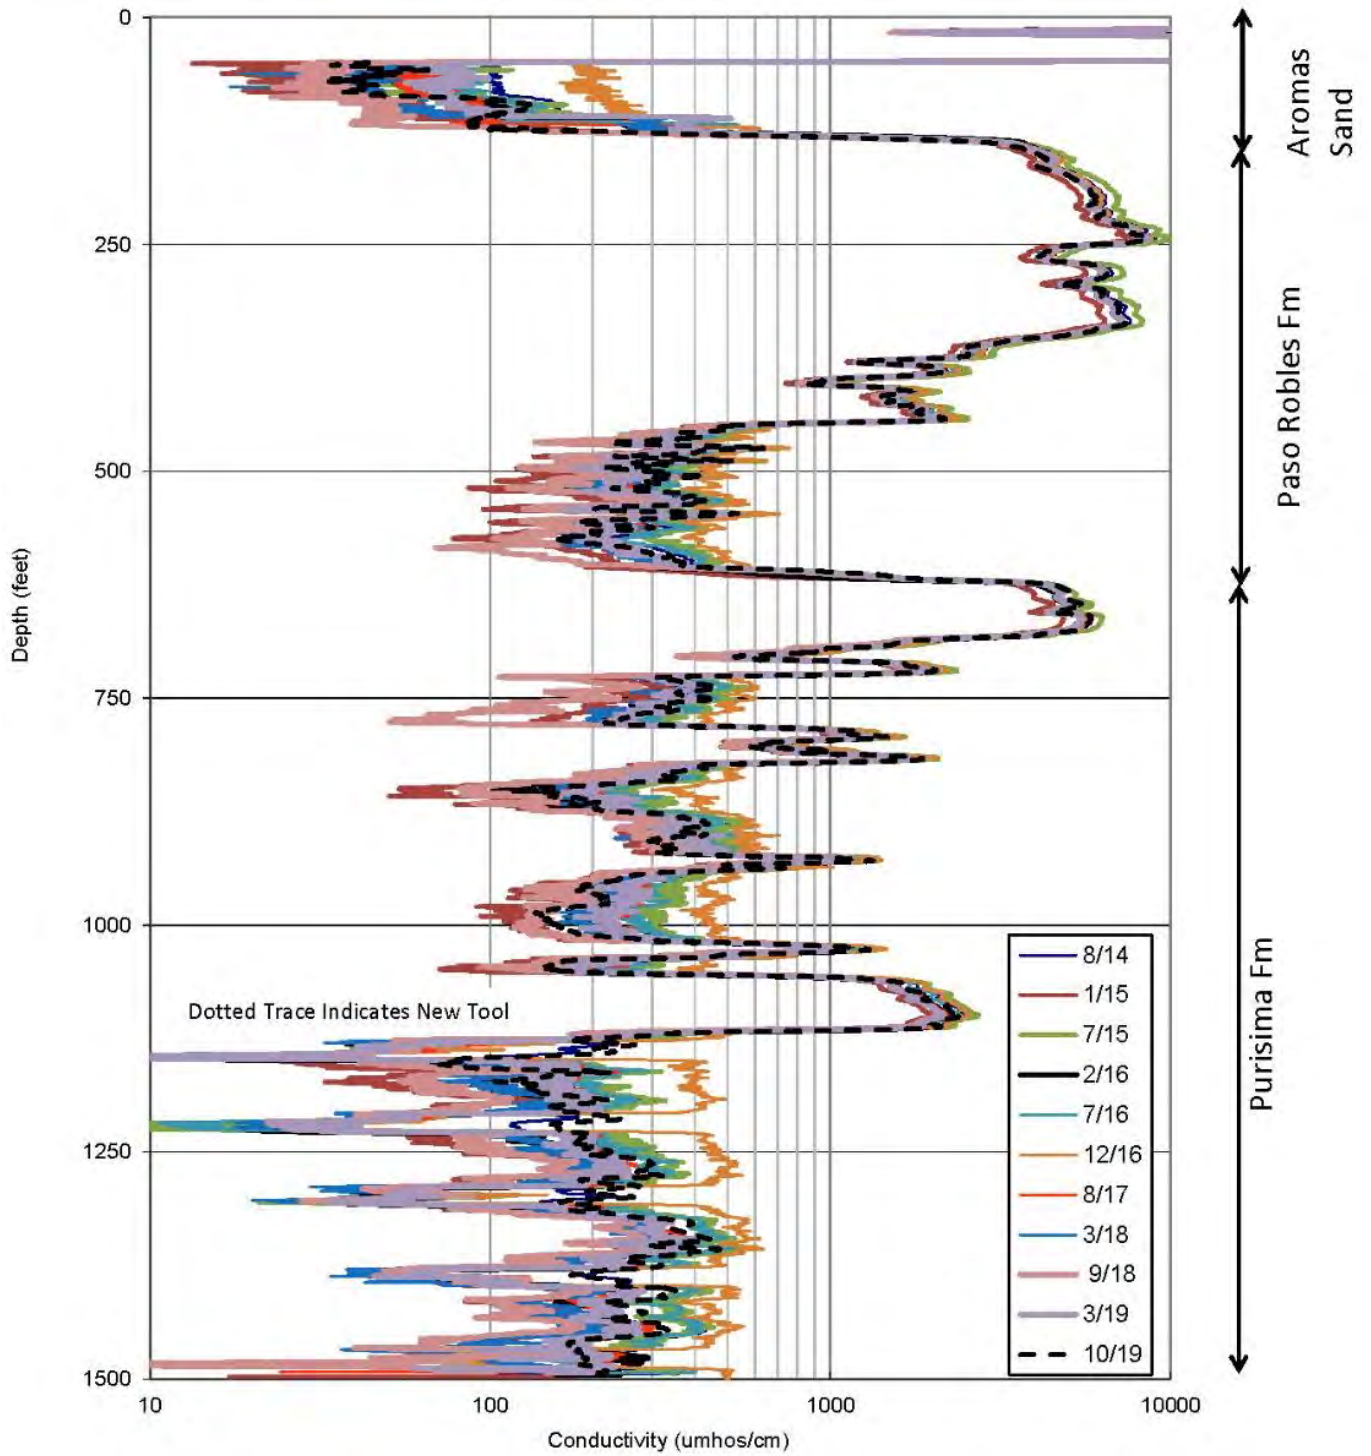
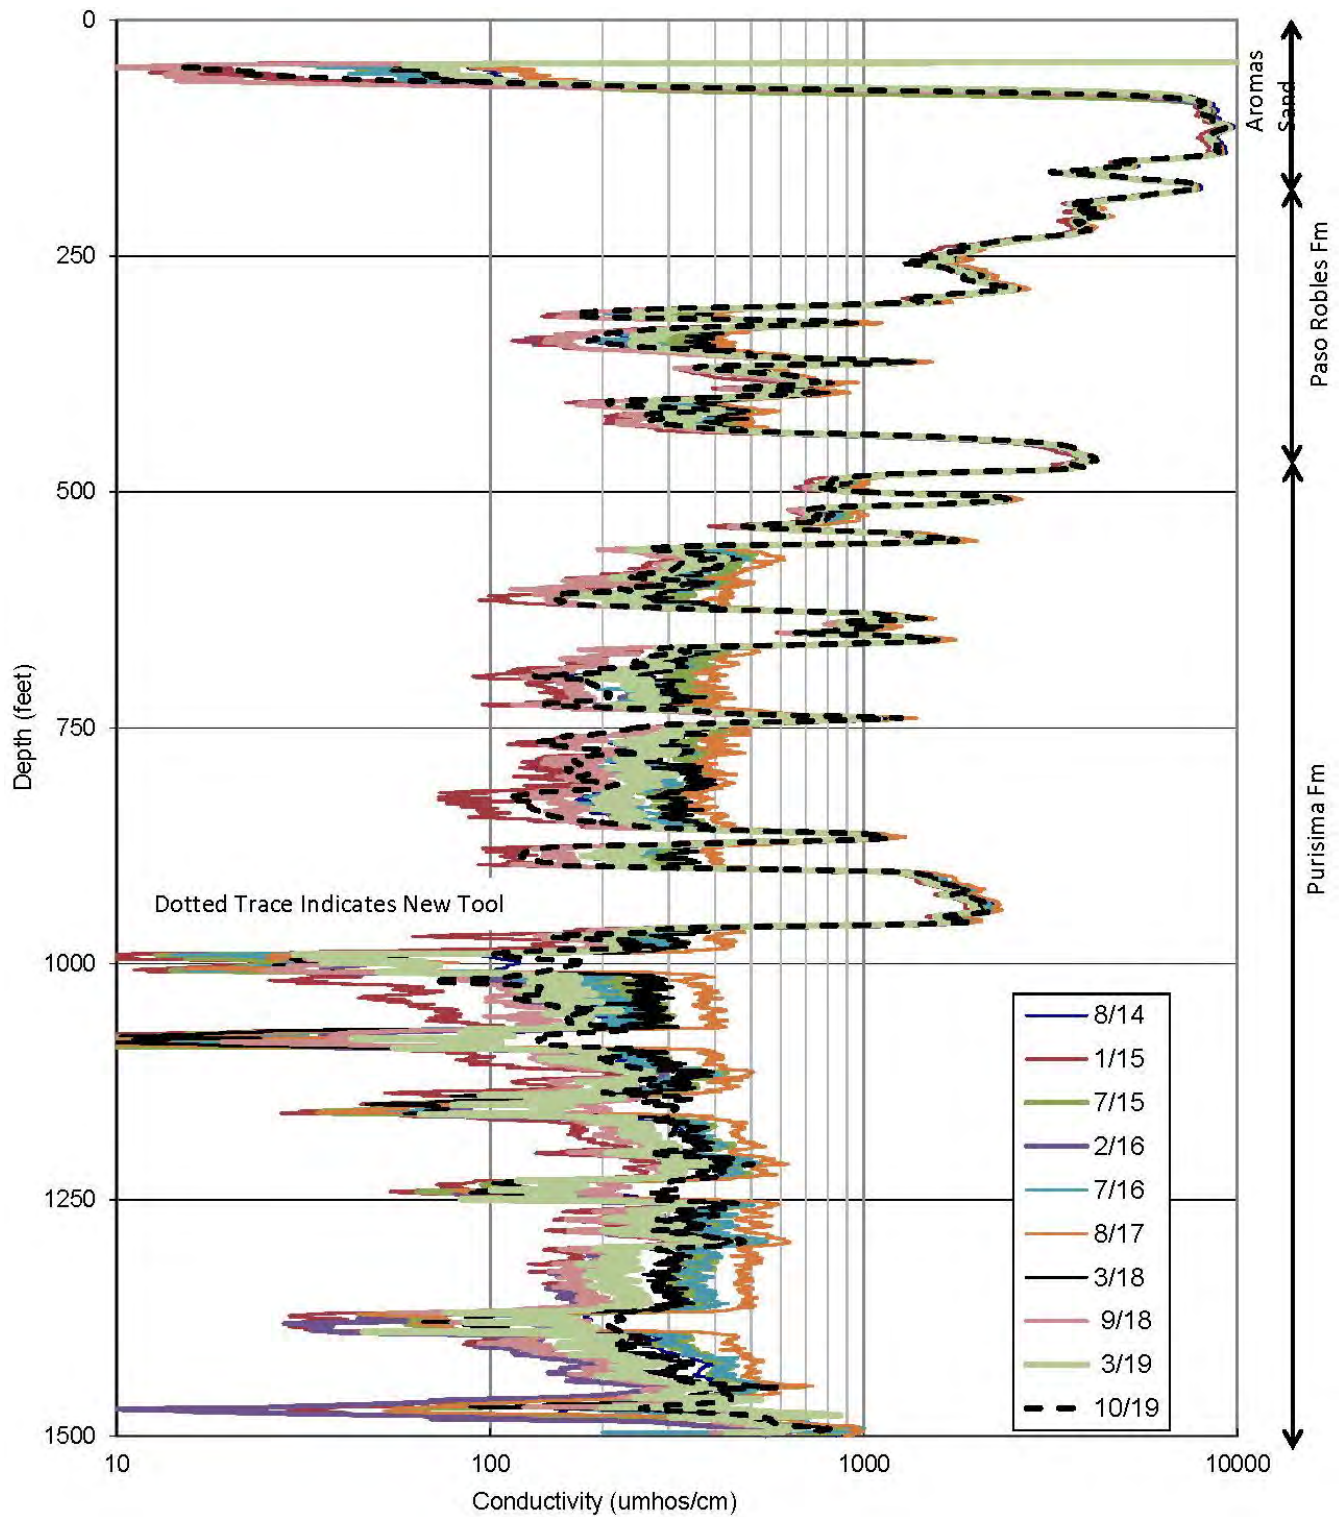
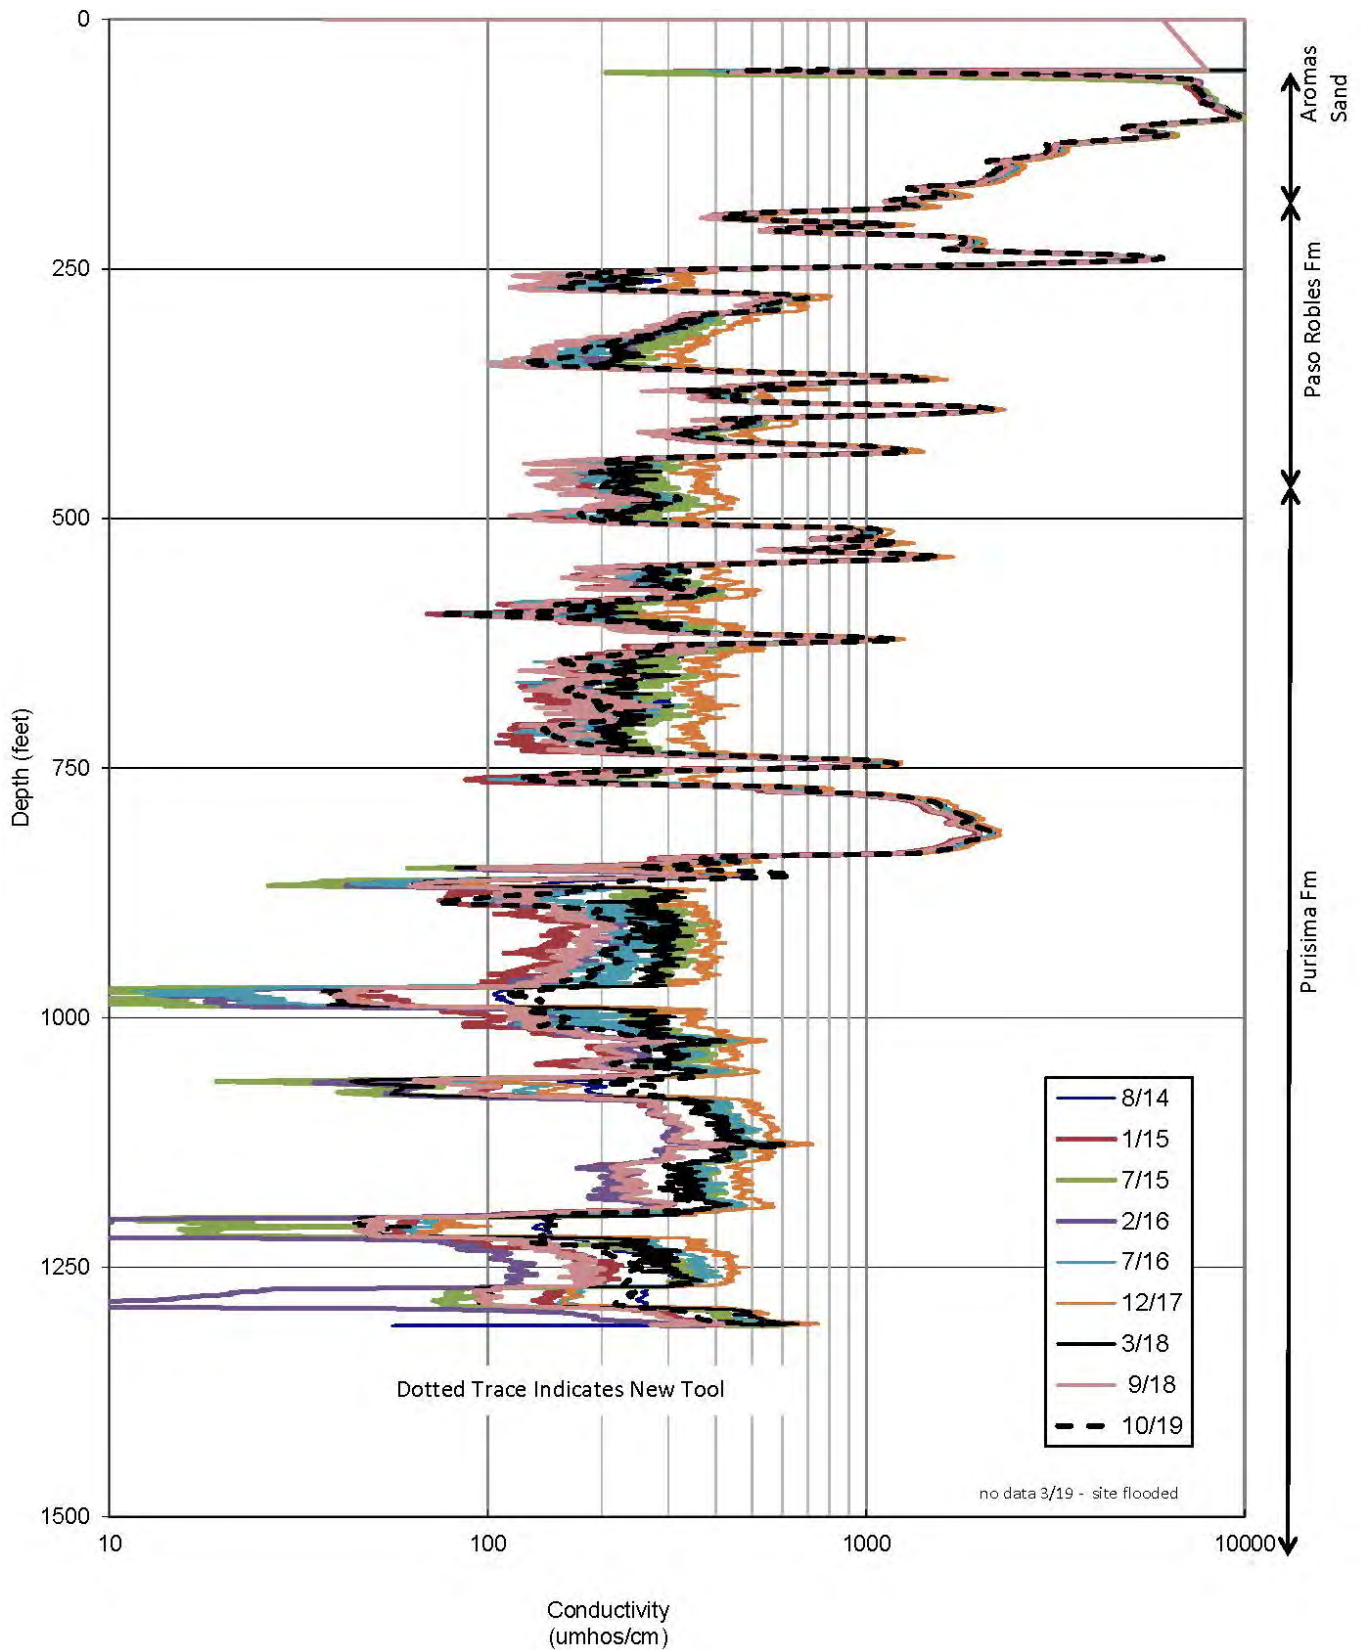
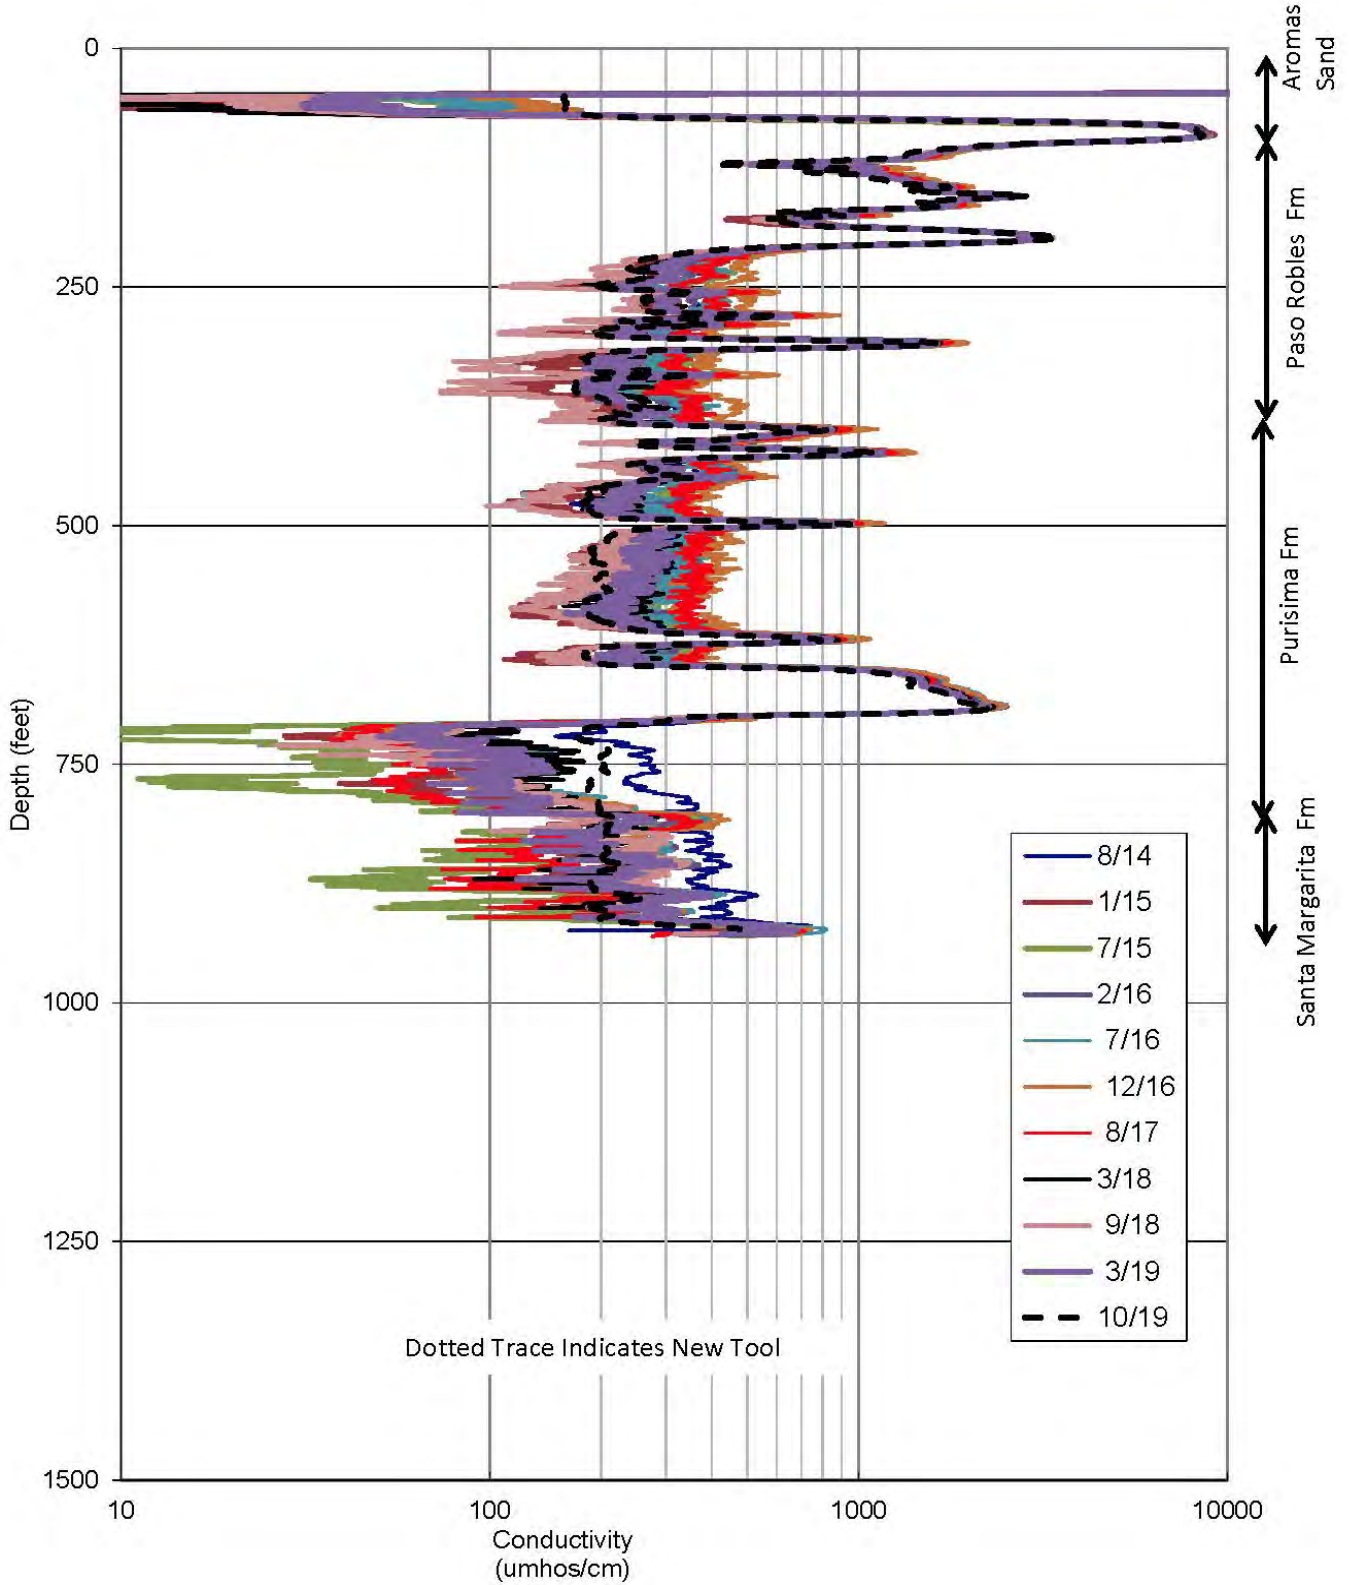
Salinity changes shown on Figure 24 through Figure 27 for Sentinel Wells 1 – 4, respectively, are only relative, and do not allow direct measurement of TDS or chloride concentrations in the aquifer. They do, however, provide a means to determine changes in salinity over time. It appears that the salinity in the Dune Sands and Aromas Formation overlying the main production aquifers fluctuates from season to season; becoming more saline in the summer months when stresses on the aquifer are greatest. As has been the case historically, none of the wells show detectable changes in conductivity to the deeper aquifers where production wells extract groundwater.

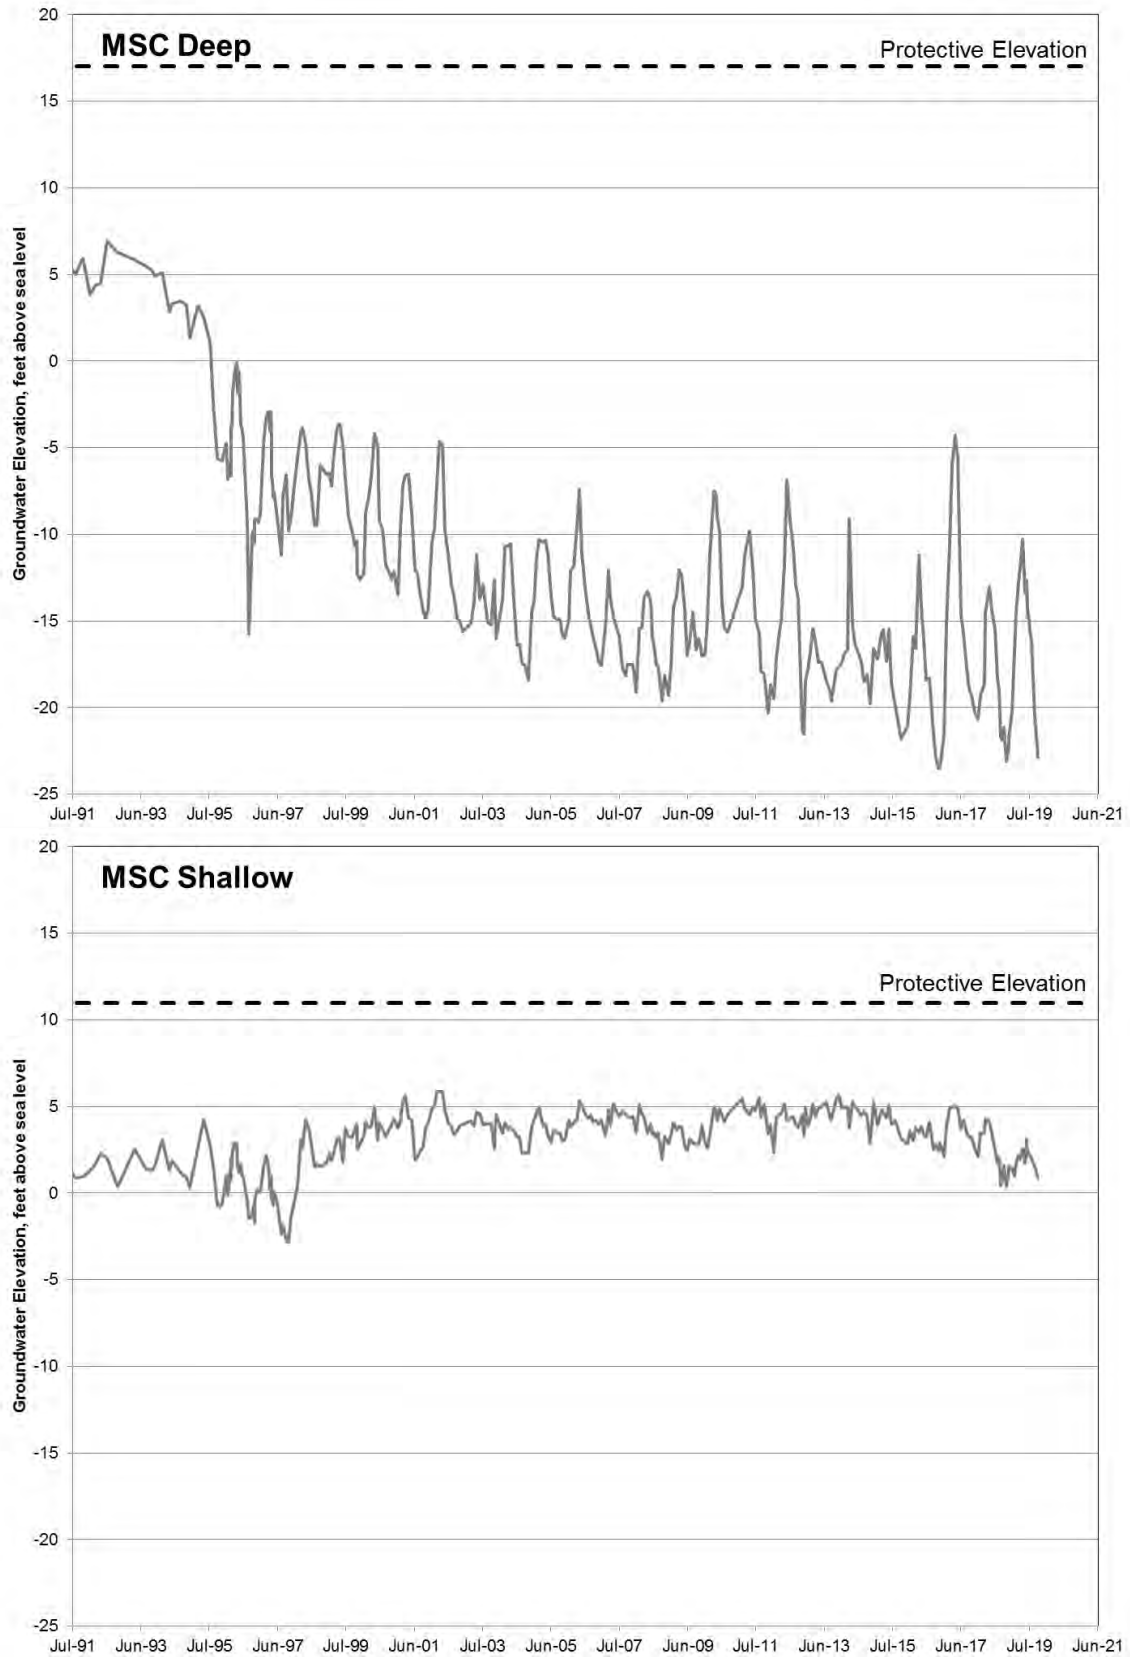
Figure 37. MSC Deep and Shallow Groundwater and Protective Elevations

Figure 37 through Figure 40 show the historical groundwater elevations at each of the target protective elevation monitoring wells. Groundwater levels continue to be below protective elevations in all deep target monitoring wells (MSC deep, PCA-West deep, and Sentinel Well 3). Two of the three shallow wells' groundwater levels are again above protective elevations: the PCA-W shallow well and the CDM-MW4 well. In Water Year 2018, the PCA shallow well groundwater levels fell slightly below protective elevations. The greater seasonal fluctuations in this well are likely due to the recommencement of pumping from the shallow aquifer in 2015 at the Coe Ave well. Groundwater levels in the MSC shallow well continue to be below its protective elevation.

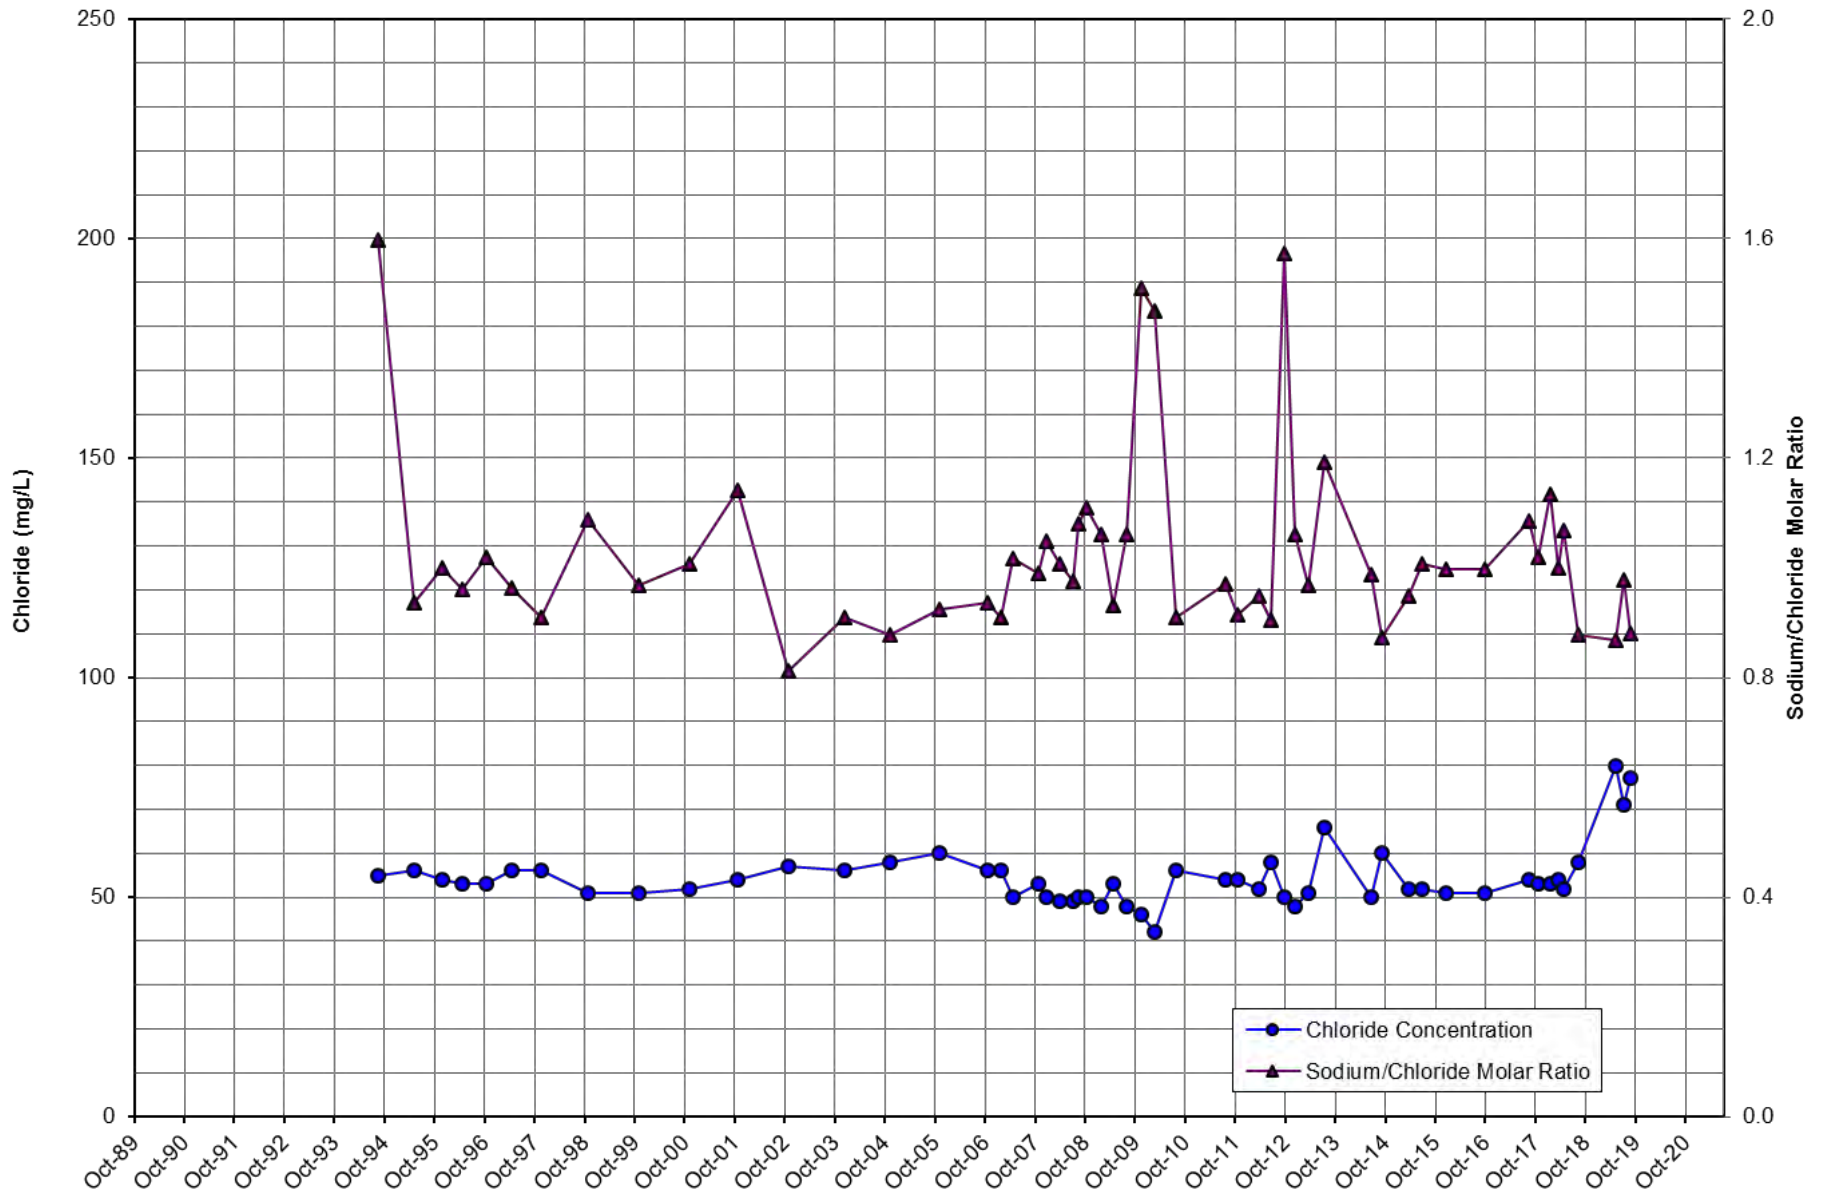
Figure D-11. Fort Ord 9 Shallow Well Chloride and Sodium/Chloride Molar Ratio Graph

- Chloride concentration trends were stable for most monitoring wells. One monitoring well, FO-09 shallow, has sustained increased chloride concentrations in all three samples taken during Water Year 2019. The increase in concentrations from the previous year are between 20 and 30 mg/l. The increase is greater than fluctuations observed historically over the period of record. Elevated concentrations in themselves do not indicate seawater intrusion, however, this well should be carefully observed over the next year to determine if the increasing chloride concentrations are temporary or not.

Based on recent increases in chloride concentrations at monitoring well FO-9 shallow and its proximity to known intrusion in the Salinas Valley, it is recommended that groundwater quality results from it be reviewed after each sampling event to identify if the recent increases are part of natural fluctuations or an ongoing increasing trend. If the March 2020 sample has a greater concentration than this year's highest concentration of 80 mg/L, it is recommended that its sampling frequency be increased to quarterly as a precaution.
