November 23, 2022

# **Seaside Groundwater Basin 2022 Seawater Intrusion Analysis Report**

Seaside Groundwater Basin Watermaster  
Monterey County, California

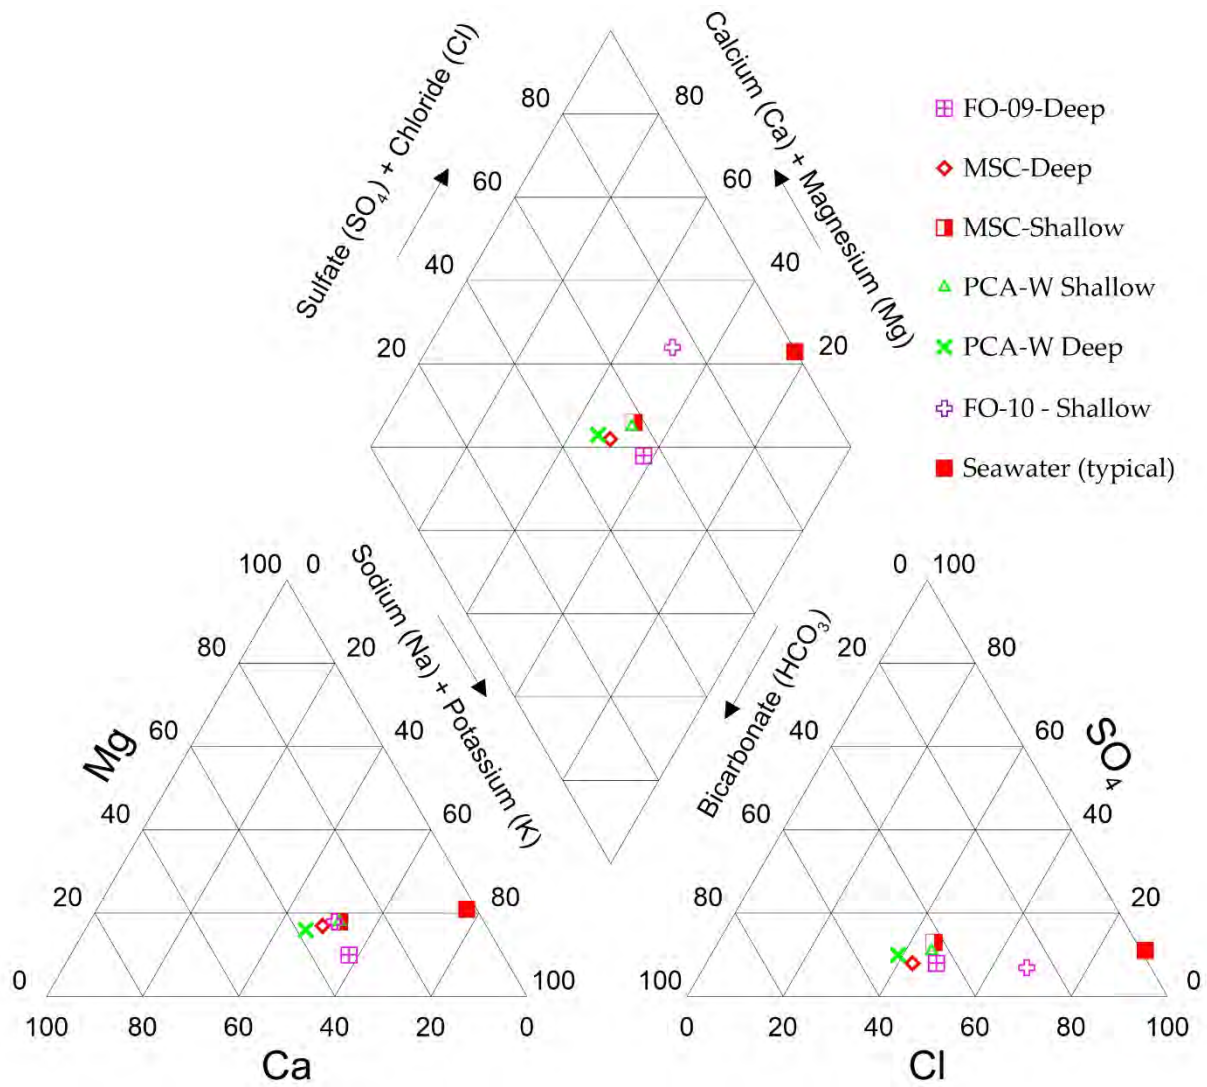
Figure 11. Piper Diagram for Seaside Groundwater Basin Monitoring Wells,  
2<sup>nd</sup> Quarter Water Year 2022 (January-March 2022)  
(Data source: Watermaster)

As noted in the previous 2 SIARs (M&A, 2020; M&A, 2021) and shown on Figure 11, monitoring well FO-10 Shallow plots differently than the other wells on the Piper diagram and has exhibited a marked increase in chloride over the past 3 years, departing significantly from its historical trends (Appendix D: Figure D-9). This year FO-10 Deep also plots differently than other wells due to increased chloride (Appendix D: Figure D-10). Downhole logging at the FO-10 site and subsequent historical record search identified a 1,300 foot, 2-inch steel tremie pipe that has been stuck in the FO-10 borehole since the well's construction (Feeney, 2021; Feeney 2022). While comparison of WY 2021 resistivity at the well with a historical log does show increased conductivity in the well, which may be a sign of seawater intrusion, the presence of the steel pipe obfuscates water quality determinations by muting the induction log response. Further, this steel pipe may act as a conduit allowing flow between overlying intruded Dune Sands sediments and the underlying aquifer. In WY 2022, FO-10 Shallow and FO-10 Deep's anions and cations drifted further on the piper diagram, following the paths of intruded groundwater shown on Figure 4.

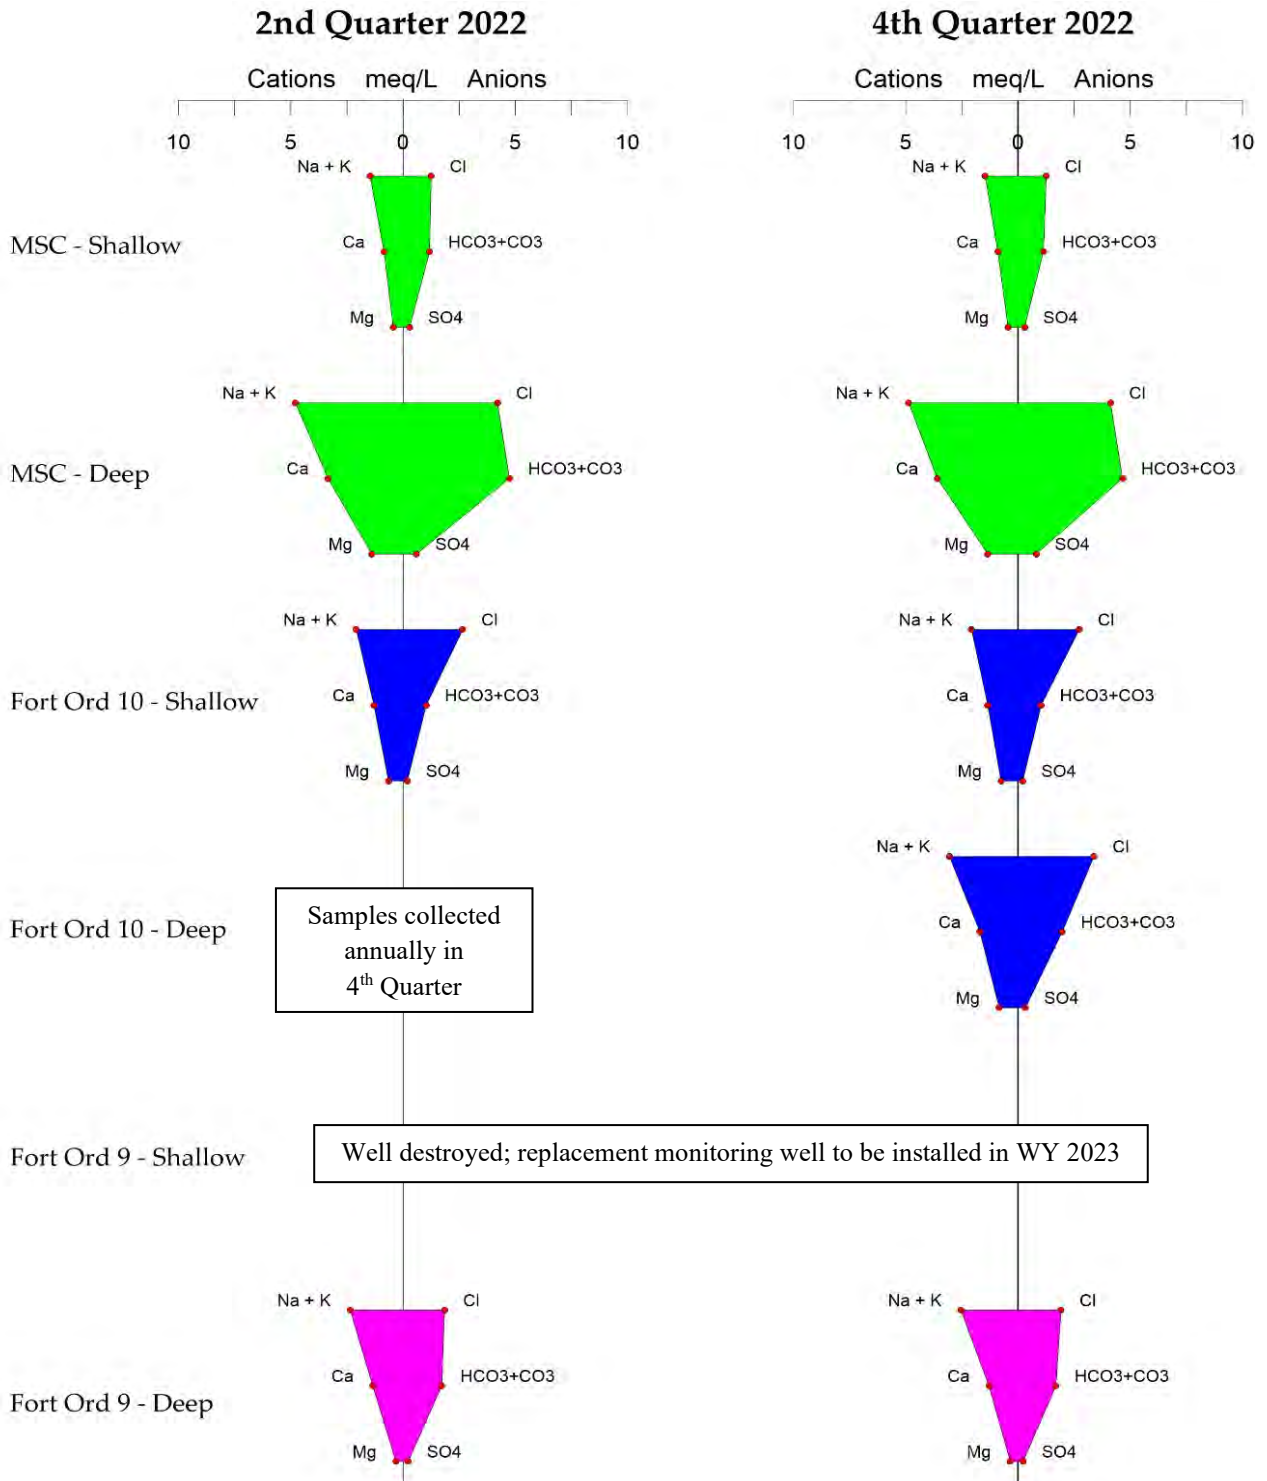
Figure 12. Stiff Diagrams for Monterey Sand Company (MSC), Fort Ord 9, and Fort Ord 10 Wells (Data source: Watermaster)

Stiff diagrams for the monitoring wells sampled during the second quarter of WY 2022 are shown in the left column on Figure 12 through Figure 14. None of the Stiff diagrams, including monitoring well FO-10 Shallow and FO-10 Deep, show the high chloride spike shown on Figure 7 that indicates seawater intrusion. FO-10 Shallow and FO-10 Deep do show a slightly different shape than other shallow wells because of their increased chloride. As described above, the exact mechanism behind the evolving shape of these wells on the stiff diagrams is not currently known, and it is recommended that the well nest is destroyed and replaced.

Stiff diagrams for 11 monitoring wells sampled during the fourth quarter of WY 2022 are shown in the right column on Figure 12 through Figure 14. The shapes of the Stiff diagrams for the paired monitoring wells are similar to the shapes of the Stiff diagrams for most prior years, with the exception of FO-10 Shallow and FO-10 Deep which have greater chloride equivalent concentration than  $\text{HCO}_3$  compared to other shallow coastal wells.

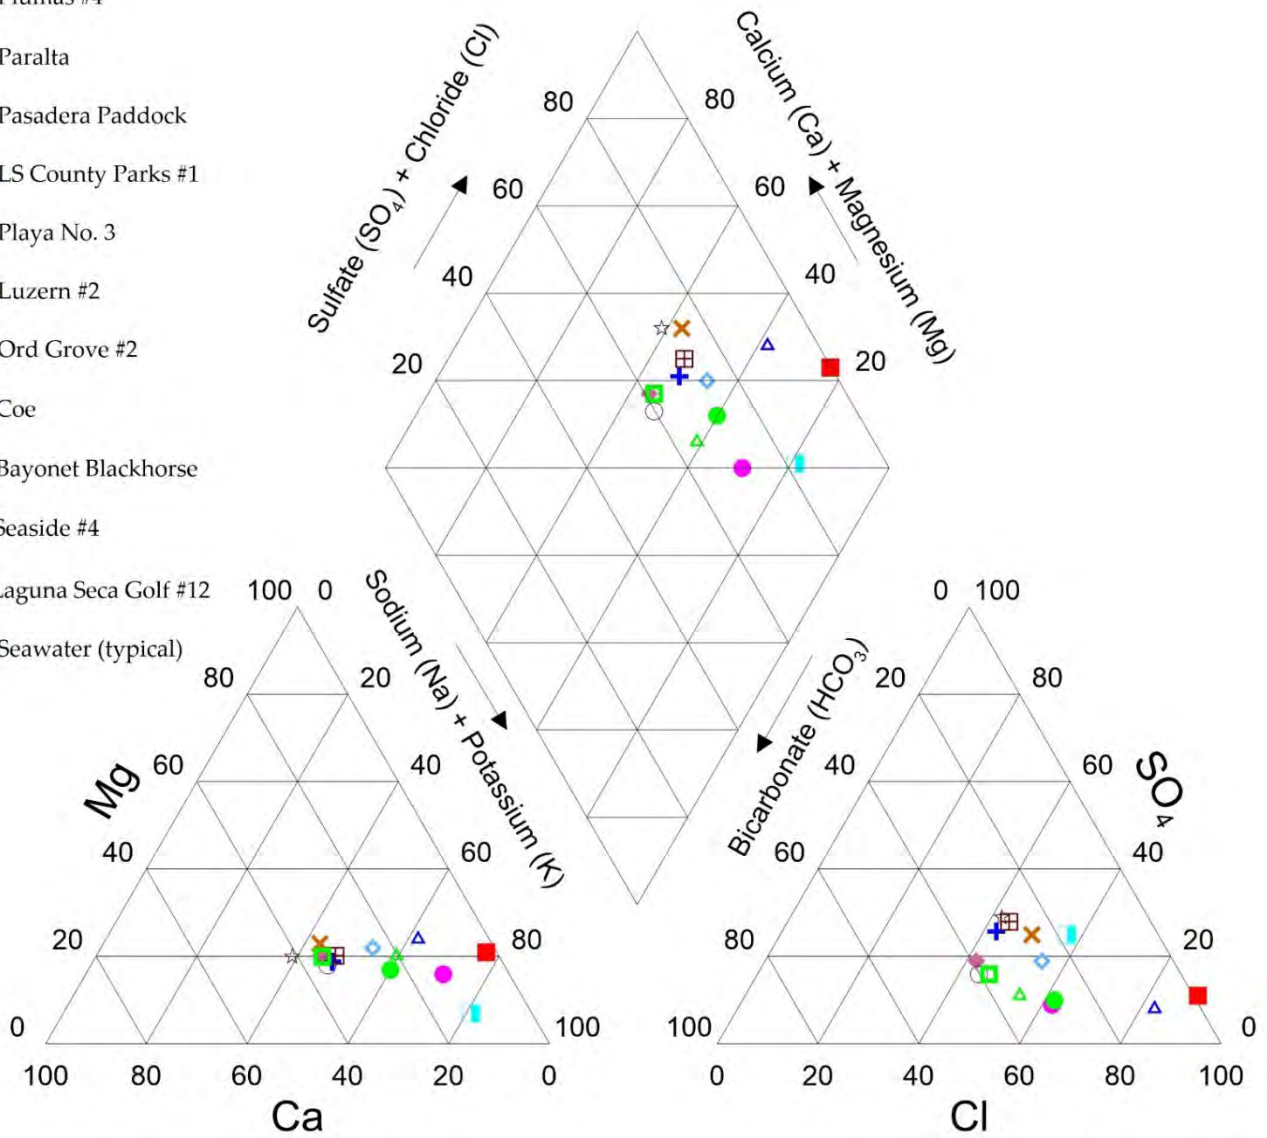
Figure 16. Piper Diagram for Seaside Groundwater Basin Production Wells,  
4<sup>th</sup> Quarter Water Year 2021 (July-September 2021)  
(Data source: Watermaster)

Figure 16 presents a Piper diagram for fourth quarter groundwater from production wells. The production wells plot in roughly the same location on the Piper diagram as most monitoring wells on Figure 15. The variation of the plot location on the Piper diagram for production wells is due to higher sulfate and chloride anions than in the monitoring wells. Groundwater from these wells is characterized as sodium-sulfate-chloride type waters. The York School well plots closest to typical seawater on this diagram, however its inland location precludes seawater intrusion as the cause for its observed water chemistry. Overall, the Piper diagram shows no indication of seawater intrusion at any of the production wells.

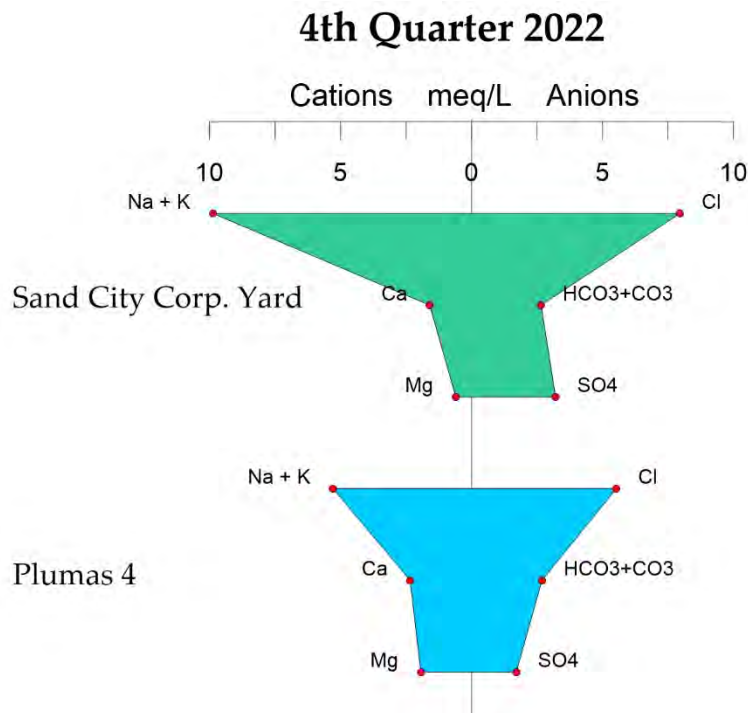
Figure 17. Stiff Diagrams for Southern Coastal Subarea Production Wells  
 (Data source: Watermaster)

Stiff diagrams for 13 of the production wells sampled during the fourth quarter of WY 2022 are shown on Figure 17 through Figure 20. Production well Stiff diagrams show no significant changes from the shapes observed in previous years. Groundwater quality data for many of these wells was not available in WY 2022 at the time of this report. Ryan Ranch #7, #8, and #11 production wells were destroyed in 2021 and therefore groundwater quality data are no longer available for these wells. The Pasadera Paddock and LS Golf #12 production wells have a Stiff diagram shape that are slightly different from the other wells' chemistry. The cause of this could be localized mineralization. The Laguna Seca subarea is known to have higher salinity groundwater than the rest of the basin due to the underlying Monterey shale that was deposited in a marine environment. None of the Stiff diagrams for production wells near the coast show the high chloride spike shown on Figure 7 that indicates seawater intrusion.

The Sand City's Public Works Corp Yard production well in the Southern Coastal subarea and the York School production well in the Laguna Seca subarea typically have Stiff diagrams quite different from most other wells' groundwater quality. However, they do not have a large chloride spike associated with seawater intrusion as shown on Figure 7. None of the production wells sampled in WY 2022 and analyzed using Stiff and Piper diagrams show an indication of seawater intrusion.

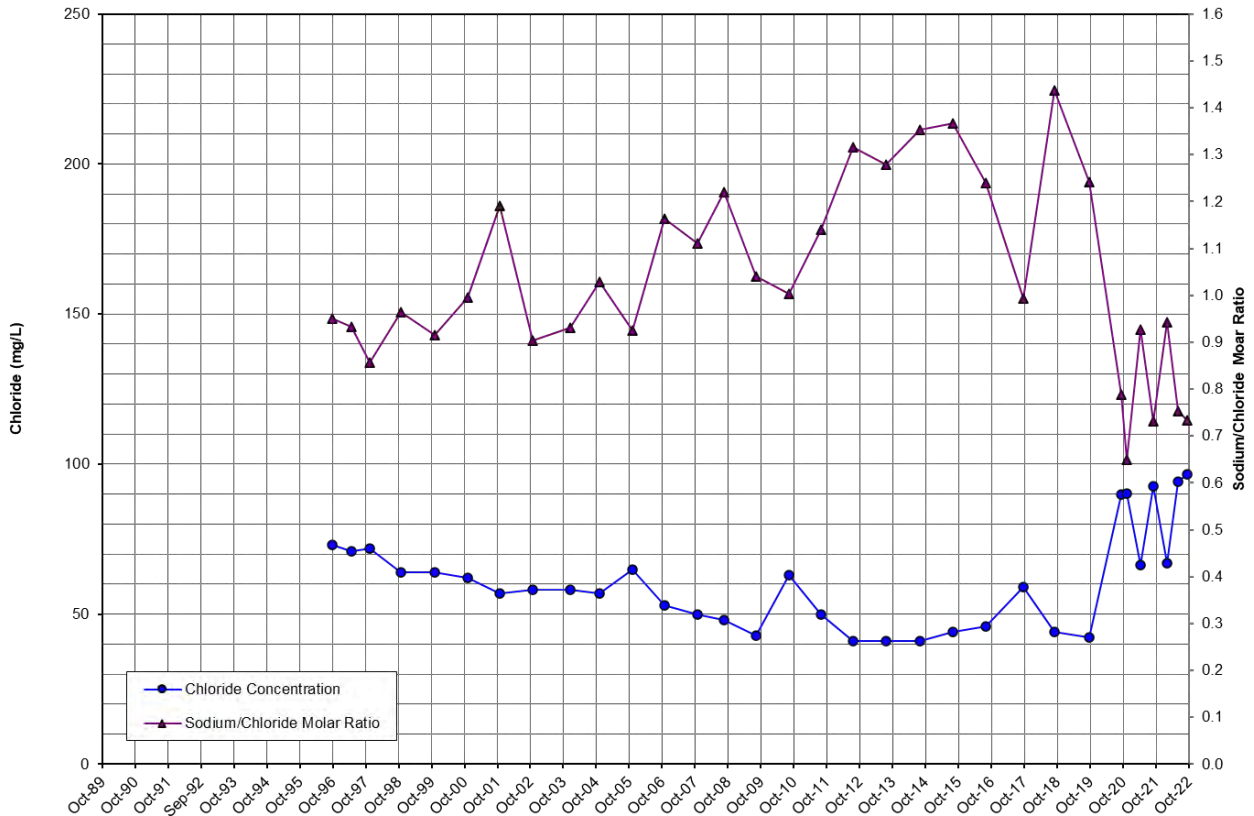
Figure 22. Historical Chloride and Sodium/Chloride Molar Ratios, FO-10 Shallow

- Chloride concentration trends are stable for most monitoring wells, with the notable exception of FO-10 Shallow and FO-10 Deep. FO-10 Shallow experienced a 48 mg/L increase in chloride concentrations in WY 2020 and has risen by another 8 mg/L since then. FO-10 Deep experienced a 60 mg/L increase in WY 2022. However, the sustained elevated concentrations in themselves do not indicate seawater intrusion. As noted above, recent induction logging was unable to conclusively determine whether seawater intrusion is the source of the elevated chloride level, and the well's integrity for water quality sampling may be compromised by a steel tremie pipe stuck in the borehole since 1997.

water quality results and may act as a conduit for groundwater in overlying sediments to enter underlying aquifers, it is recommended that both FO-10 Shallow and FO-10 Deep are destroyed and replaced to maintain a consistent water quality record in the area.

intrusion north of the Basin in the Monterey Subbasin. Therefore, it is recommended that Monterey Peninsula Water Management District (MPWMD) develop plans to destroy both FO-10 Shallow and FO-10 Deep, and that MCWD install similarly constructed monitoring wells to maintain a continuous water quality record at the location. Because seawater intrusion cannot be excluded as the source of increasing chloride concentrations at FO-10 Shallow over the past several years, groundwater quality sampling at this well should continue at the increased quarterly frequency until the well is destroyed. When the well is replaced, the replacement well should likewise be sampled at a quarterly frequency. As detailed in the Monterey Subbasin GSP (MCWDGSA and SVBGSA, 2022) Section 9.4.7, additional monitoring wells may be installed in both the Lower 180-Foot and 400-Foot Aquifer and the Deep aquifers of the Monterey Subbasin. The proposed location for these wells is in an identified data gap area northeast of FO-10 Shallow (see Monterey Subbasin GSP Figures 7-7 and 7-8). When these wells are installed, they may provide additional insight into potential seawater intrusion in the area.

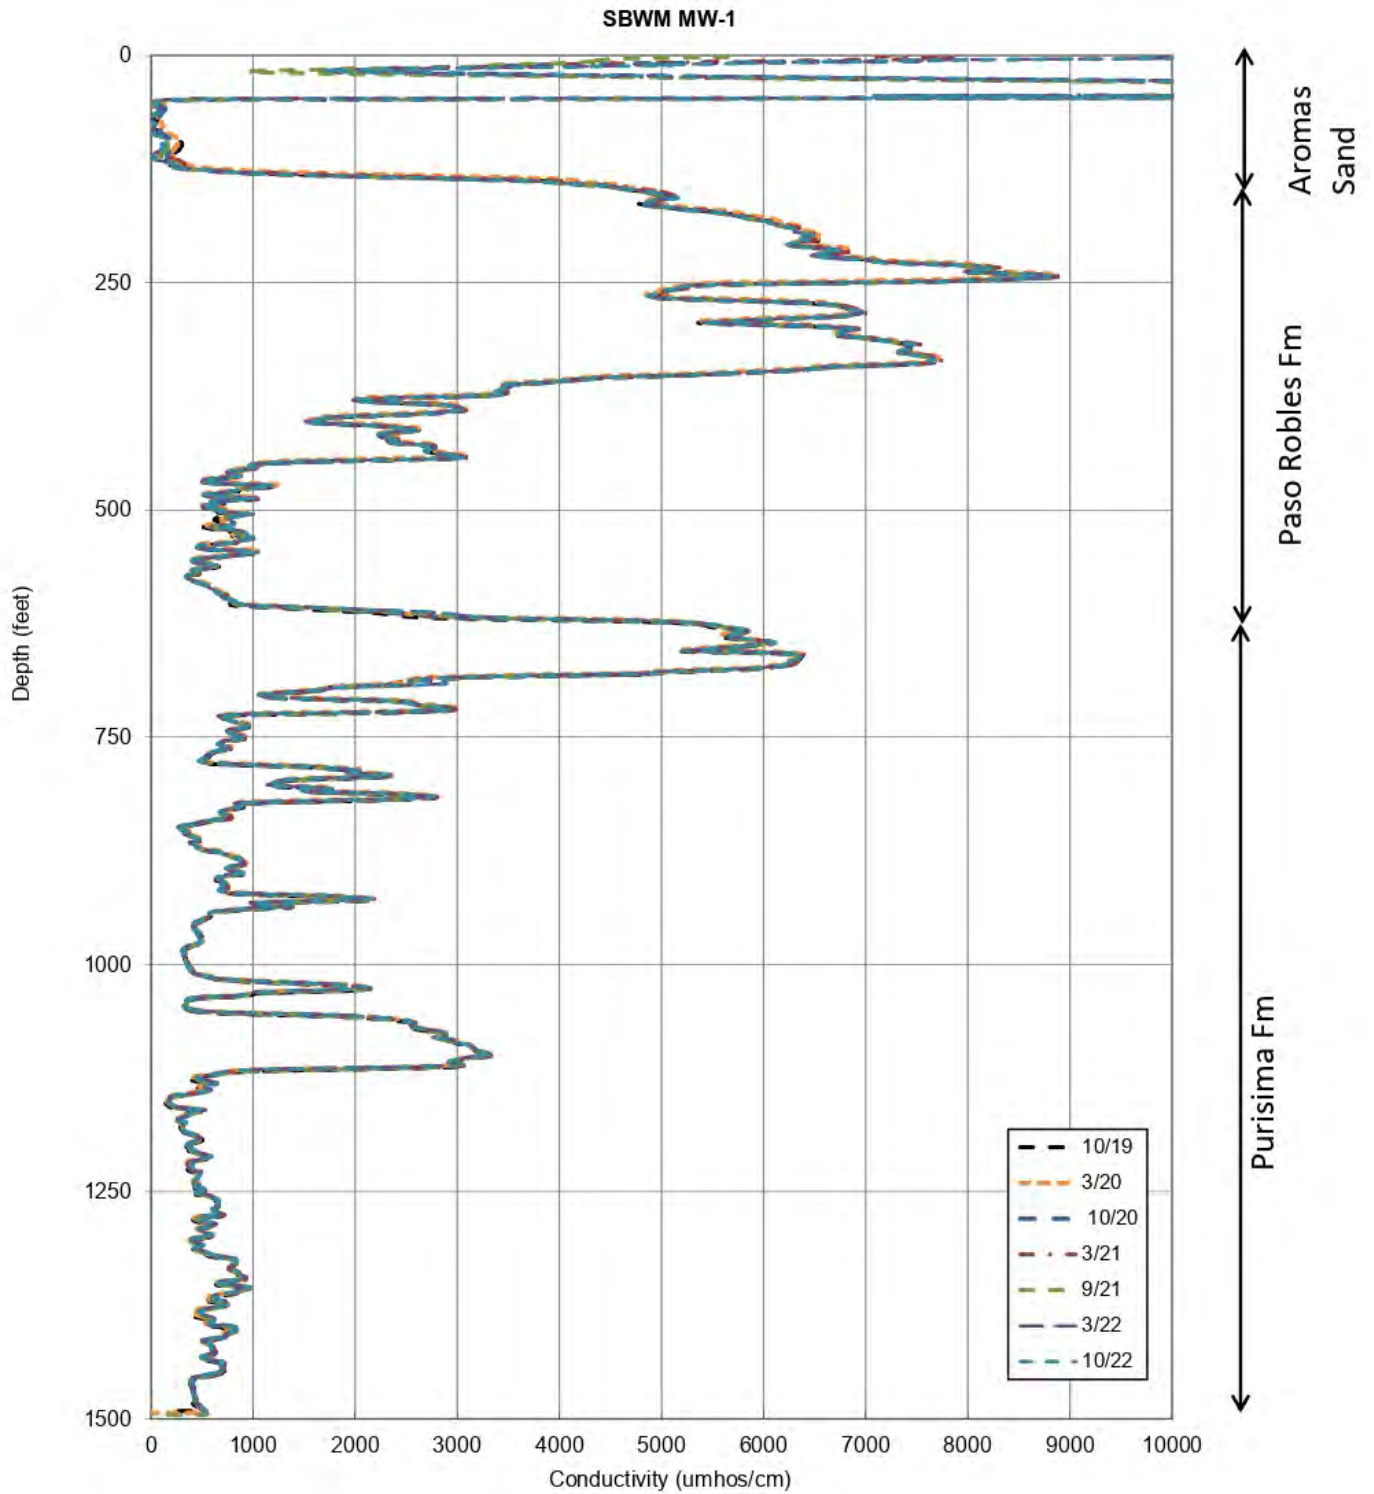
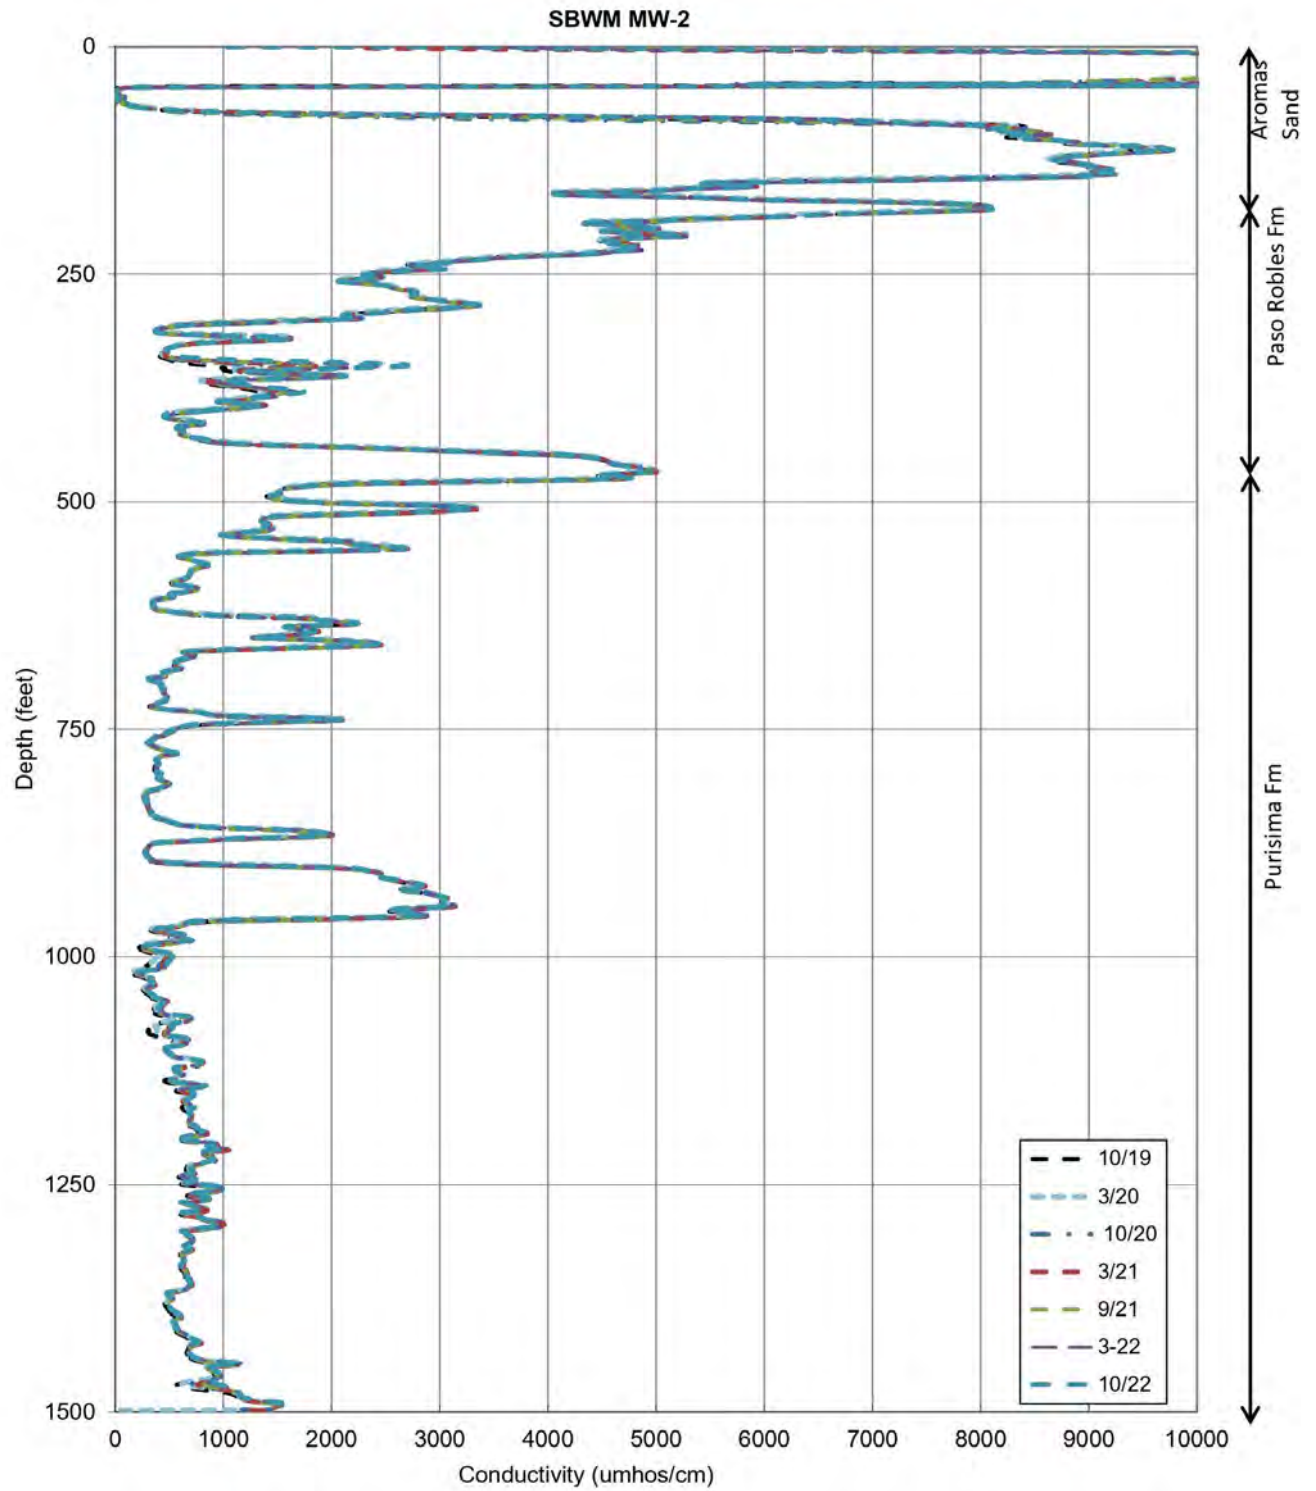
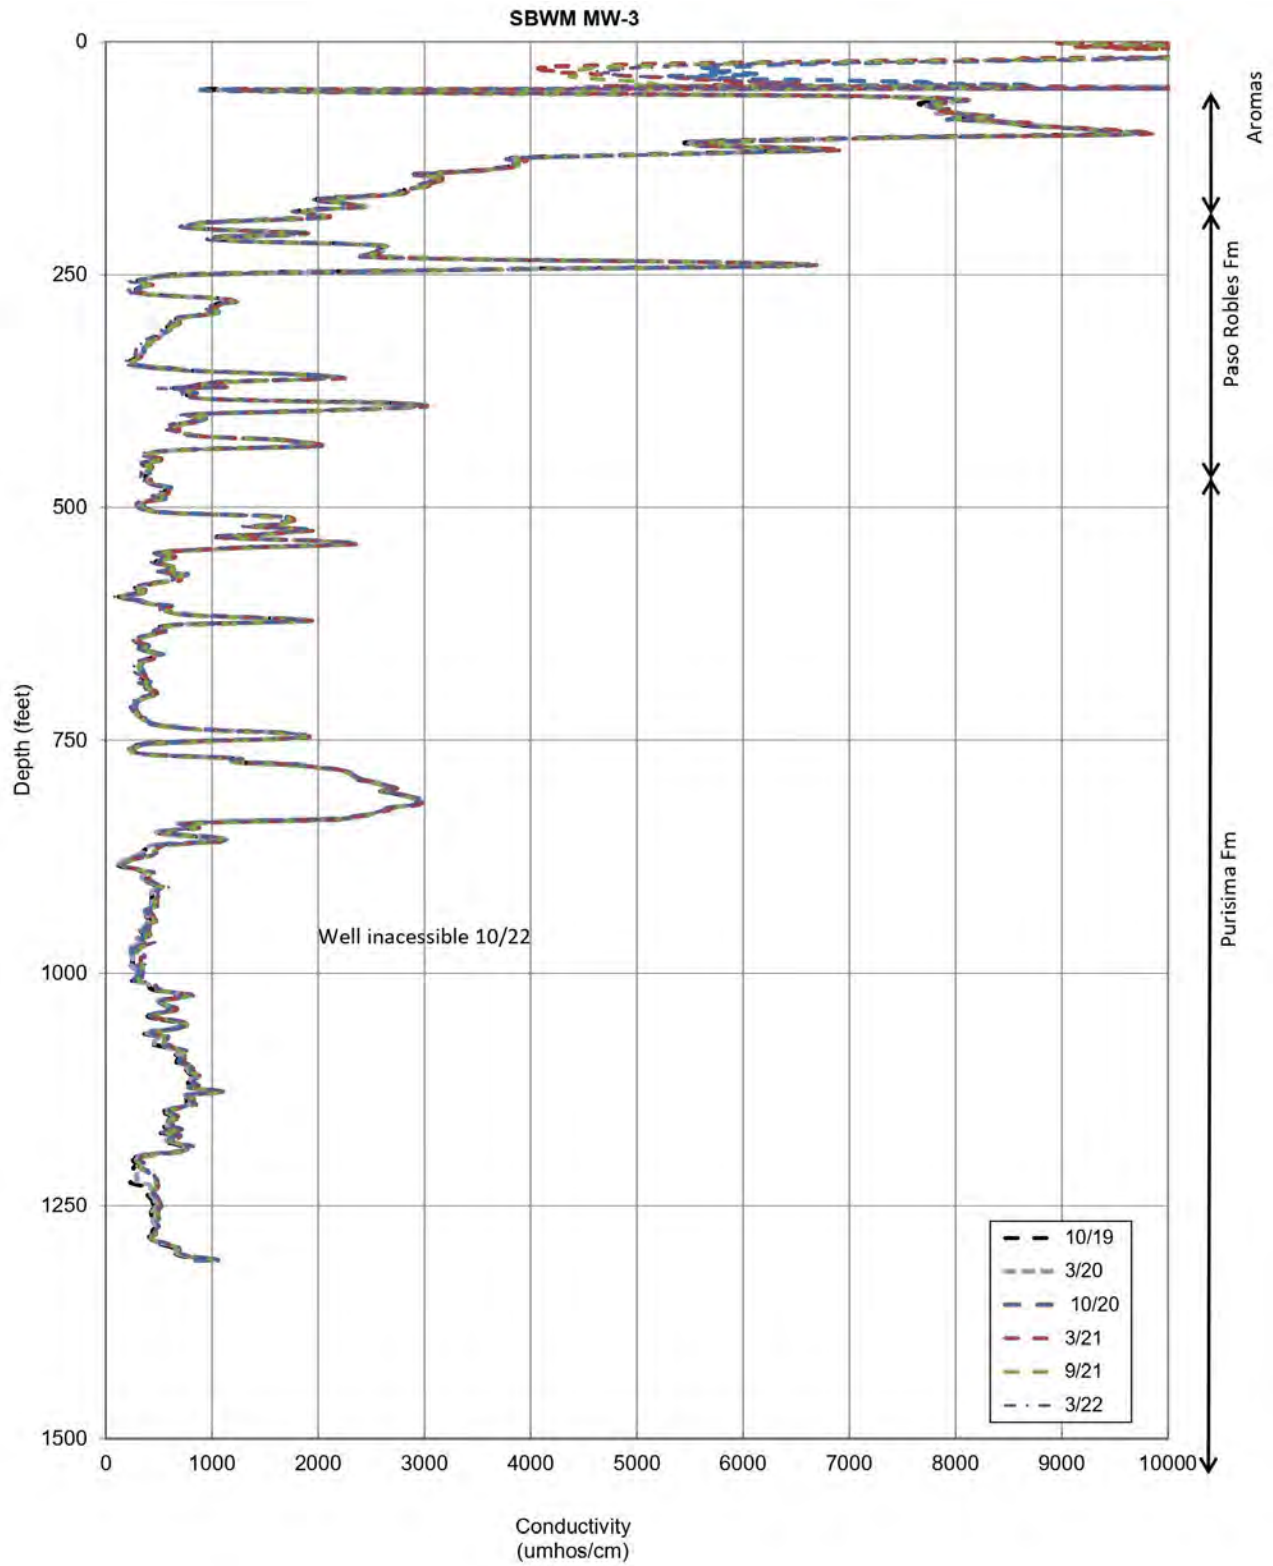
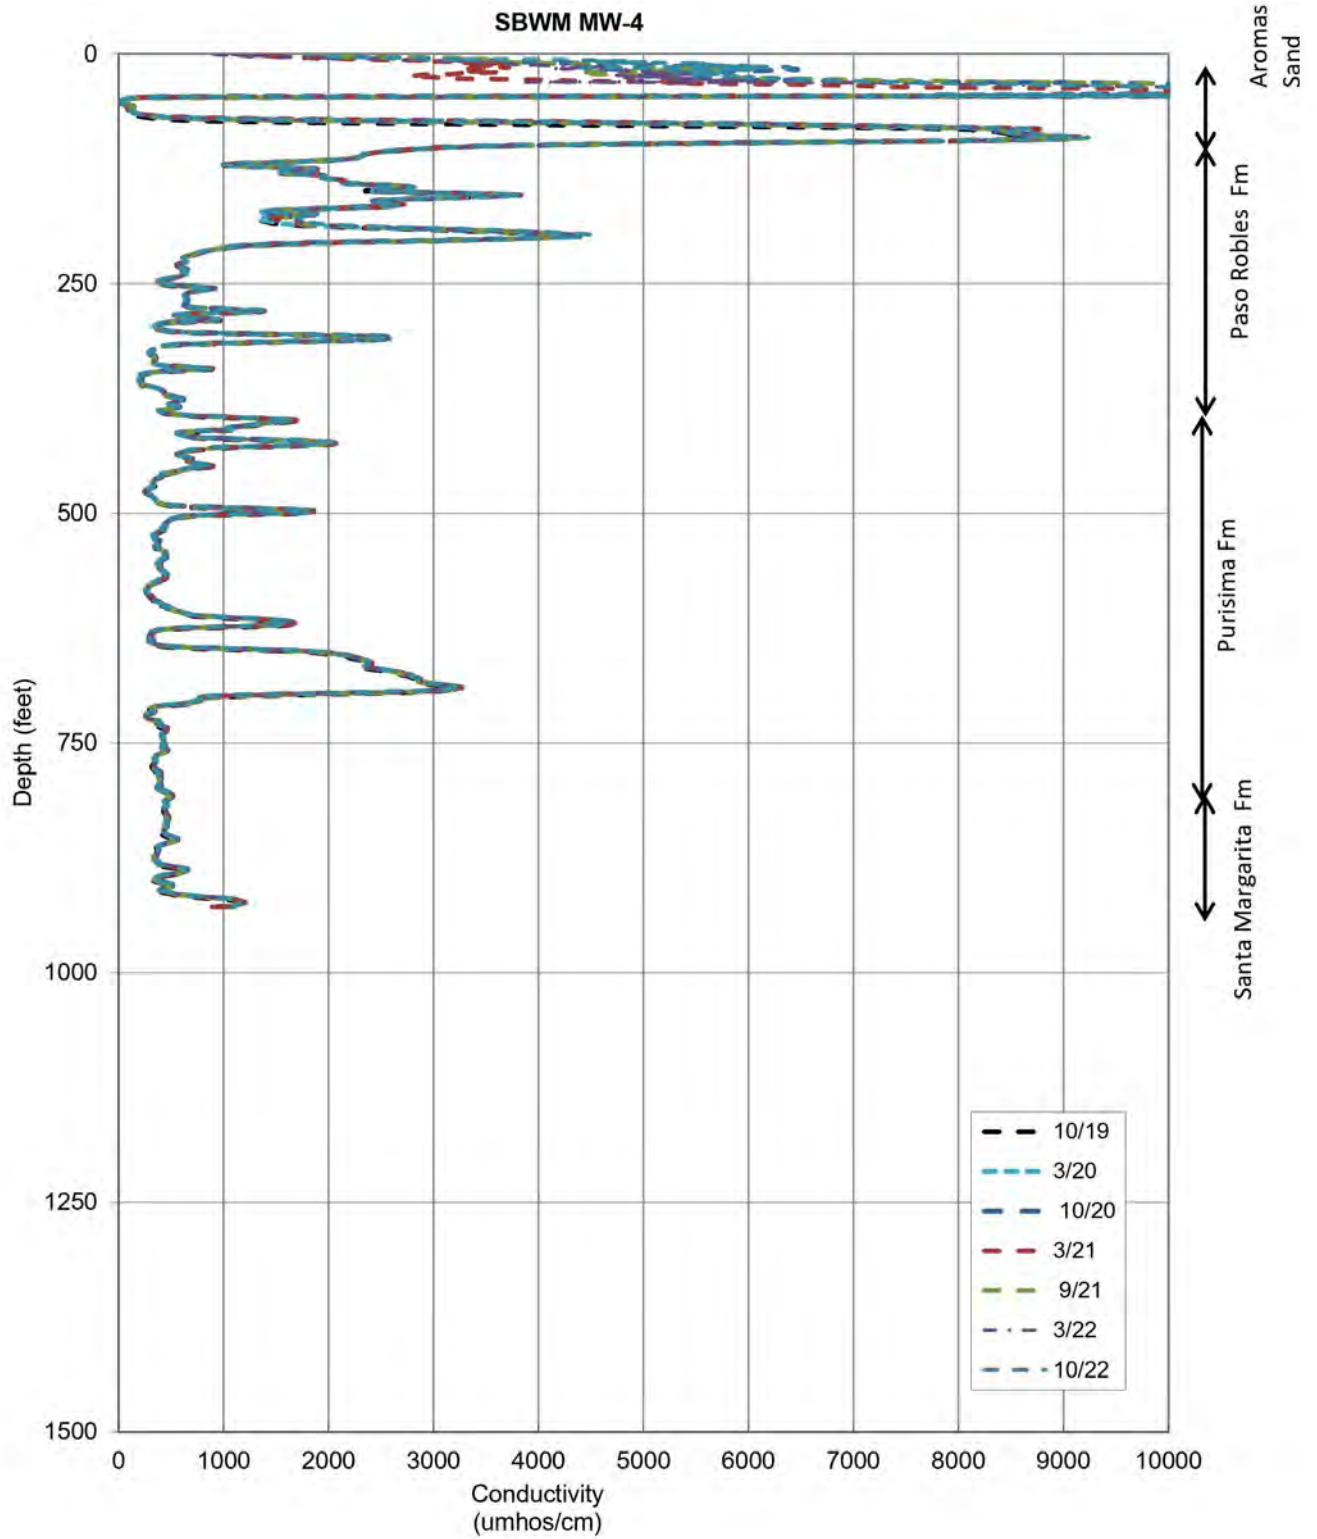
Salinity changes shown on Figure 25 through Figure 28 for Sentinel Wells 1 – 4, respectively, are only relative, and do not allow direct measurement of TDS or chloride concentrations in the aquifer. They do, however, provide a means to determine changes in salinity over time. Induction logging in previous years indicated salinity in the Dune Sands and Aromas Formation overlaying the main production aquifers fluctuates from season to season; becoming more saline in the fall months when stresses on the aquifer are greatest. The logging events that took place in WY 2022 plot similarly on the figures below, suggesting very little net change in salinity over the course of the year. As has been the case historically, none of the wells show detectable changes in conductivity to the deeper aquifers where the majority of production wells extract groundwater.

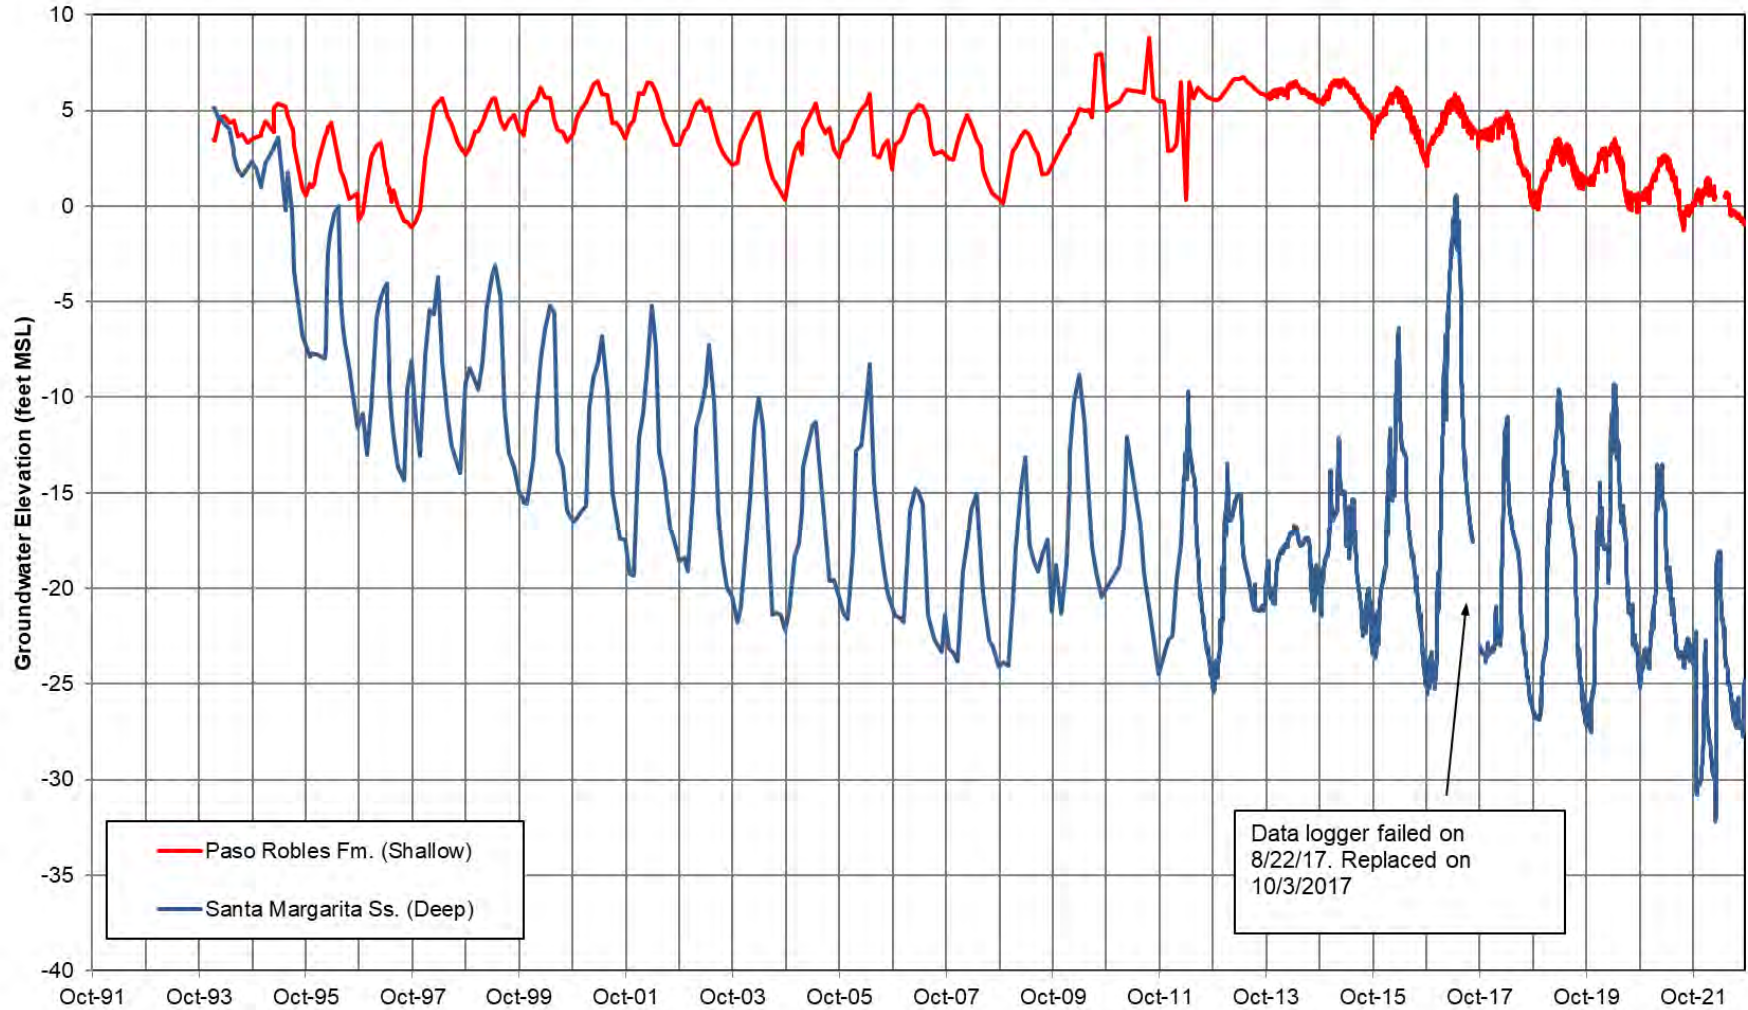
Figure 30. PCA-East Deep and Shallow Monitoring Well Hydrograph (Source: Watermaster)

Groundwater levels measured at the PCA-East well are generally representative of groundwater levels in the Northern Coastal subarea, west of nearby production wells. The hydrograph shows peaks and lows that are strongly influenced by pumping by the nearby CAWC production wells on groundwater levels in the deep zone and injection of Carmel River water and Pure Water Monterey (PWM) highly treated recycled water at the eastern boundary of the subarea (Figure 30). Other influences such as tides which can cause up to a 1-foot fluctuation in the deep completion of PCA-East are also recognized. Because of all the possible influences on groundwater levels, it is difficult to compare the present year to the previous year directly. What is more important is to look at long-term trends.

Seasonal fluctuations are noticeable in the winter season when deep groundwater elevations are at their highest for the year. For example, the 2017 winter high in PCA-East deep increased to a level last seen in 1995, because 2,345 acre-feet of excess Carmel River water was injected as it was a very wet year. As described in Section 2.6.1, WY 2022 was a very dry year, resulting in a limited excess Carmel River Water for ASR injection. Dry conditions and limited ASR injection resulted in some of the lowest on record seasonal high elevations shown on Figure 30. The well has since then experienced decline over the past 2 years; in WY 2022 both seasonal high and seasonal lower groundwater elevations were amongst the lowest on record. Despite dry conditions, the groundwater level decline is likely ameliorated by PWM injection of 3,647 acre-feet.
