November 25, 2019

# **Seaside Groundwater Basin 2019 Seawater Intrusion Analysis Report**

Seaside Groundwater Basin Watermaster  
Monterey County, California

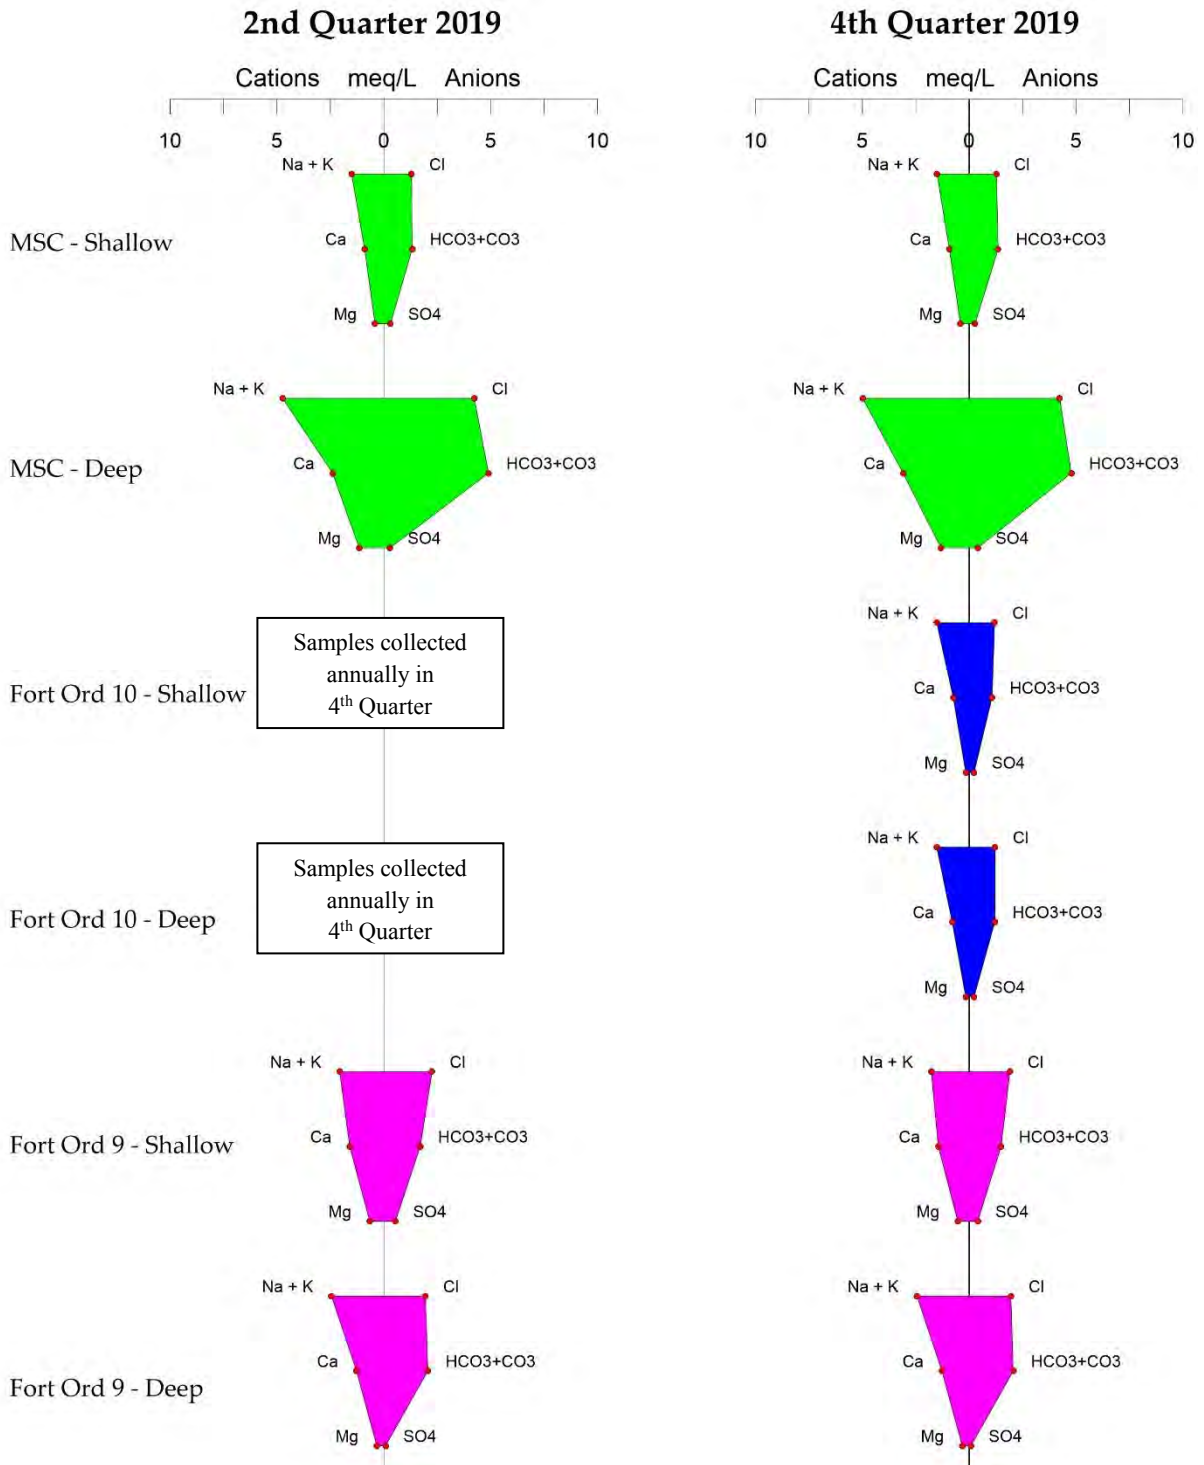
Figure 12. Stiff Diagrams for MSC, Fort Ord 9, and Fort Ord 10 Wells  
(Data source: Watermaster)

Stiff diagrams for the monitoring wells sampled during the 2<sup>nd</sup> quarter of Water Year 2019 are shown in the left column on Figure 12 through Figure 14. None of the Stiff diagrams show the high chloride spike shown on Figure 7 that indicates seawater intrusion, this includes FO-9 shallow which has shown a recent change in chloride anions, as mentioned in the above paragraph.

Based on recent increases in chloride concentrations at monitoring well FO-9 shallow and its proximity to known intrusion in the Salinas Valley, it is recommended that groundwater quality results from it be reviewed after each sampling event to identify if the recent increases are part of natural fluctuations or an ongoing increasing trend. If the March 2020 sample has a greater concentration than this year's highest concentration of 80 mg/L, it is recommended that its sampling frequency be increased to quarterly as a precaution.

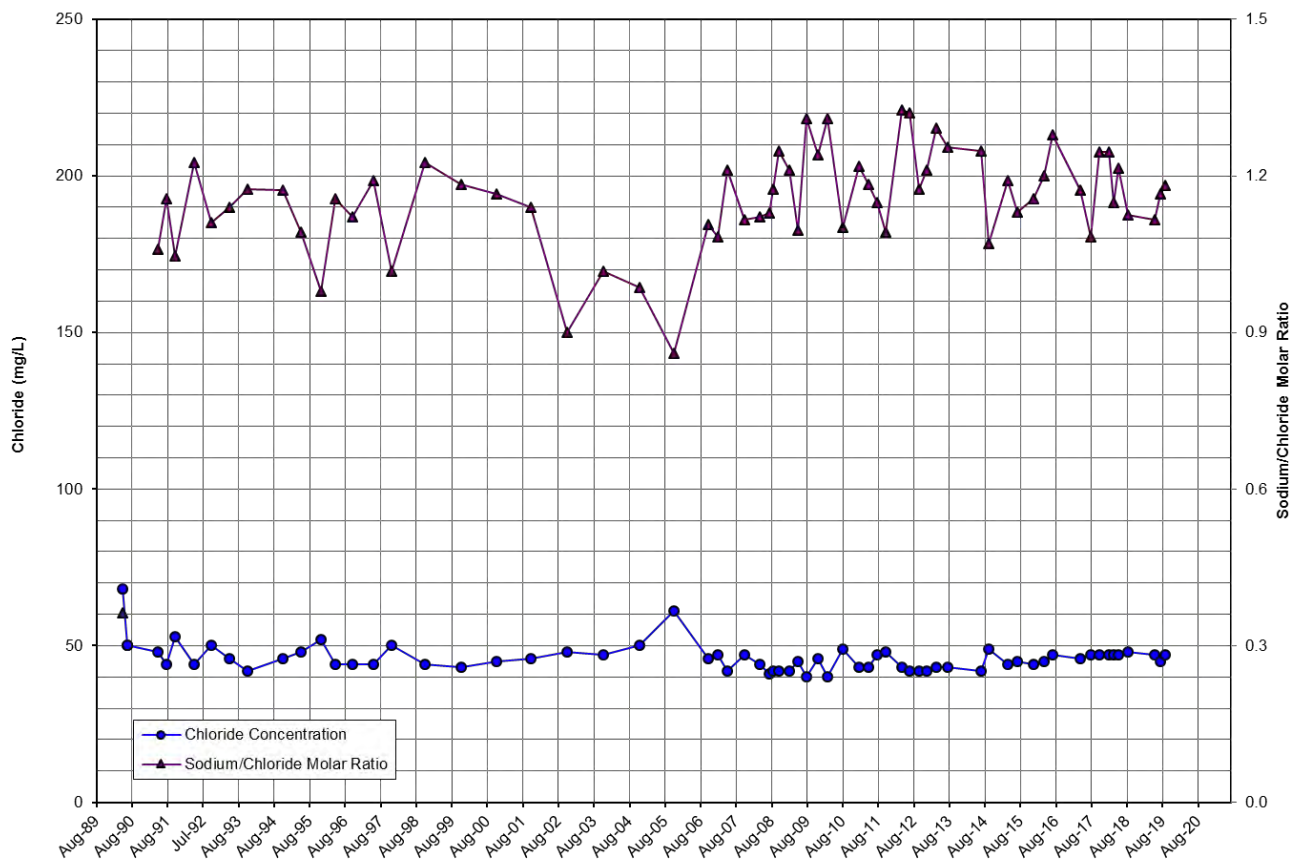
Figure 21. Historical Chloride and Sodium/Chloride Molar Ratios, PCA West Shallow

Chemographs showing chloride concentrations over time are plotted for each of the monitoring wells shown on the Piper and Stiff diagrams and one production well. An example plot displaying chloride concentrations for the shallow PCA West well is shown on Figure 21. The complete set of chemographs is included in Appendix D. Chloride trends for most monitoring wells remain stable, or fluctuate within a historical range. One monitoring well, FO-09 shallow, has sustained increased chloride concentrations in all three samples taken during Water Year 2019 (Appendix D: Figure D-11). The increase is greater than fluctuations observed historically over the period of record but the elevated concentrations in themselves do not indicate seawater intrusion.

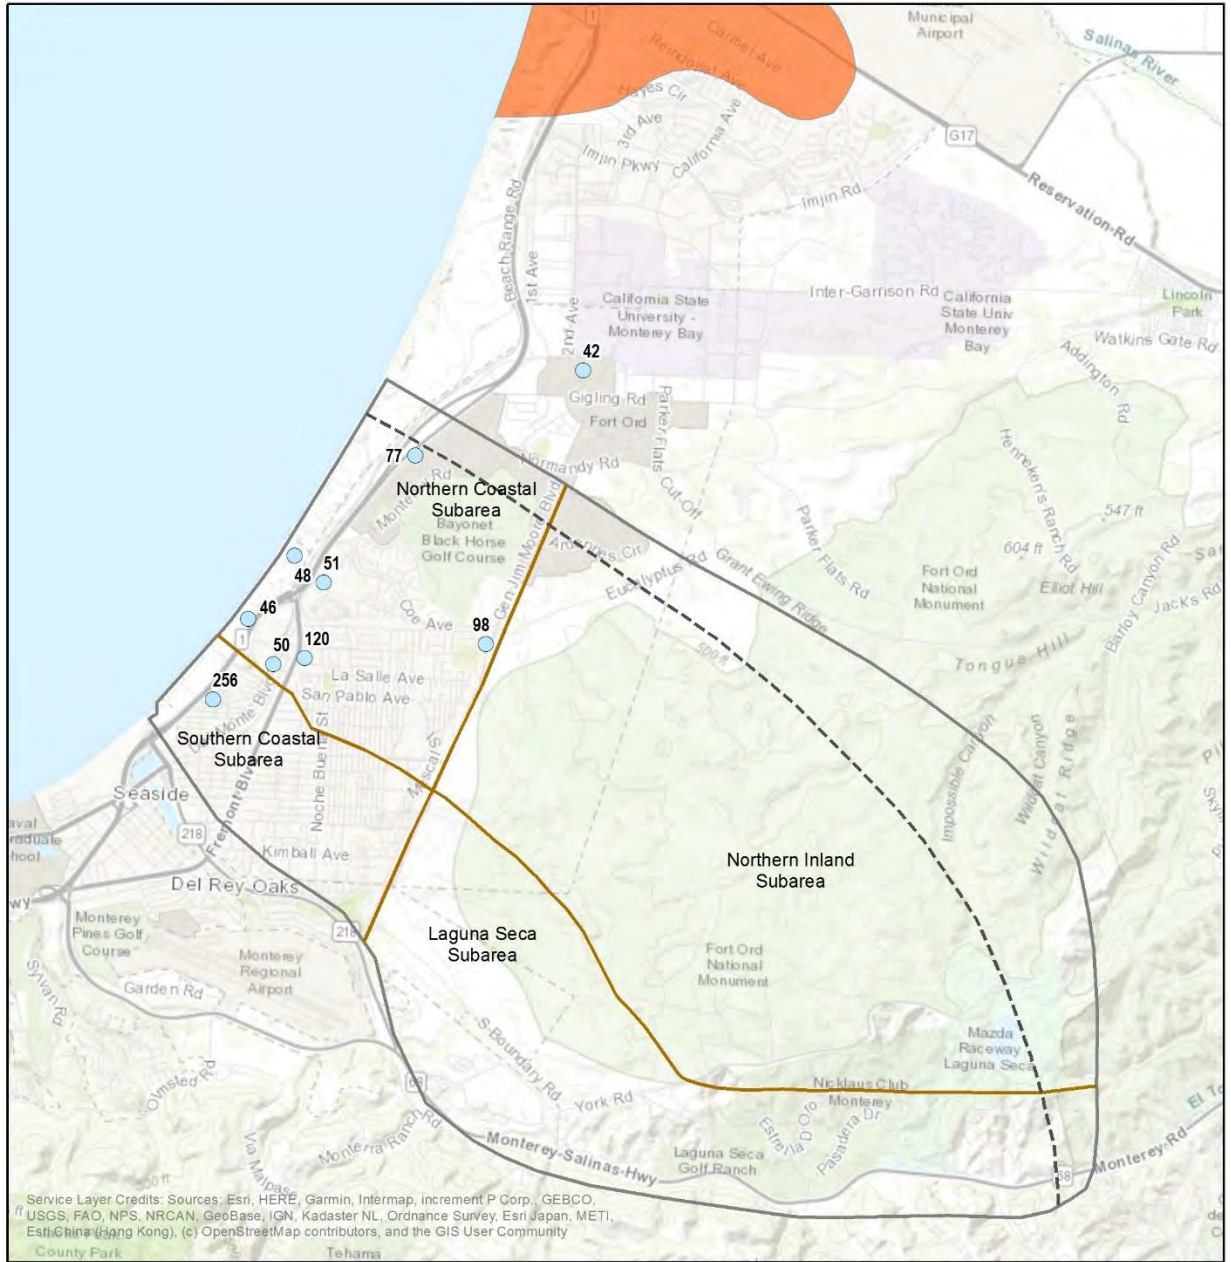
Figure 22. Shallow Zone Chloride Concentration Map – 4<sup>th</sup> Quarter WY 2019

For the data available in the shallow zone, chloride concentrations near the coast now average slightly higher than 50 mg/L in the Northern Coastal subarea because of the increase in FO-9 shallow concentrations. The more inland Northern Coastal subarea wells have slightly higher chloride concentrations that may be due to depositional mineralization differences in the Paso Robles Formation. Based on available data, there is no discernible spatial trend of higher coastal chloride concentrations, and therefore no indication of seawater intrusion within the shallow aquifer. Sand City's Public Works Corp Yard well continues to be the only coastal well in the Southern Coastal subarea with measured chloride data, which has historically had the highest concentration of all shallow coastal monitoring wells (Appendix D: Figure D-13). The Piper and Stiff diagrams and sodium/chloride molar ratio for the well continue to suggest that the source of high chloride is not seawater.

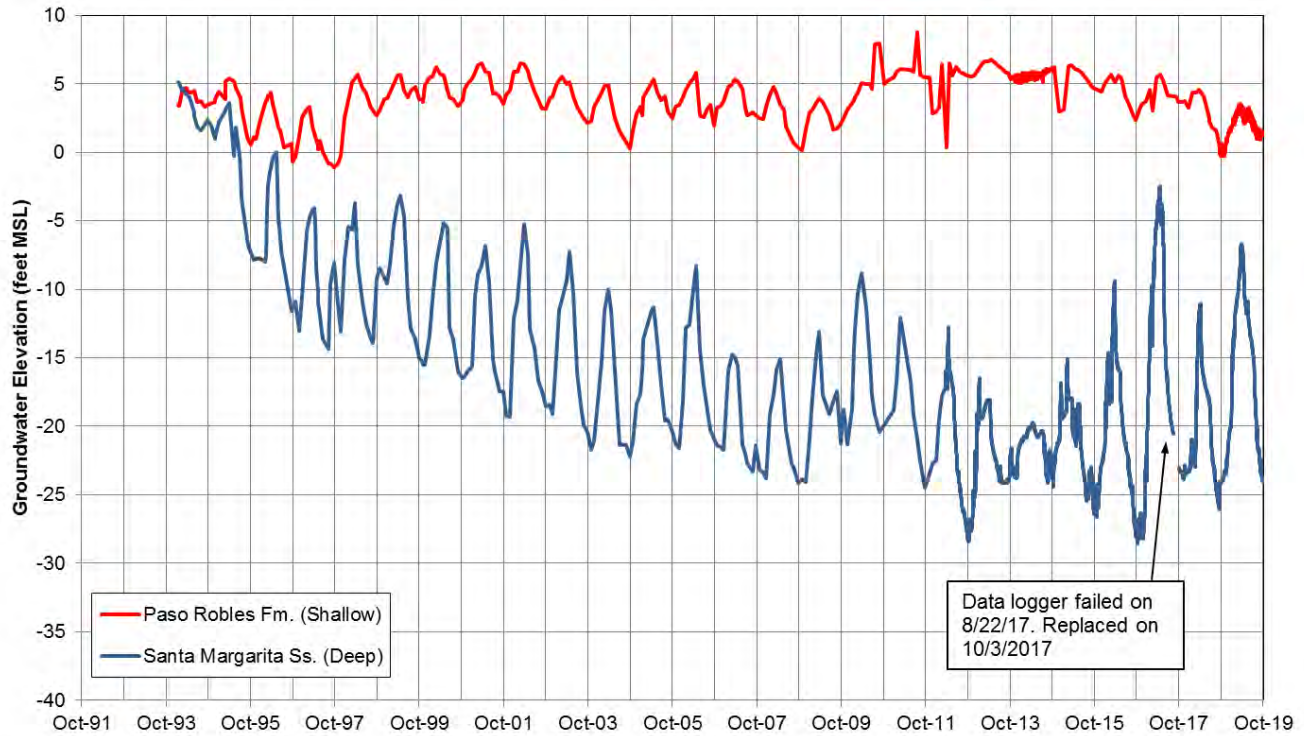
Figure 28. PCA-East Deep and Shallow Monitoring Well Hydrograph (Source: Watermaster)

PCA-East deep on Figure 28 shows an overall decline in groundwater levels until 2009, levels increase and then more or less stabilize over the next two years, and then from 2011 to 2016 experienced a continued decline. Groundwater levels recovered slightly in 2017 due to record rainfall to levels similar to those experienced during the drought (2012 – 2015). Groundwater levels have remained at a somewhat similar level since 2017, with no clear increasing or decreasing trend (Figure 28). The start of the overall decline in groundwater levels in the deep completion of PCA-East corresponds with the shift in CAWC's production from their shallow Paso Robles wells to deeper Santa Margarita wells.

Seasonal fluctuations are noticeable in the winter season when groundwater elevations are at their highest for the year. For Water Year 2017, the winter high in PCA-East deep increased to a level last seen in 1995, which is 17 feet higher than the lowest winter high level experienced during the recent drought. This is because 2,345 acre-feet of excess Carmel River water was injected as it was a very wet year. A volume of 744.4 acre-feet was injected in Water Year 2019

and thus the seasonal high in Water Year 2019 is much higher than 2018, when only 530 acre-feet was injected.

The hydrograph of shallow groundwater levels in PCA-East shows a declining trend since Water Year 2014, where levels have dropped about five feet over the past four years (Figure 28). The decline in shallow groundwater levels and greater seasonal fluctuations corresponds with the

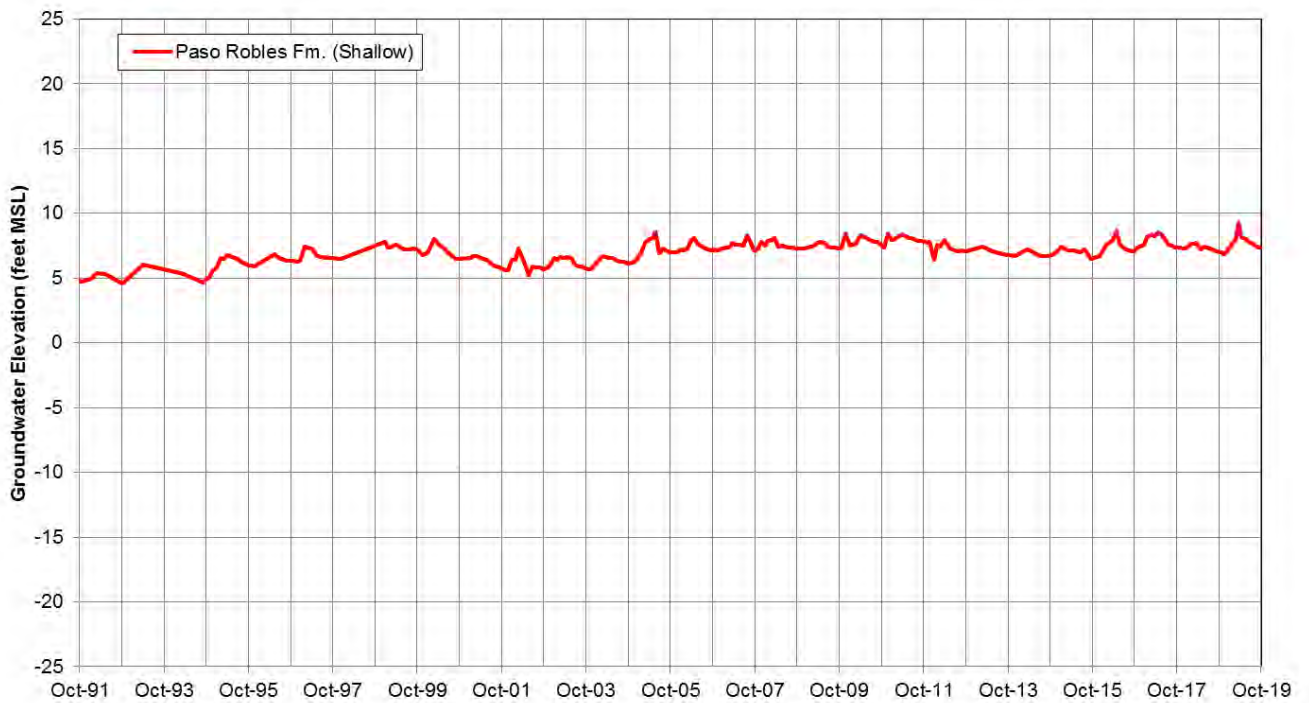
Figure 30. K-Mart Well Hydrograph (Source: Watermaster)

In the Southern Coastal subarea, the KMART monitoring well is representative of groundwater levels near the coast (Figure 30). The hydrograph shows that groundwater elevations have always been above sea level and continue to remain fairly stable over time.

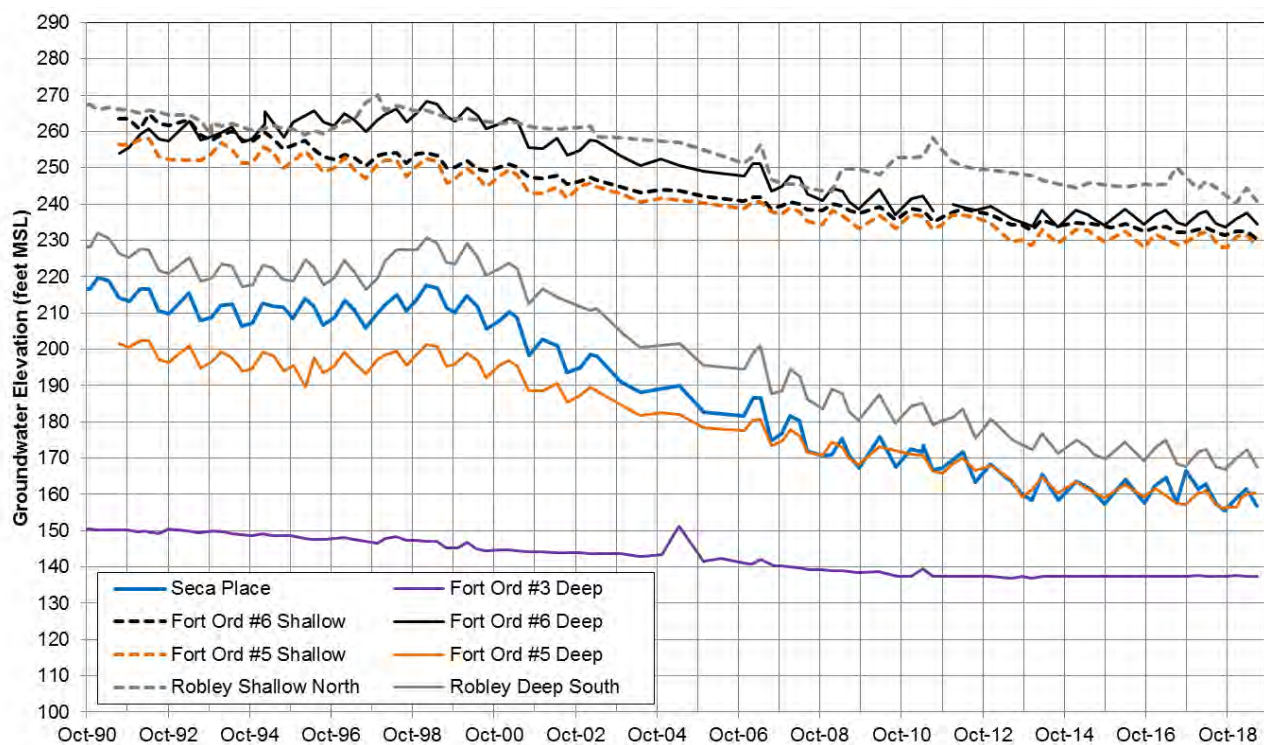
Figure 31. Eastern Laguna Seca Subarea Hydrographs

Although wells in the Laguna Seca subarea are far enough from the coast not to induce seawater intrusion, there is concern that since 2001 this area has experienced ongoing groundwater level declines that is not being halted or improved upon by triennial pumping reductions. It is believed this is occurring due in part to the Natural Safe Yield of the subarea being too high and in part due to influences of groundwater pumping east of the Seaside Basin boundary (HydroMetrics WRI, 2016). Figure 31 shows in the eastern portion of the subarea that between 1999 and 2014, shallow groundwater levels declined at a rate of approximately 0.6 feet per year, and deep groundwater levels declined up to 4 feet per year. Although there was some stabilization in groundwater levels between Water Years 2014 and 2016, groundwater levels are continuing to decline at a rate of less than 0.6 feet per year. Figure 10 shows the location of wells with hydrographs on Figure 31 while Figure 32 shows the location of all wells, including production wells in the eastern Laguna Seca Subarea.

As pointed out from Laguna Seca subarea hydrographs on Figure 31, groundwater levels in the central and eastern Laguna Seca subarea have been declining approximately 0.6 feet per year since 2014. The pumping depression caused by the Laguna Seca Golf Ranch wells remains similar in size to recent years. Groundwater levels at the Ryan Ranch wells in the western portion of the Laguna Seca subarea have continued to experience recovery since they have not been pumped from February 2018. In Water Year 2019, 2<sup>nd</sup> quarter groundwater levels in this area have recovered approximately 11 feet for a total recovery of 26 feet over the past two years.
