November 23, 2022

# **Seaside Groundwater Basin 2022 Seawater Intrusion Analysis Report**

Seaside Groundwater Basin Watermaster  
Monterey County, California

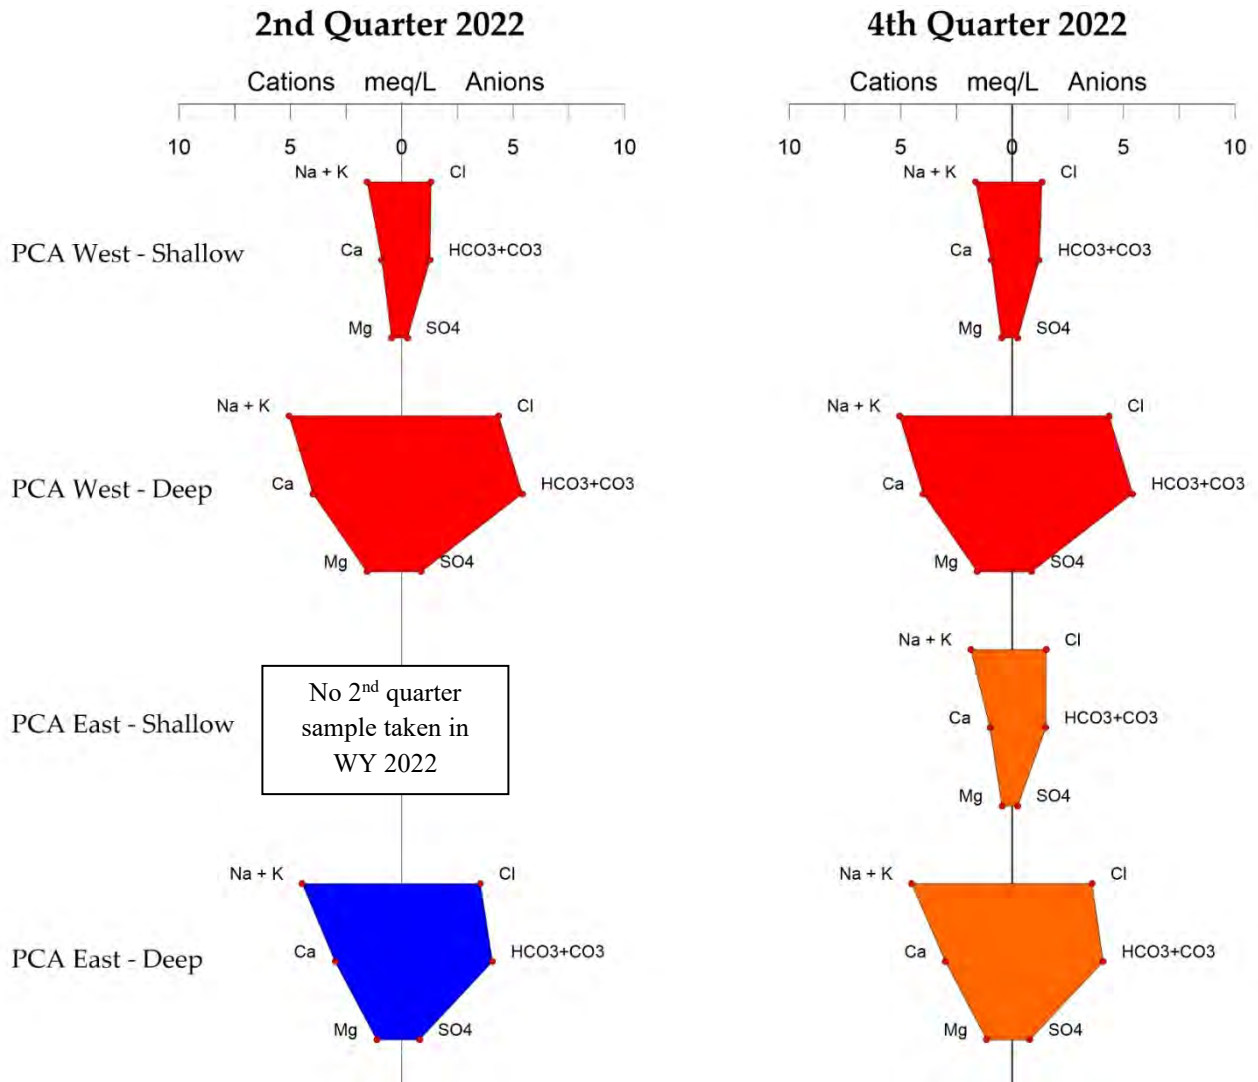
Figure 13. Stiff Diagrams for PCA West and PCA East Wells  
(Data source: Watermaster)

Stiff diagrams for the monitoring wells sampled during the second quarter of WY 2022 are shown in the left column on Figure 12 through Figure 14. None of the Stiff diagrams, including monitoring well FO-10 Shallow and FO-10 Deep, show the high chloride spike shown on Figure 7 that indicates seawater intrusion. FO-10 Shallow and FO-10 Deep do show a slightly different shape than other shallow wells because of their increased chloride. As described above, the exact mechanism behind the evolving shape of these wells on the stiff diagrams is not currently known, and it is recommended that the well nest is destroyed and replaced.

Stiff diagrams for 11 monitoring wells sampled during the fourth quarter of WY 2022 are shown in the right column on Figure 12 through Figure 14. The shapes of the Stiff diagrams for the paired monitoring wells are similar to the shapes of the Stiff diagrams for most prior years, with the exception of FO-10 Shallow and FO-10 Deep which have greater chloride equivalent concentration than  $\text{HCO}_3$  compared to other shallow coastal wells.

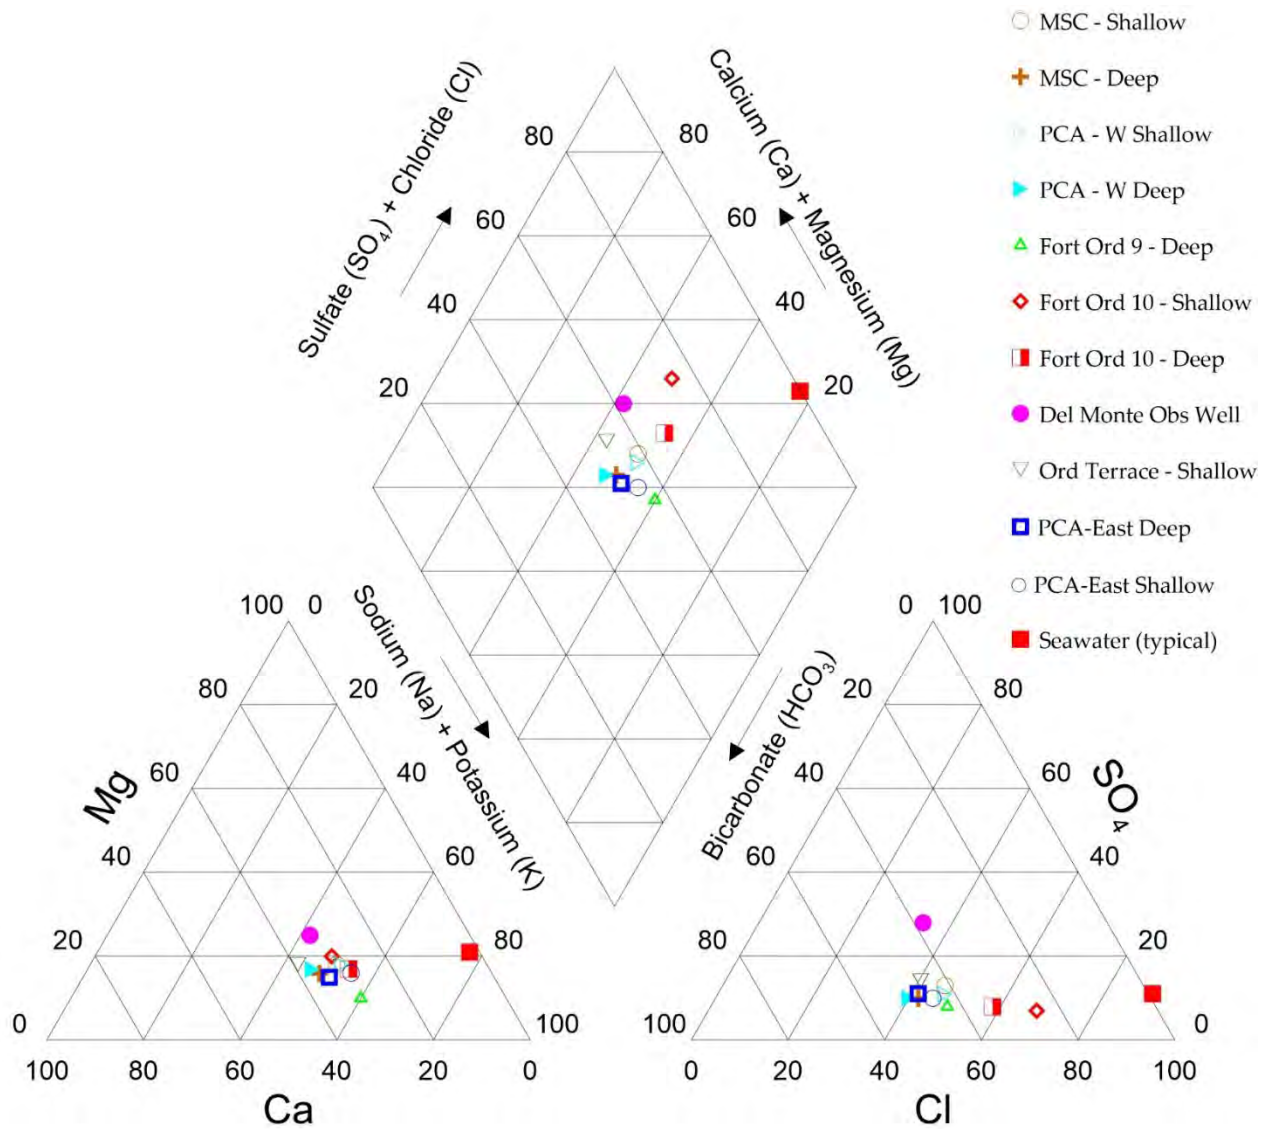
Figure 15. Piper Diagram for Seaside Groundwater Basin Monitoring Wells,  
4<sup>th</sup> Quarter Water Year 2021 (July- September 2021)  
(Data source: Watermaster)

The Piper diagram for monitoring wells (Figure 15) shows groundwater quality data clustering generally in a single area on the diagram. Groundwater is generally of a sodium-chloride/sodium-bicarbonate type and is not impacted by seawater. Monitoring well FO-10 Shallow and FO-10 Deep plot differently on both Piper (Figure 15) and Stiff (Figure 12) diagrams due to higher chloride than most other wells. As described above, current analysis is still inconclusive as to whether this is a result of seawater intrusion.

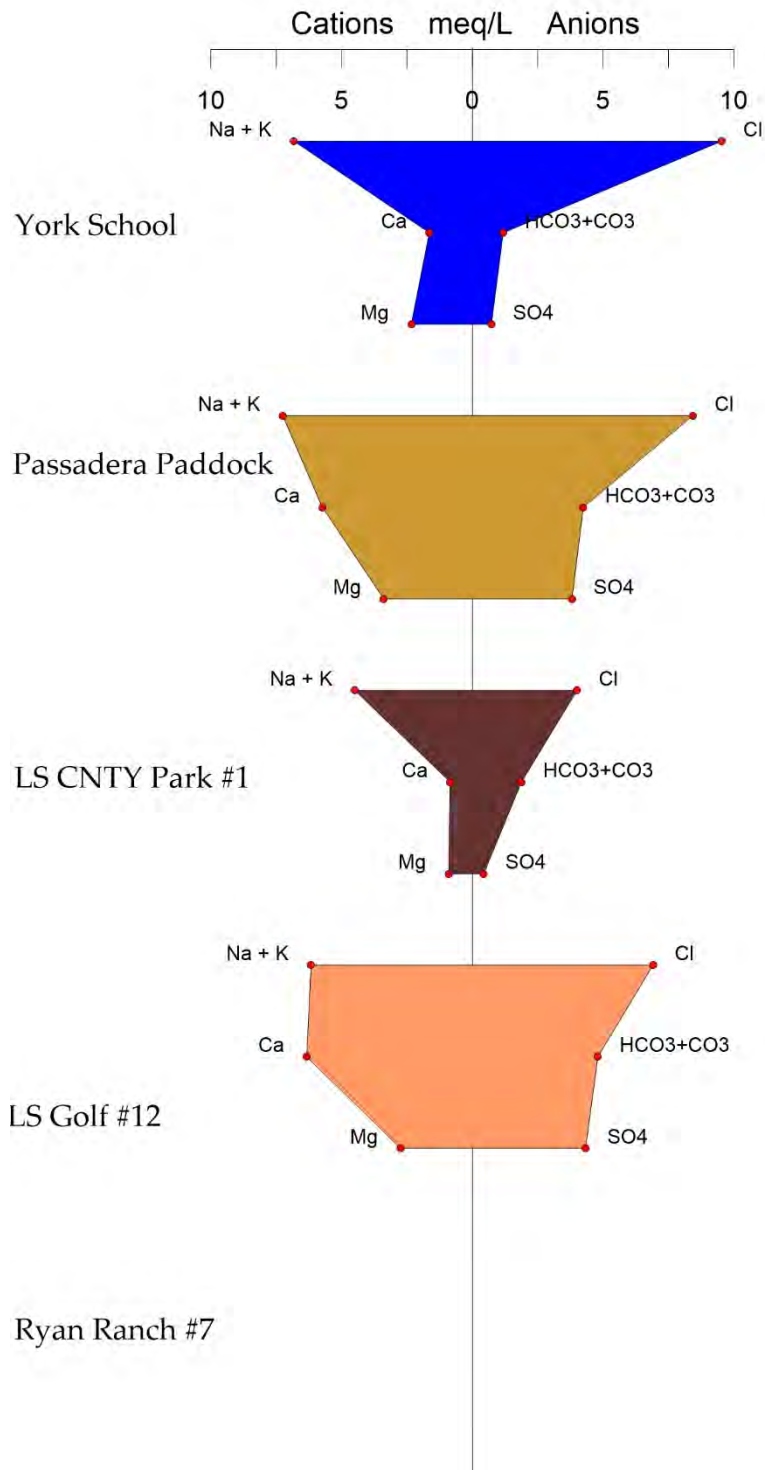
Figure 18. Stiff Diagrams for Laguna Seca Subarea Production Wells  
(Data source: Watermaster)

Stiff diagrams for 13 of the production wells sampled during the fourth quarter of WY 2022 are shown on Figure 17 through Figure 20. Production well Stiff diagrams show no significant changes from the shapes observed in previous years. Groundwater quality data for many of these wells was not available in WY 2022 at the time of this report. Ryan Ranch #7, #8, and #11 production wells were destroyed in 2021 and therefore groundwater quality data are no longer available for these wells. The Pasadera Paddock and LS Golf #12 production wells have a Stiff diagram shape that are slightly different from the other wells' chemistry. The cause of this could be localized mineralization. The Laguna Seca subarea is known to have higher salinity groundwater than the rest of the basin due to the underlying Monterey shale that was deposited in a marine environment. None of the Stiff diagrams for production wells near the coast show the high chloride spike shown on Figure 7 that indicates seawater intrusion.

The Sand City's Public Works Corp Yard production well in the Southern Coastal subarea and the York School production well in the Laguna Seca subarea typically have Stiff diagrams quite different from most other wells' groundwater quality. However, they do not have a large chloride spike associated with seawater intrusion as shown on Figure 7. None of the production wells sampled in WY 2022 and analyzed using Stiff and Piper diagrams show an indication of seawater intrusion.

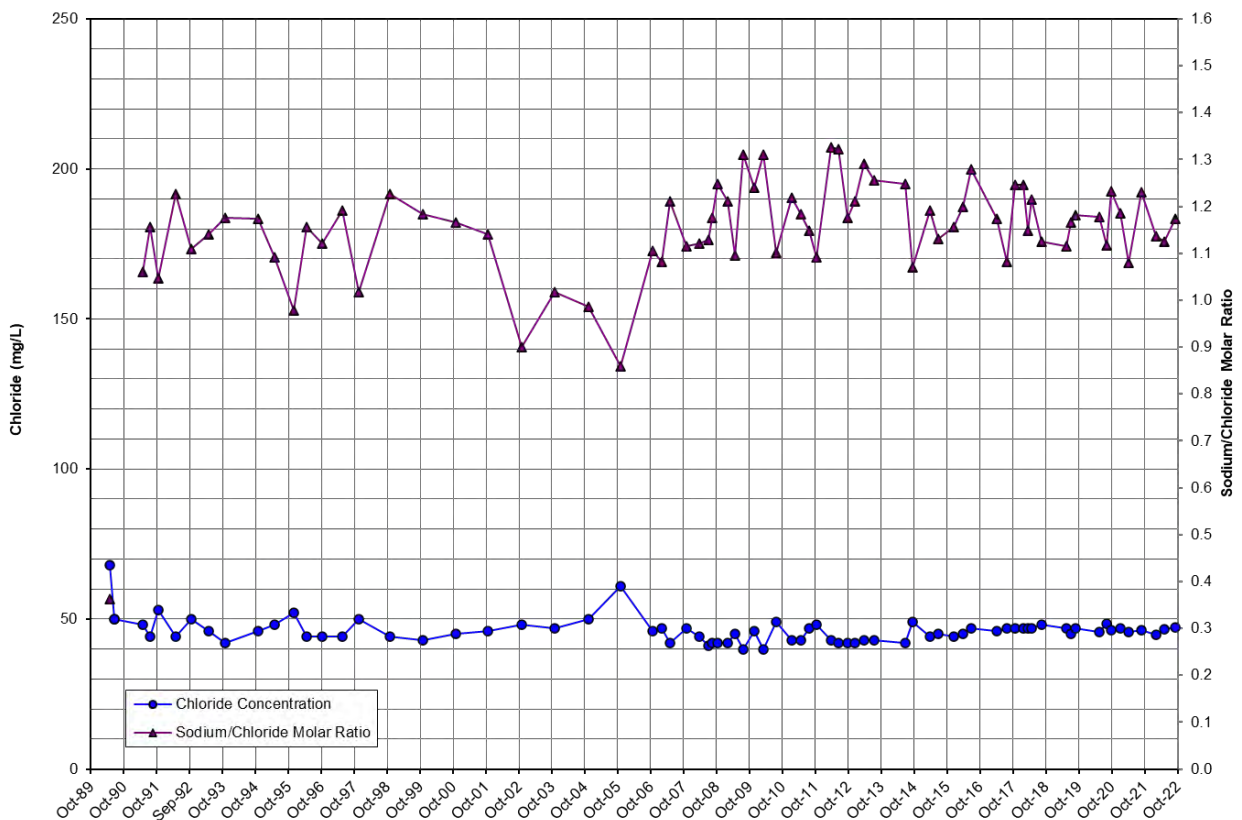
Figure 21. Historical Chloride and Sodium/Chloride Molar Ratios, PCA West Shallow

Chemographs showing chloride concentrations over time are plotted for each of the monitoring wells shown on the Piper and Stiff diagrams. An example plot displaying chloride concentrations for the shallow PCA-West Shallow monitoring well is shown on Figure 21. A complete set of chemographs is included in Appendix D. Chloride trends for most monitoring wells remain stable or fluctuate within a historical range.

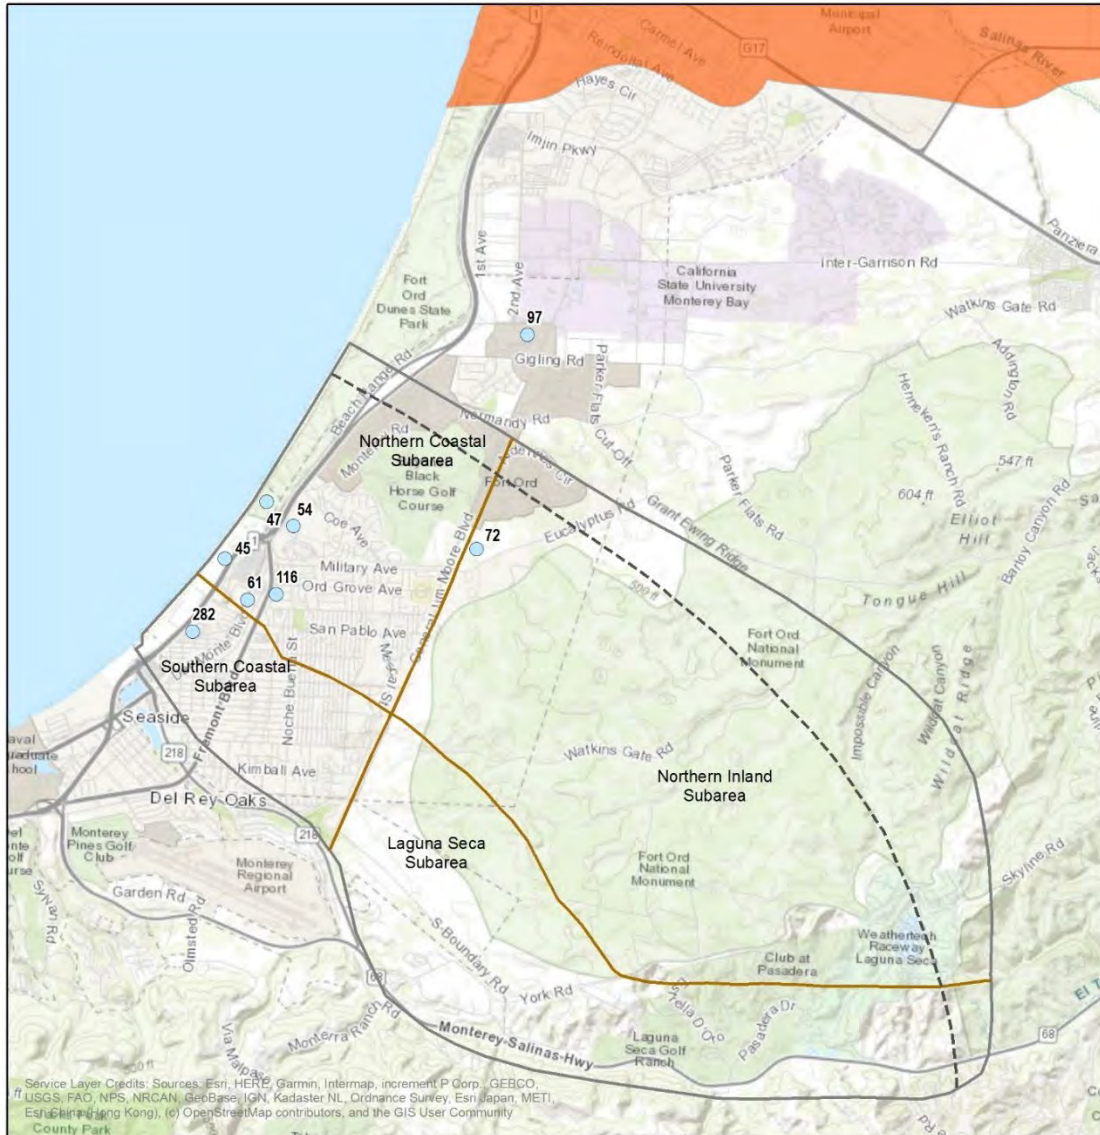
Figure 23. Paso Robles Aquifer (Shallow Zone) Chloride Concentration Map – 4<sup>th</sup> Quarter Water Year 2022

The Santa Margarita aquifer fourth quarter WY 2022 chloride concentration map is shown on Figure 23. Chloride data from Santa Margarita aquifer wells are posted on this map but do not show a spatial distribution that can be readily contoured because of differences in concentrations in wells near each other. Except for FO-10 Shallow, Santa Margarita aquifer chloride concentrations have not varied much from previous water years. FO-10 Shallow is located 0.7 miles north of the Basin, just over 1 mile inland of the coast. Chloride concentrations in the well increased 29.6 mg/L from February to September 2022. September's concentration of 96.6 mg/l reflects a continuous and sustained increase from previous years. As shown on Figure 22, chloride concentrations at this well jumped about 48 mg/L between September 2019 (42.2) and September 2020 (89.9), and continued increasing through August 2021 (92.8) and September 2022 (96.6).

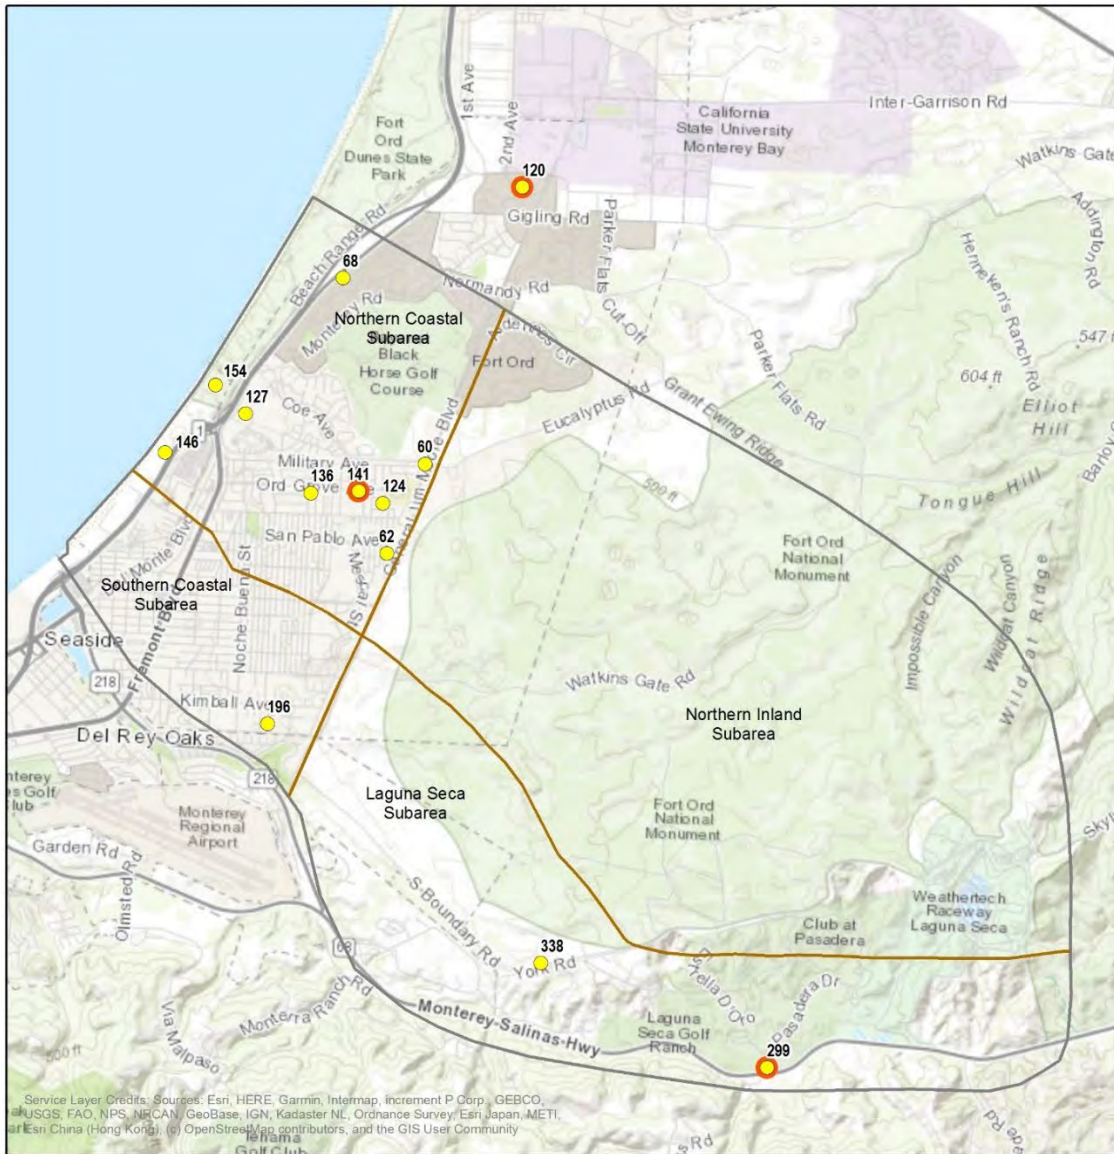
The Santa Margarita aquifer fourth quarter WY 2022 chloride concentration map is shown on Figure 24. Chloride concentrations for the Sentinel Wells are not shown on this map because it was found that groundwater samples collected from them are not representative of the aquifer. Santa Margarita aquifer chloride concentrations near the coast range roughly between 65 mg/L and 160 mg/L and are similar to last year. In WY 2021, the Ord Grove #2 production well experienced a 14 mg/L increase in chloride from last year to 134 mg/L, but that decreased in WY 2022 back down to 124 mg/L. These concentrations are generally within the 120-130 mg/L range of historical fluctuations. Since the chloride data show no discernible spatial distribution, with high concentrations close to low concentrations, the data cannot be readily contoured.

Chloride concentrations at both the Pasadera Golf- Paddock and the Ord Terrace Shallow wells increased over 20 mg/L from the previous measured year (Figure 24). The WY 2022 concentrations are the highest measured at Pasadera Golf – Paddock, and the second highest at Ord-Terrace Shallow. Due to its inland location, the increase at the Pasadera Golf-Paddock well is not related to seawater intrusion. Likewise, the Ord Terrace Shallow concentration of

141 mg/L remains within its historical range between 100 and 155 mg/L and is not likely to reflect seawater intrusion. Chloride concentrations at FO-10 Deep increased 56 mg/L from the previous year. As described earlier, the mechanism for this increase is not currently known.

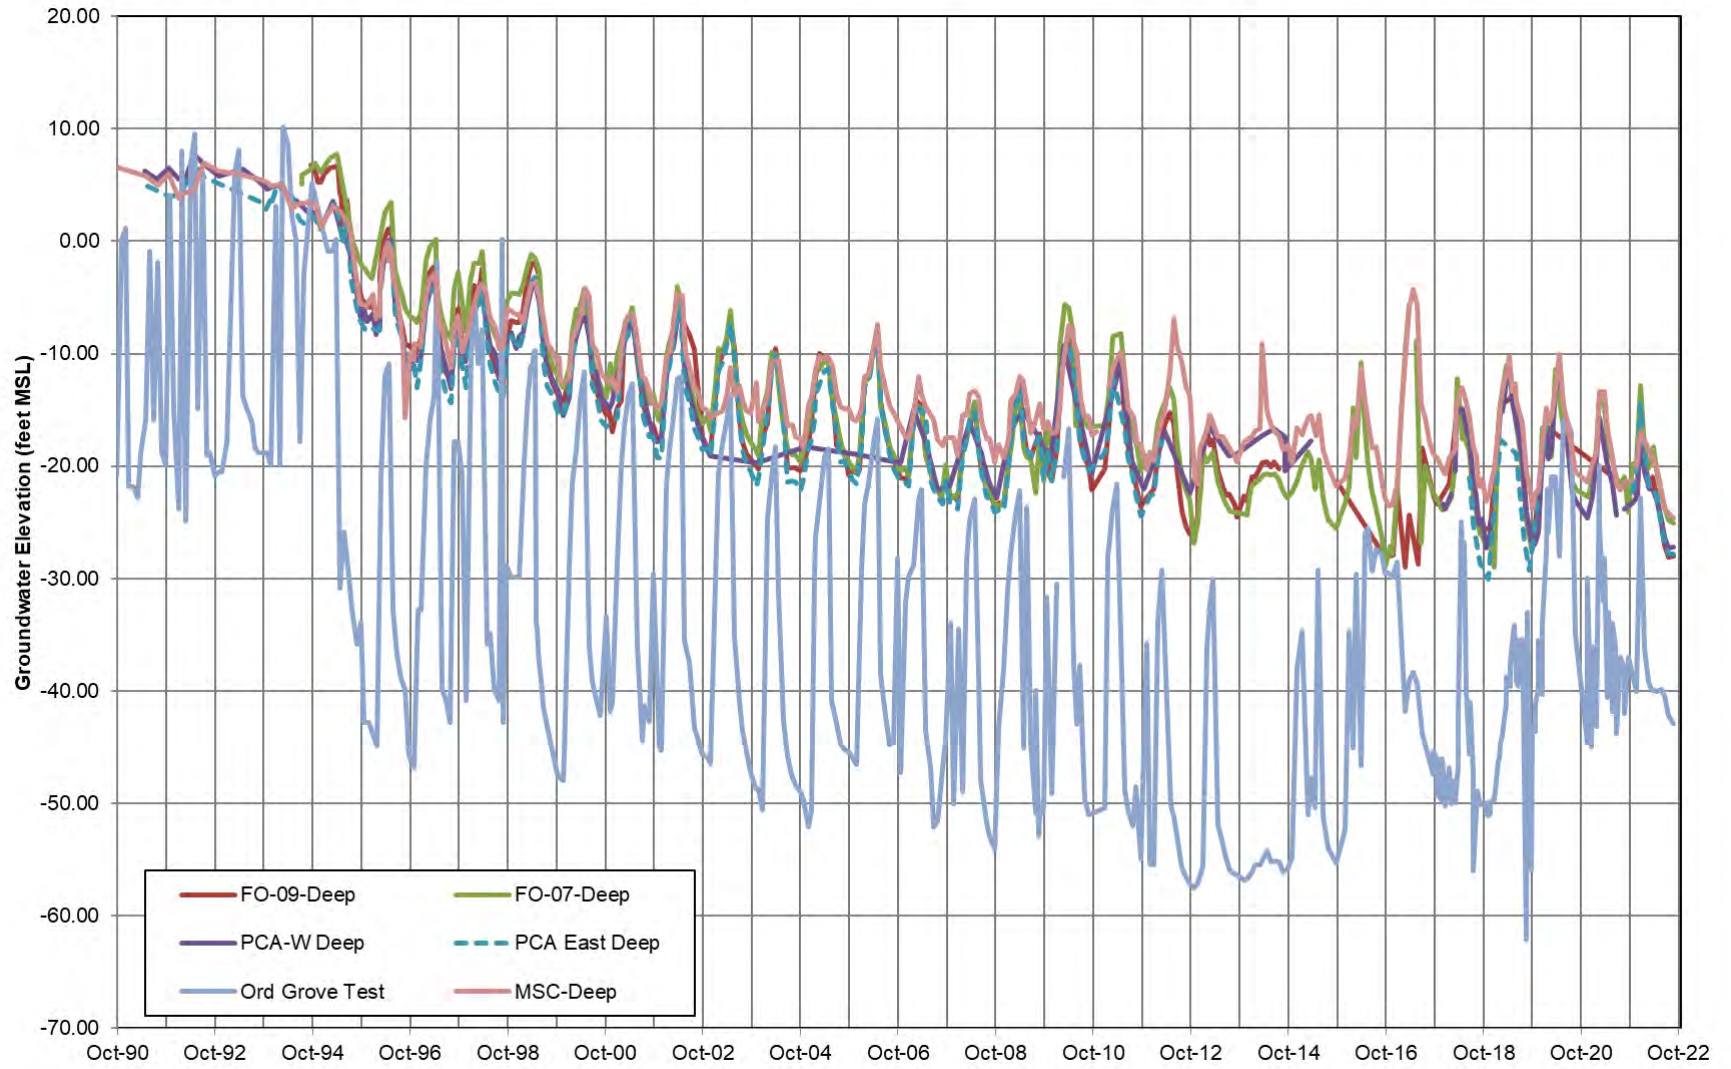
Figure 31. Santa Margarita Aquifer Northern Coastal Subarea Wells

have been below sea level since the late 1990s. The discrepancy between wells near the center of the inland pumping depression (Ord Grove Test) and more coastal and inland wells helps illustrate the gradient of the deep aquifer's pumping depression over time, shown for WY 2022 on Figure 38 and Figure 40. This discrepancy is illustrative of conditions near the very center of the pumping depression as compared to those further from its center. Because the Ord Grove Test is highly influenced by pumping at the Ord Grove #2 well, it is better to compare seasonal highs between this well and others in the Northern Coastal Subarea. The discrepancy between this well and others in the Northern Coastal Subarea tends to widen during dry periods in response to lessened recharge and increased groundwater demand (See October 2012 through October 2016 on Figure 31). Over the past 4 years this discrepancy has shrunk for 2 reasons. First, elevations in the deeper portion of the pumping depression have risen somewhat over the past 4 years, likely a result of ASR injection in WY 2019 and WY 2020, and PWM injection in WY 2021 and WY 2022 (See October-2018 through October 2022 on Figure 31). Secondly, elevations in some of the wells further from the center of the pumping depression have fallen over the past 4 years (FO-07 Deep, FO-09 Deep, PCA-W Deep, MSC-Deep). As discussed above, elevations at PCA-East Deep have likewise fallen over the past 2 years. From this we can conclude that although the depth of the pumping depression's center has decreased in the past few years, its lateral extent continues to grow. How the shape and gradient of this deep pumping depression evolves over time should be examined to inform projects and sustainability in the Northern Coastal Subarea.

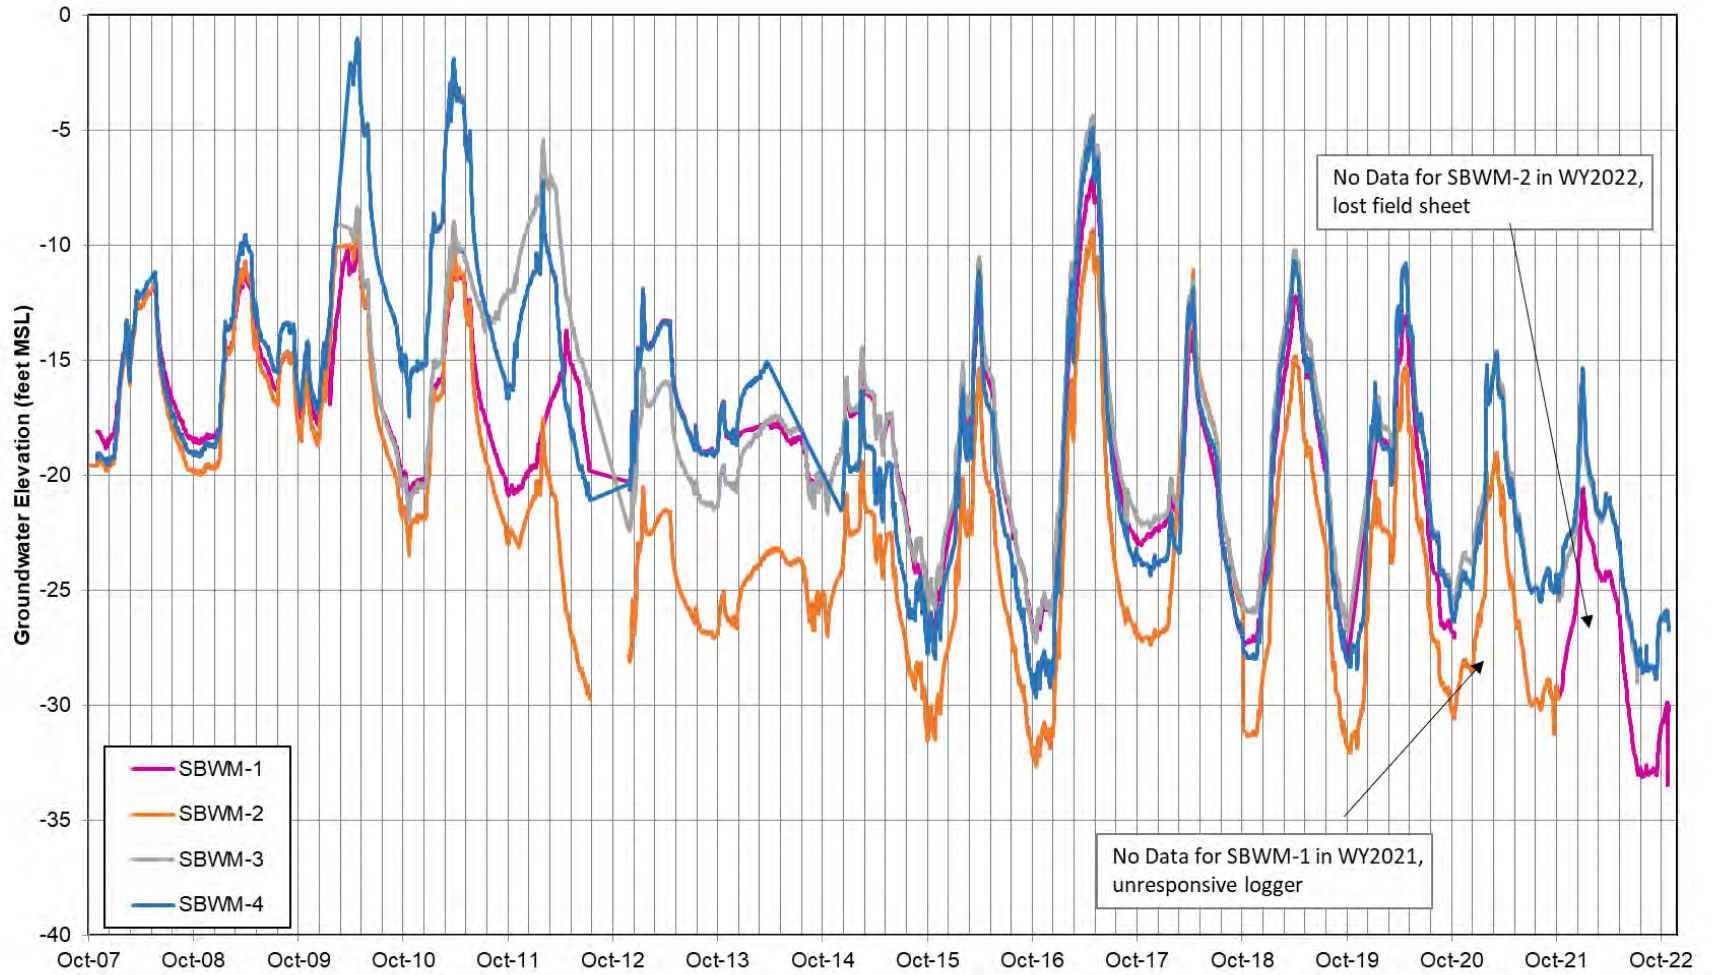
Figure 32. Sentinel Well Hydrographs (Source: Watermaster)

Figure 32 includes hydrographs of groundwater elevations for the 4 deep coastal Sentinel Wells. Groundwater elevations on this chart are collected from dataloggers in each well that record levels every 30 minutes. The hydrographs plot daily average elevations, thereby smoothing out the more detailed data which are affected by tidal variations. Hydrographs for the Sentinel Wells are similar to the PCA-East Deep hydrograph and show that groundwater elevations over winter and spring were the highest in WY 2017 because of increased ASR injection. Comparison between WY 2021 and WY 2022 is complicated by a lack of WY 2021 data at SBWM-1 and WY 2022 data at SBWM- 2. Data at SBWM-1 were not available during WY 2021 due to an unresponsive datalogger, but the logger was reinstated in WY 2022. Data at SBWM-2 were not available during WY 2022 due to a lost field sheet. Seasonal low groundwater levels in WY 2022 at SBWM-1 are the lowest over its period of record (Figure 32).

Seasonal high groundwater elevations in WY 2022 are very similar to the previous year. However, seasonal low elevations are roughly 4 feet lower than the previous year, likely a result of continued dry conditions and a lack of available surface water to support ASR injection (Section 2.6.1; Section 2.7).

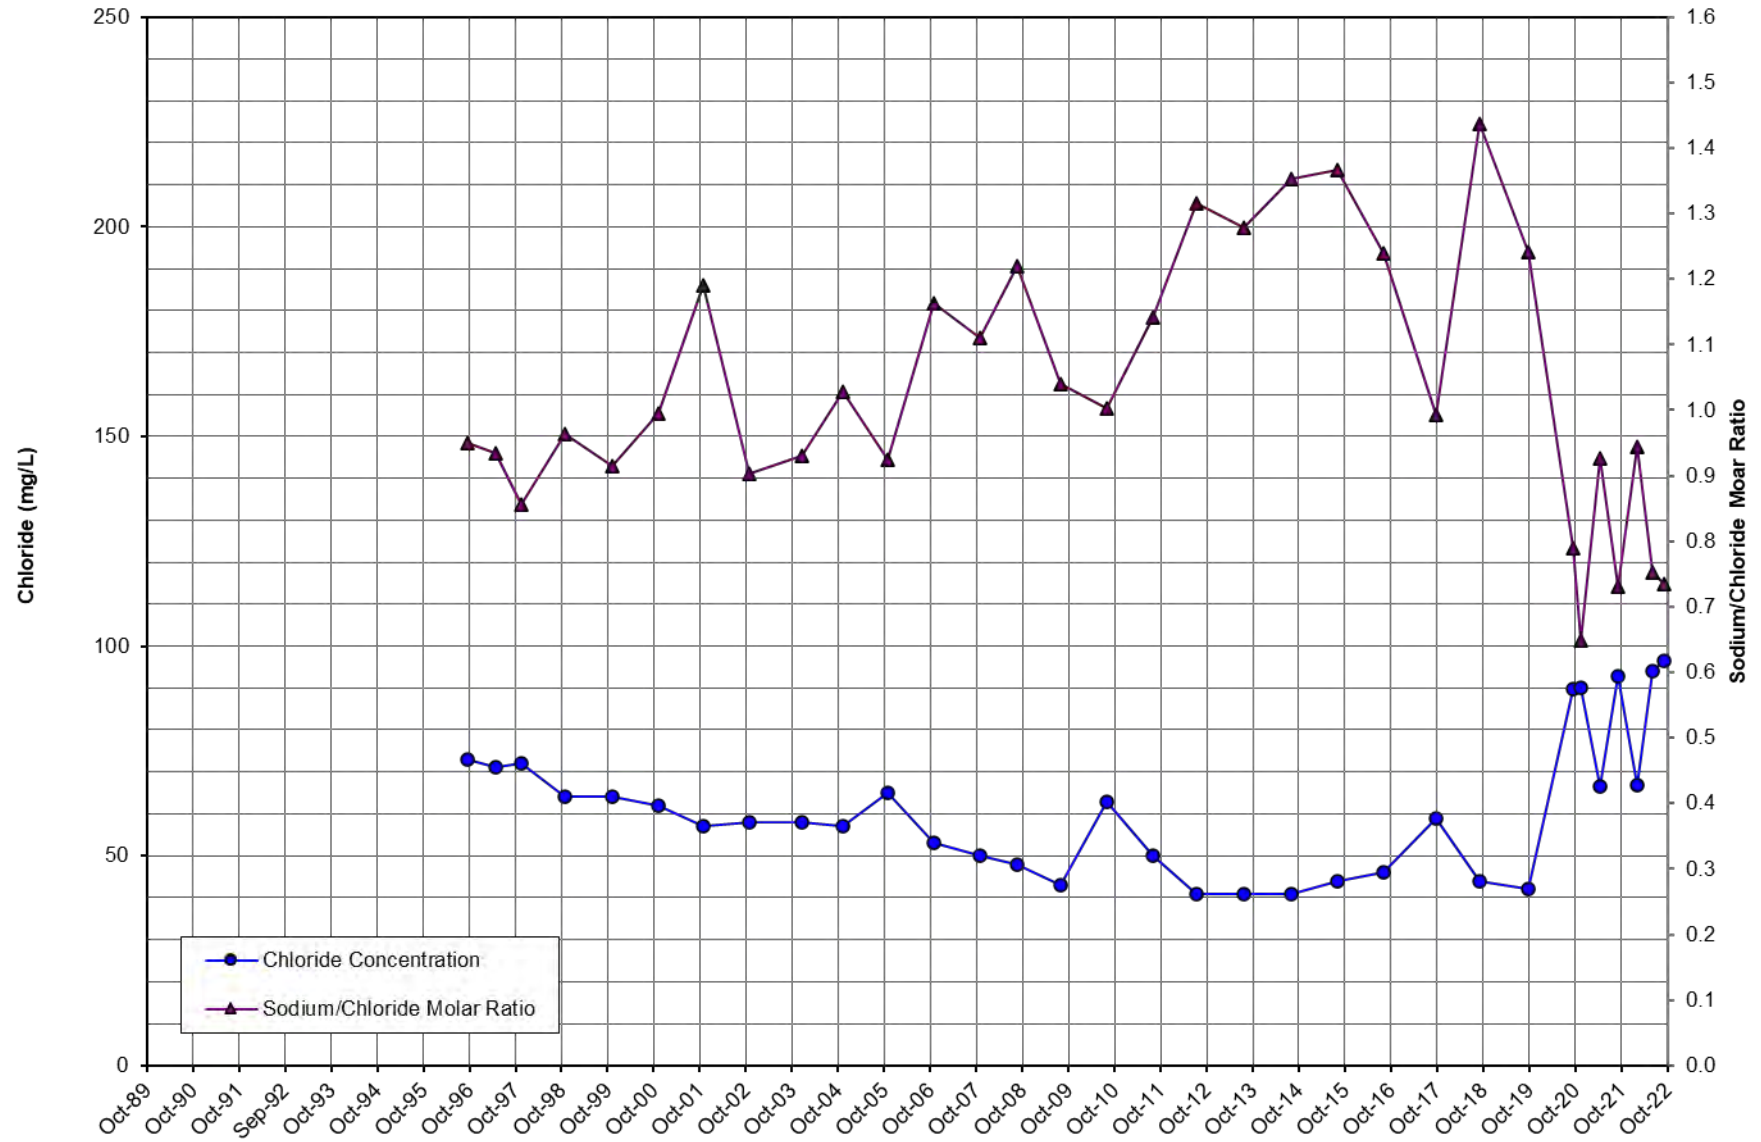
Figure D-9. Fort Ord 10 Shallow Well Chloride and Sodium/Chloride Molar Ratio Graph

- Chloride concentration trends are stable for most monitoring wells, except FO-10 Shallow and FO-10 Deep. FO-10 Shallow experienced a 48 mg/L increase in chloride concentrations in WY 2020 and has risen by another 8 mg/L since then. FO-10 Deep experienced a 60 mg/L chloride increase in WY 2022. However, the sustained elevated concentrations in themselves do not indicate seawater intrusion. As noted above, recent induction logging of the well was unable to provide data with regard to whether seawater intrusion is the source of the elevated chloride level, and the well's integrity for water quality sampling may be compromised by a steel tremie pipe stuck in the borehole since 1997.

The discovery of a 1,300-foot steel tremie pipe in the FO-10 borehole complicates evaluation of water quality at the location and may act as a conduit allowing groundwater to flow between overlying sediments and the underlying aquifers. This is further supported by similar trends in groundwater elevation and chemistry over the past 3 years. These wells are outside of the Basin, yet still provide critical information regarding the extent of seawater intrusion north of the Basin in the Monterey Subbasin. Therefore, it is recommended that MPWMD develop plans to destroy the well and that MCWD install a similarly constructed monitoring to maintain a continuous water quality record at the location. Because seawater intrusion cannot be excluded as the source of increasing chloride concentrations at FO-10 Shallow over the past several years, groundwater quality sampling at this well should continue at the increased quarterly frequency until the well is destroyed. When the well is replaced, the replacement well should likewise be sampled at a quarterly frequency.
