December 14, 2023

# **Seaside Groundwater Basin 2023 Seawater Intrusion Analysis Report**

Seaside Groundwater Basin Watermaster

Montgomery & Associates

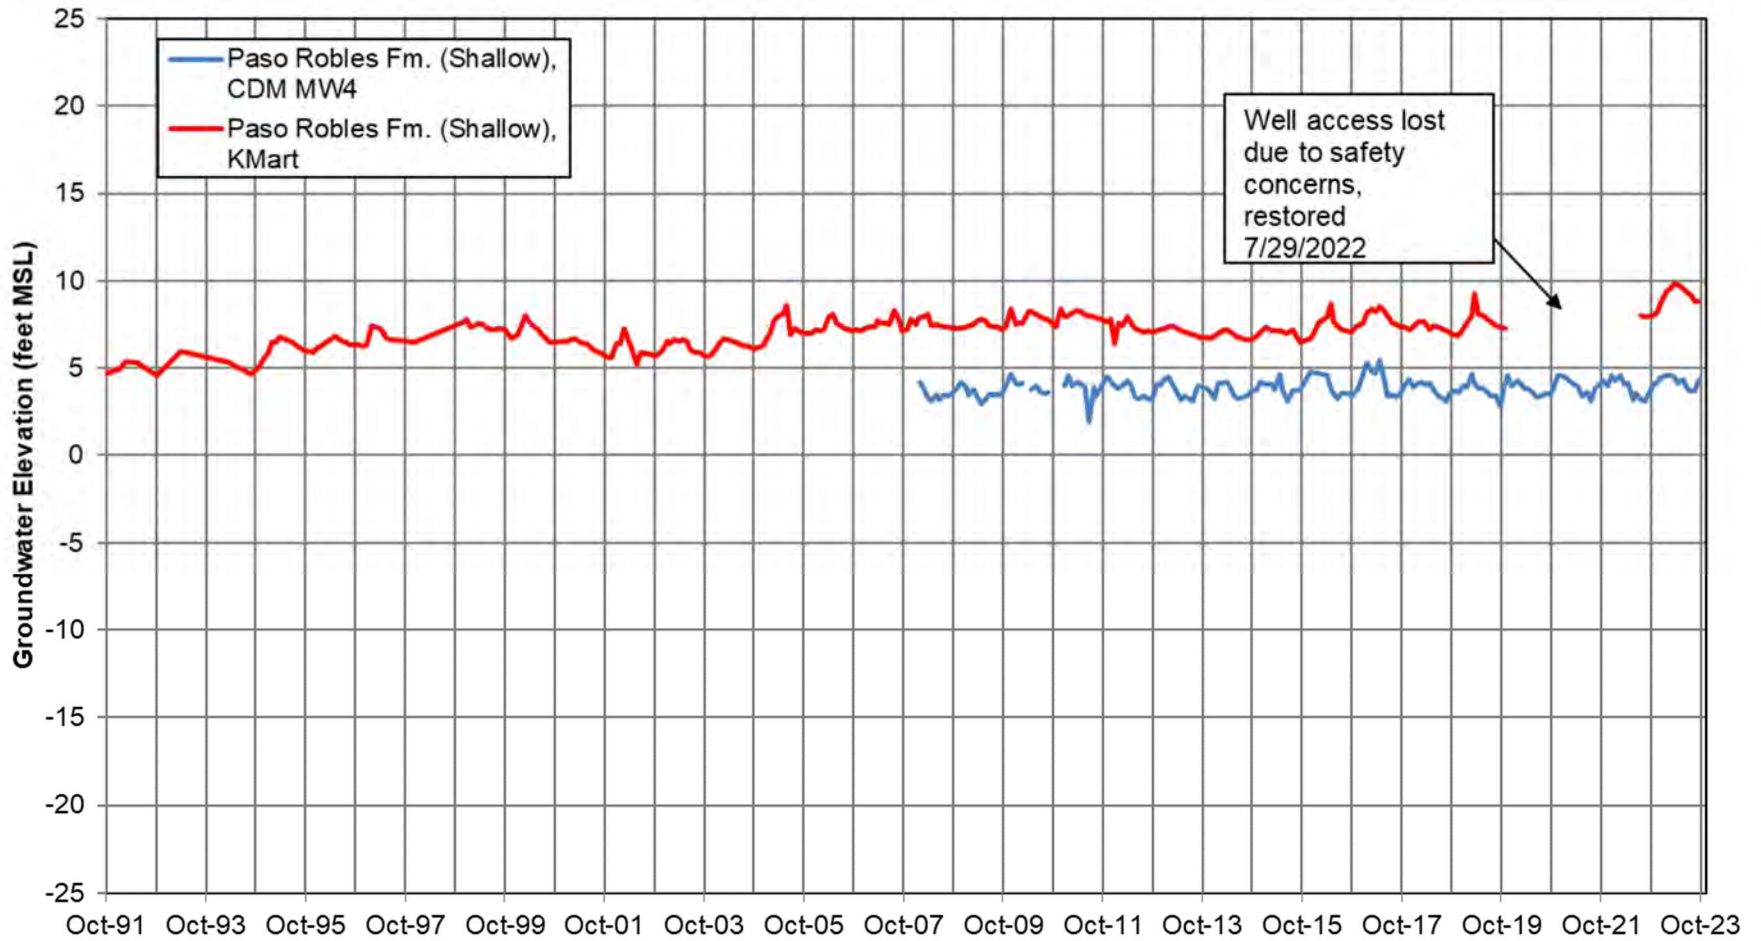
Figure 36. K-Mart and CDM MW4 Hydrographs, Southern Coastal Subarea

In the Southern Coastal subarea, the K-Mart and CDM MW4 monitoring wells are representative of groundwater levels near the coast. Figure 36 shows groundwater elevations have remained above sea level and slightly increased in WY 2023. K-Mart well groundwater elevations have increased slightly over the period of record with WY 2023 elevations being the highest on record for the well.

measurements. While access to the well has been restored in late WY 2022, the nearby CDM MW4 monitoring well is added to the hydrograph on Figure 36 to show groundwater elevation trends in the subarea during the data gap period.

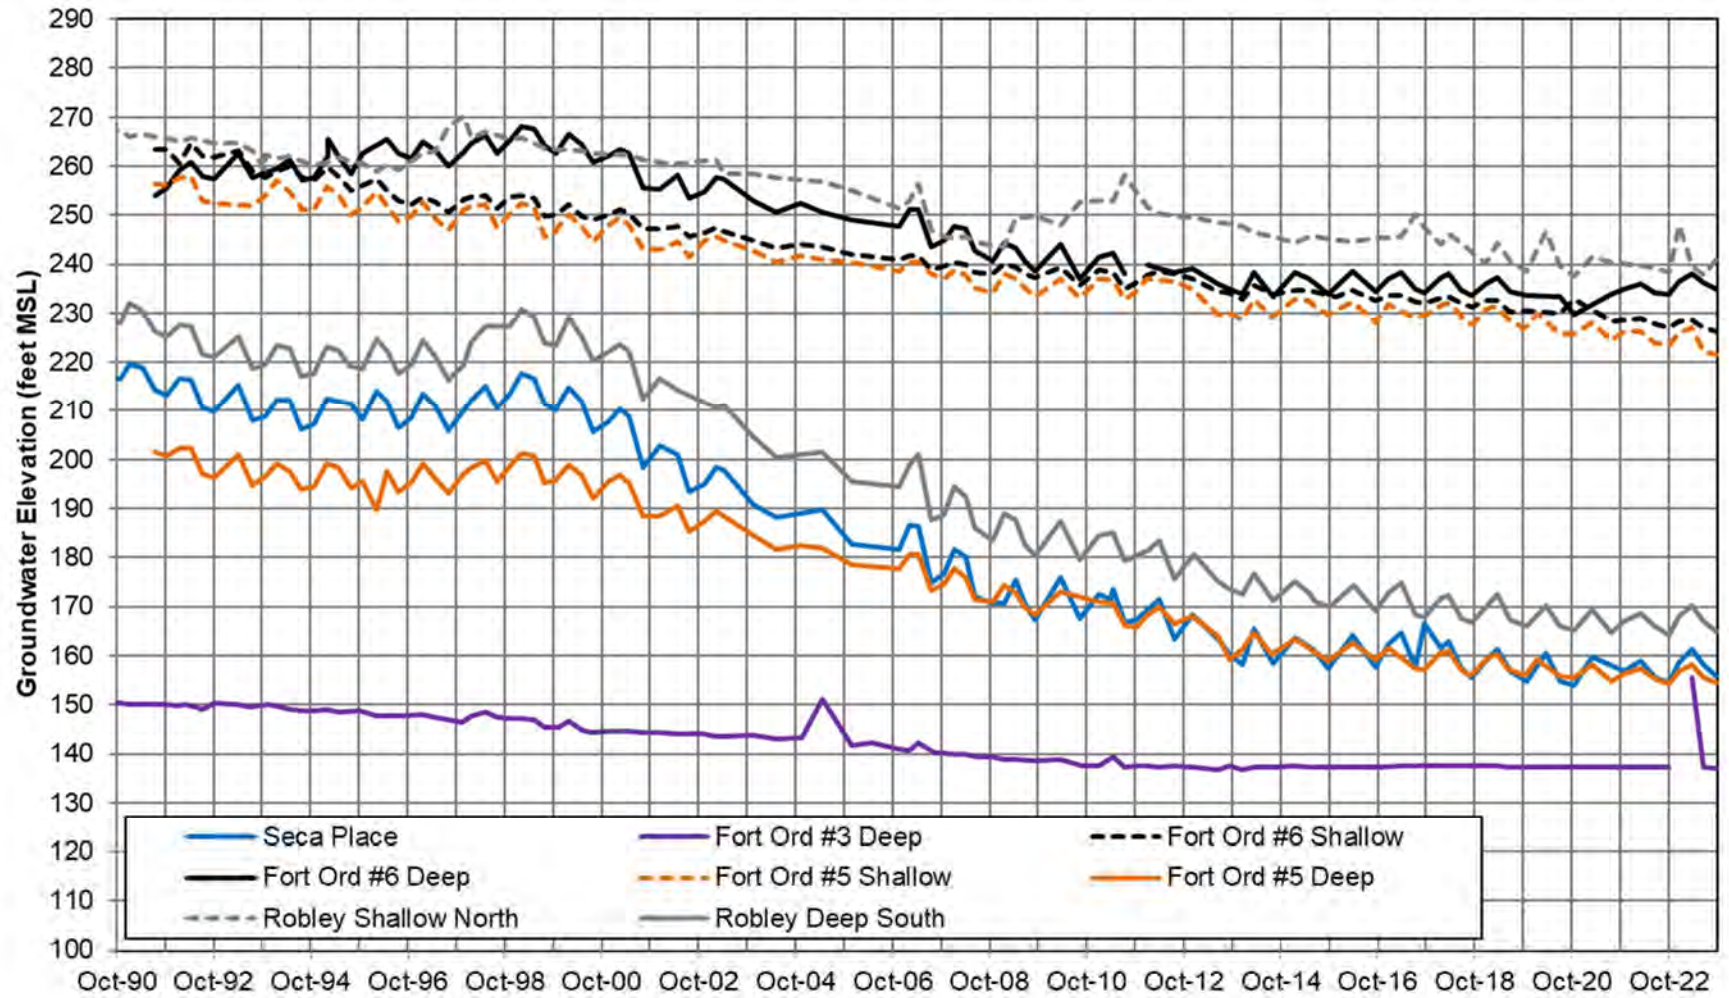
Figure 37. Eastern Laguna Seca Subarea Monitoring Well Hydrographs

In the eastern portion of the subarea between 1999 and 2014, Paso Robles aquifer groundwater levels declined at a rate of approximately 0.6 feet per year and Santa Margarita groundwater levels declined up to 4 feet per year, as shown on Figure 37. Although there was some stabilization between WY 2014 and WY 2016, groundwater levels were declining at a general rate of roughly 0.5 feet per year in both the Paso Robles and Santa Margarita aquifer systems. In WY 2023, the declining trend stabilized at LS No. 1 Subdivision. No data was available in WY 2023 for LS Golf Old #12. In WY 2023, groundwater elevations at the Bishop #3 well continue to rise in response to CAWC ceasing pumping in the Bishop unit. There has been approximately 20 feet of recovery since 2020. Similar trends are present in the central portion of the subarea, as shown on Figure 38.

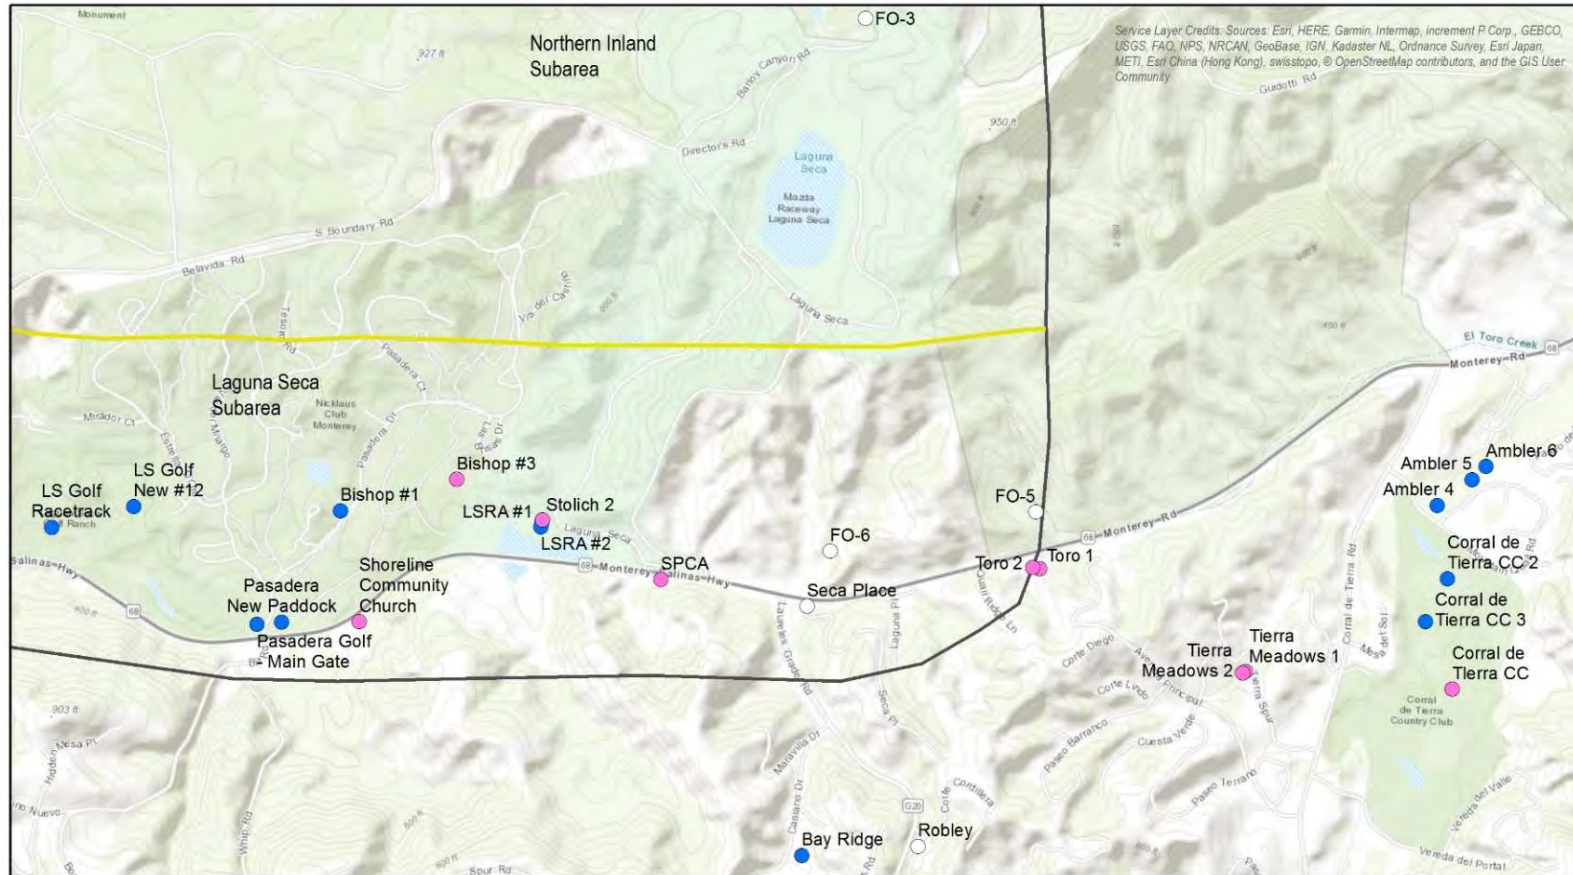
Although the Laguna Seca subarea is far enough from the coast not to have seawater intrusion, there is concern that since 2001 this area has experienced ongoing groundwater level declines that have not been controlled or improved by triennial pumping reductions. It is believed this is occurring due to the subarea's limited groundwater inflows and natural recharge compounded by the influence of wells pumping east of the Basin (HydroMetrics WRI, 2016a). Figure 10 shows the location of wells with hydrographs on Figure 37 while Figure 39 shows the location of all wells, including production wells in the eastern Laguna Seca subarea.

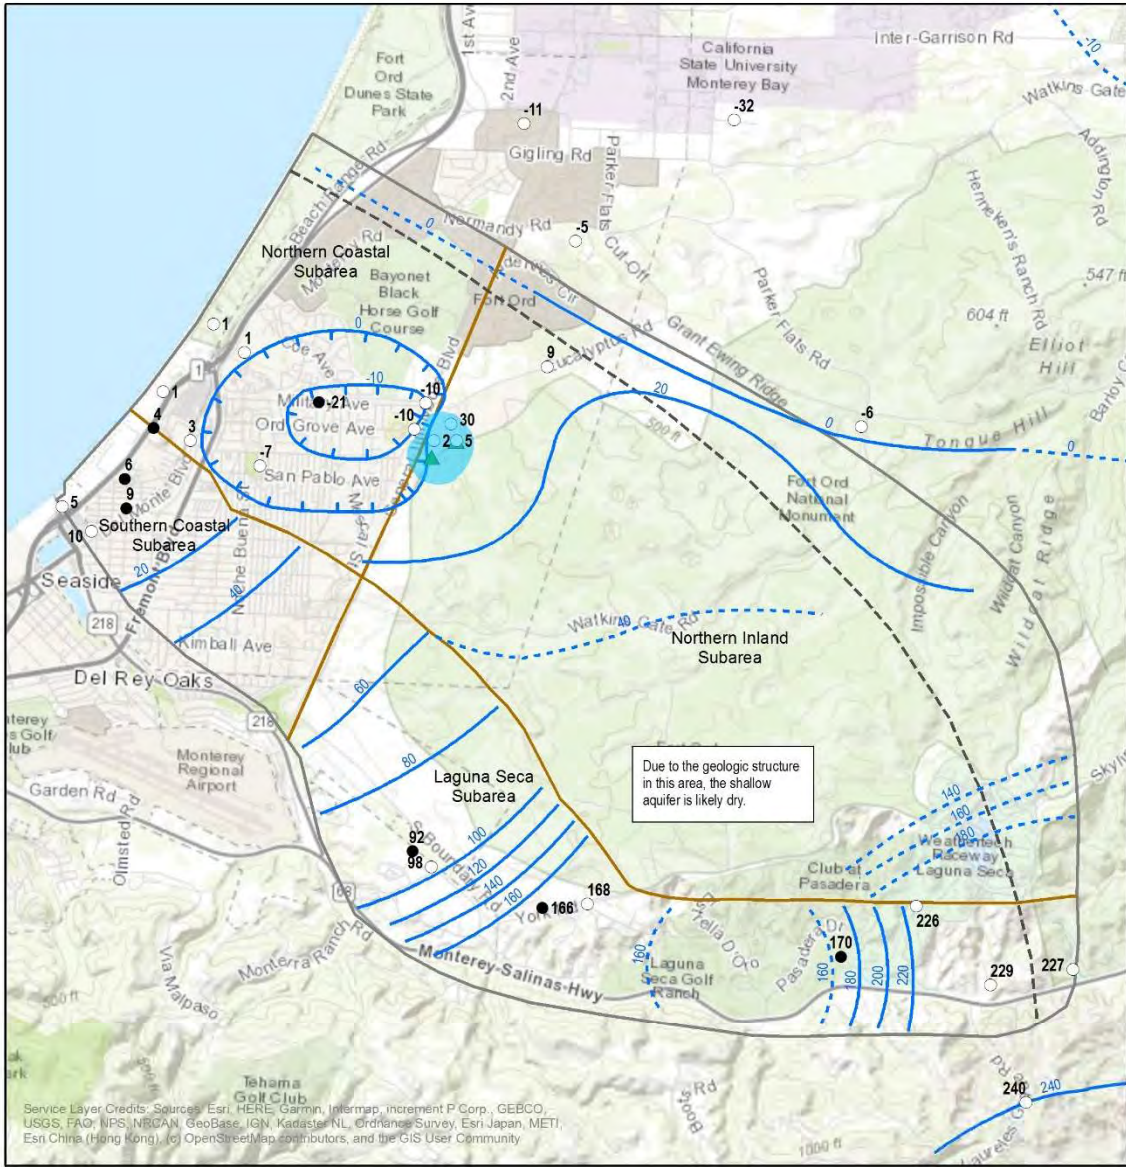
Figure 40. Paso Robles Aquifer (Shallow Zone) Water Elevation Map – Second Quarter Water Year 2023 (January-March 2023)

The following are observations on the second quarter groundwater elevation contours for the Paso Robles aquifer (Figure 40):

- In the Northern Coastal subarea and just north of the subarea (outside of the basin), second quarter (spring) Paso Robles groundwater elevations for WY 2023 remain generally stable, mirroring levels observed in the second quarter of WY 2022. Changes are limited to 1 to 2 feet of decline or increase, with no significant trend in either direction.

- The Southern Coastal subarea had a 1-foot increase in groundwater elevations in WY 2023.
- Available data indicate that the pumping depression caused by the Laguna Seca Golf Ranch wells in the central Laguna Seca subarea has likely reduced in size due to reduced pumping in WY 2023 and increased recharge from above-normal rainfall. Although spring groundwater elevation data for the well were not received, the typical pumping depression around the golf courses is still reflected on the contour map. Spring 2023 groundwater elevations at the Bishop #3 well rose roughly 7 feet from the previous year in response to CAWC ceasing pumping at the well.

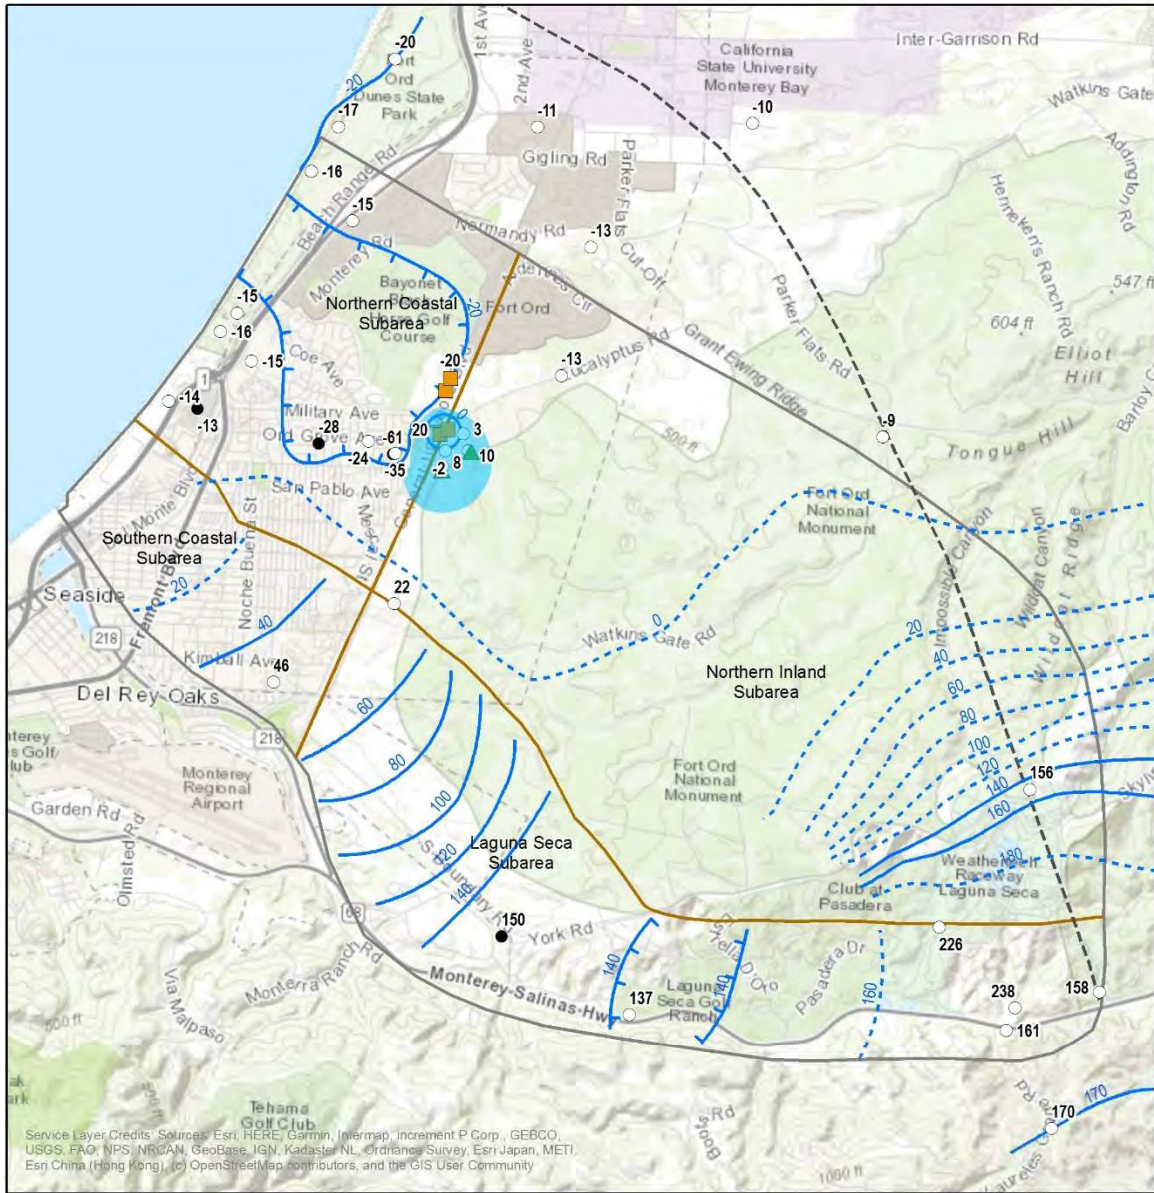
Figure 41. Santa Margarita Aquifer (Deep Zone) Water Elevation Map – Second Quarter Water Year 2023 (January-March 2023)

The following are observations on the second quarter groundwater elevation contours for the Santa Margarita aquifer (Figure 41):

- In the Northern Coastal subarea, along the coast and just north of the subarea, Santa Margarita groundwater levels along the coast increased roughly 5 to 12 feet from last spring.
- The Santa Margarita aquifer pumping depression in the Northern Coastal subarea shrunk significantly since WY 2022, with the -20 feet msl contour line now within the Basin while last year it extended farther north into the Salinas Valley - Monterey Subbasin.
- PWM monitoring well data were available in WY 2023; elevations in these monitoring wells are now above sea level, except for MW-2AD.
- Available data indicate the pumping depression associated with pumping at the Laguna Seca golf courses is similar to spring levels last year.
- The eastern portion of the Laguna Seca subarea has groundwater levels similar to last year, with minor rises in groundwater elevations across wells ranging from 1 to 2 feet.

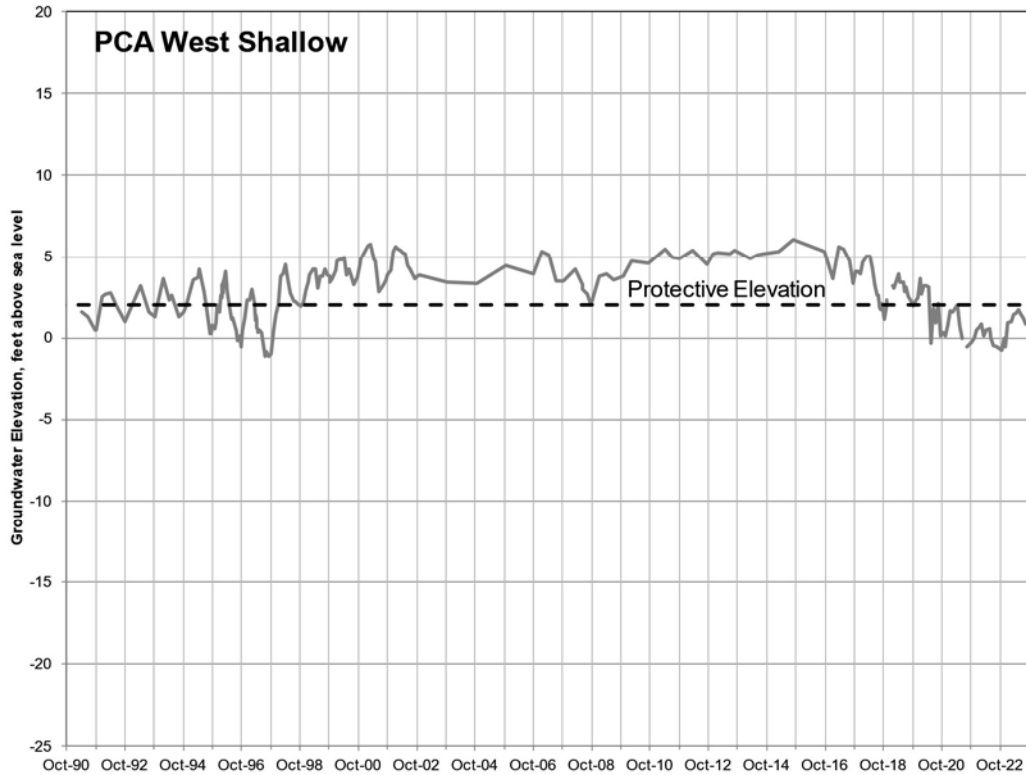
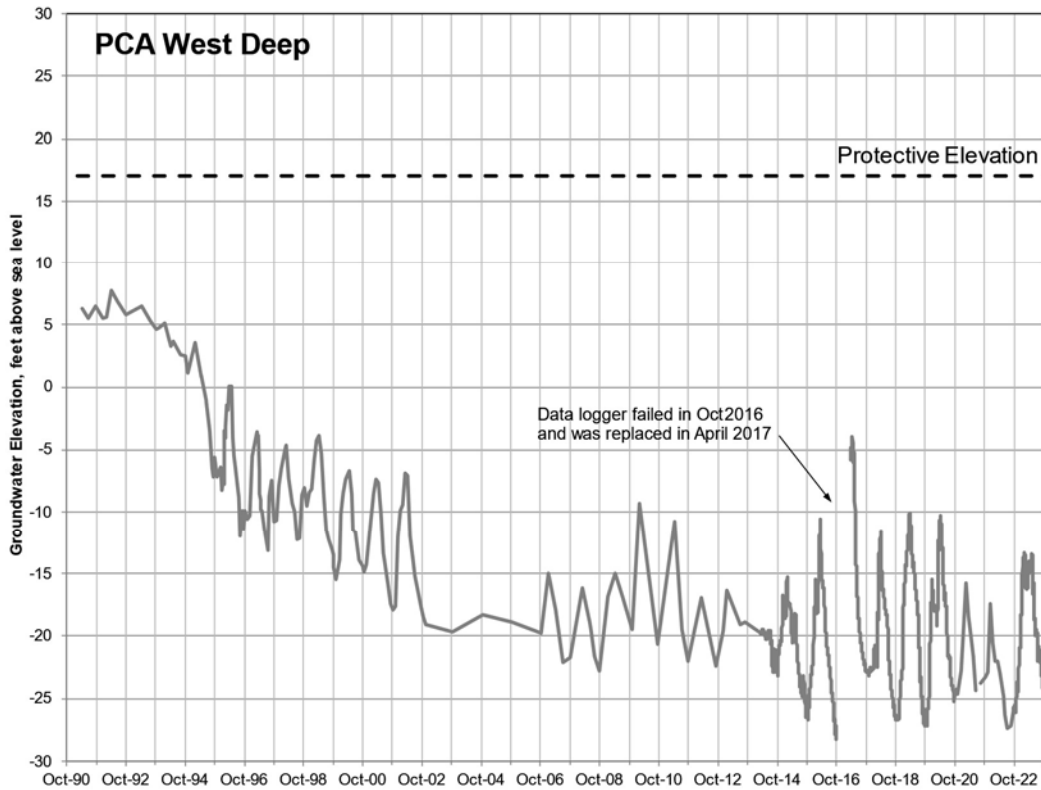
Figure 45. PCA West Deep and Shallow Groundwater and Protective Elevations

Figure 44 through Figure 47 show the historical groundwater elevations at each of the target protective elevation monitoring wells. Groundwater levels continue to be below protective elevations in all Santa Margarita target monitoring wells (MSC deep, PCA-West deep, and Sentinel Well 3). Last year, groundwater levels at all 3 Santa Margarita monitoring wells were the lowest over their historical records. In WY 2023, groundwater levels stabilized and are slightly higher than the previous year. Monitoring well CDM-MW4 is the only Paso Robles well (1 of 3 Paso Robles wells total) with groundwater level above its protective elevation. Groundwater levels in the PCA West Shallow well fell below protective elevations in WY 2020 and remained below through WY 2022. In WY 2023 groundwater elevations briefly increased to just below the protective elevation in June. Elevations at this well declined during the summer but the WY 2023 fall elevation remains 1 to 2 feet higher than the 2 previous years. Groundwater levels in the MSC Shallow well continue to be below its protective elevation.

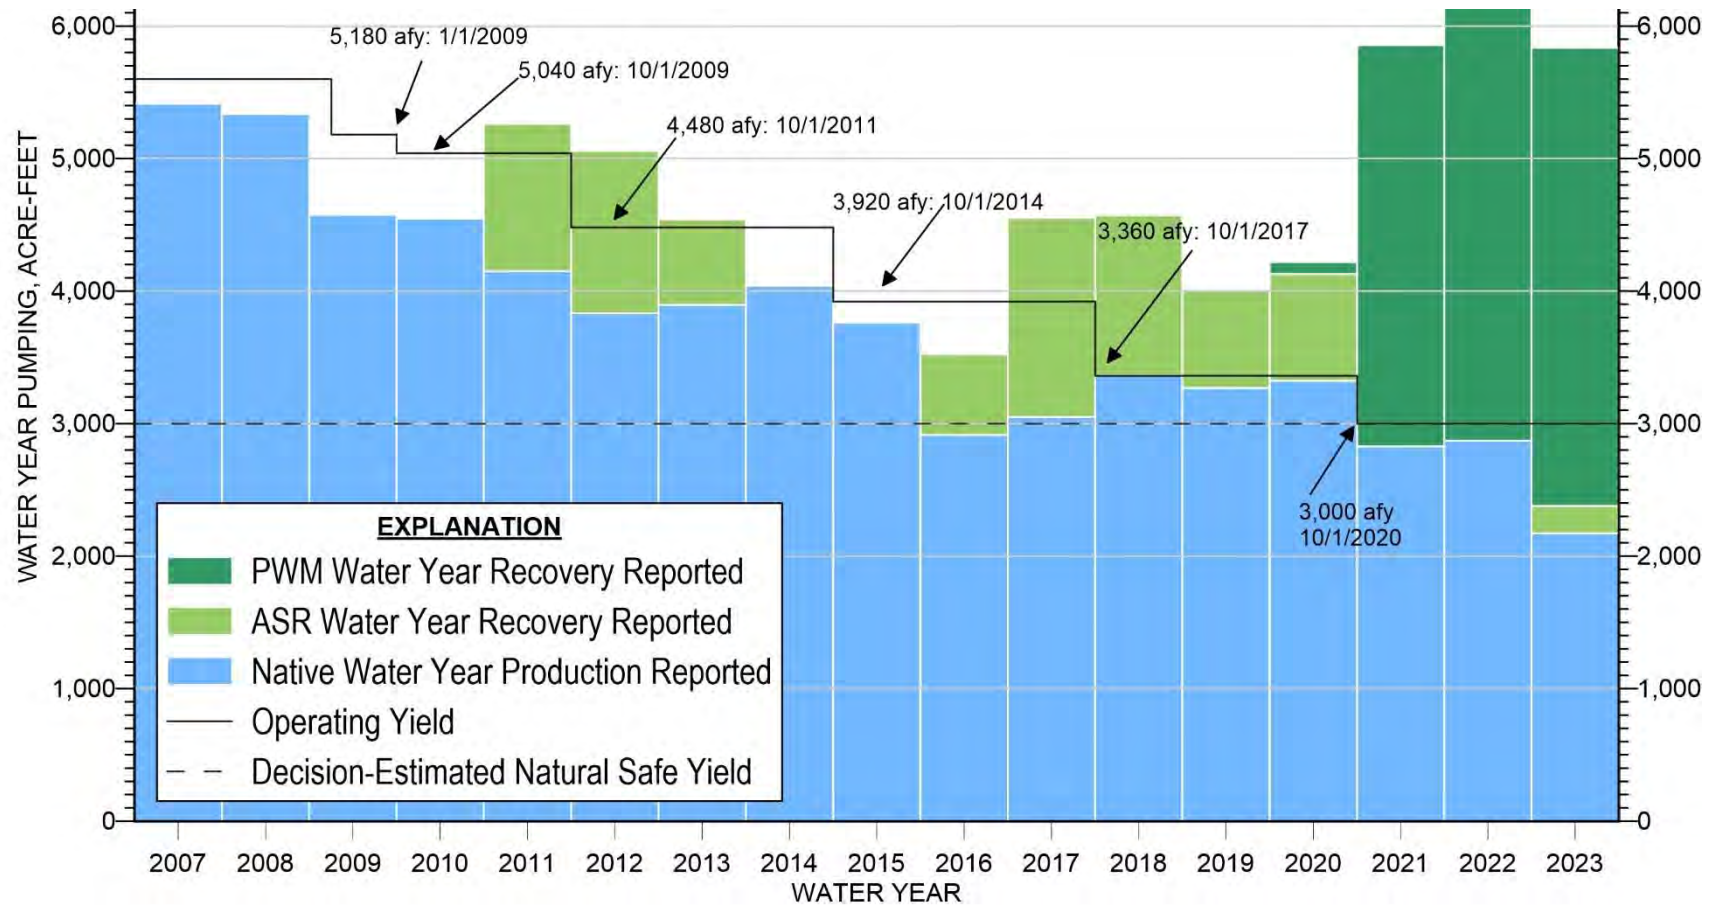
Figure 48. Annual Reported Groundwater Production and Operating Yield for Watermaster Producers

In WY 2023, ASR and PWM wells injected 1,451 and 3,755 acre-feet, respectively, for a total of 5,206 acre-feet of injection. Of the injected water, 3,458 acre-feet were recovered by production wells. As reported by the Watermaster, net or native groundwater production was 2,173 acre-feet (gross pumping less recovery), which is 827 acre-feet below the Decision-ordered Operating Yield for WY 2023 of 3,000 acre-feet (Figure 48). The net or native groundwater produced from the Basin in WY 2023 was roughly 698 acre-feet less than in WY 2022. The Decision-ordered Operating Yield will continue to be 3,000 acre-feet unless a revised Sustainable Yield is developed.

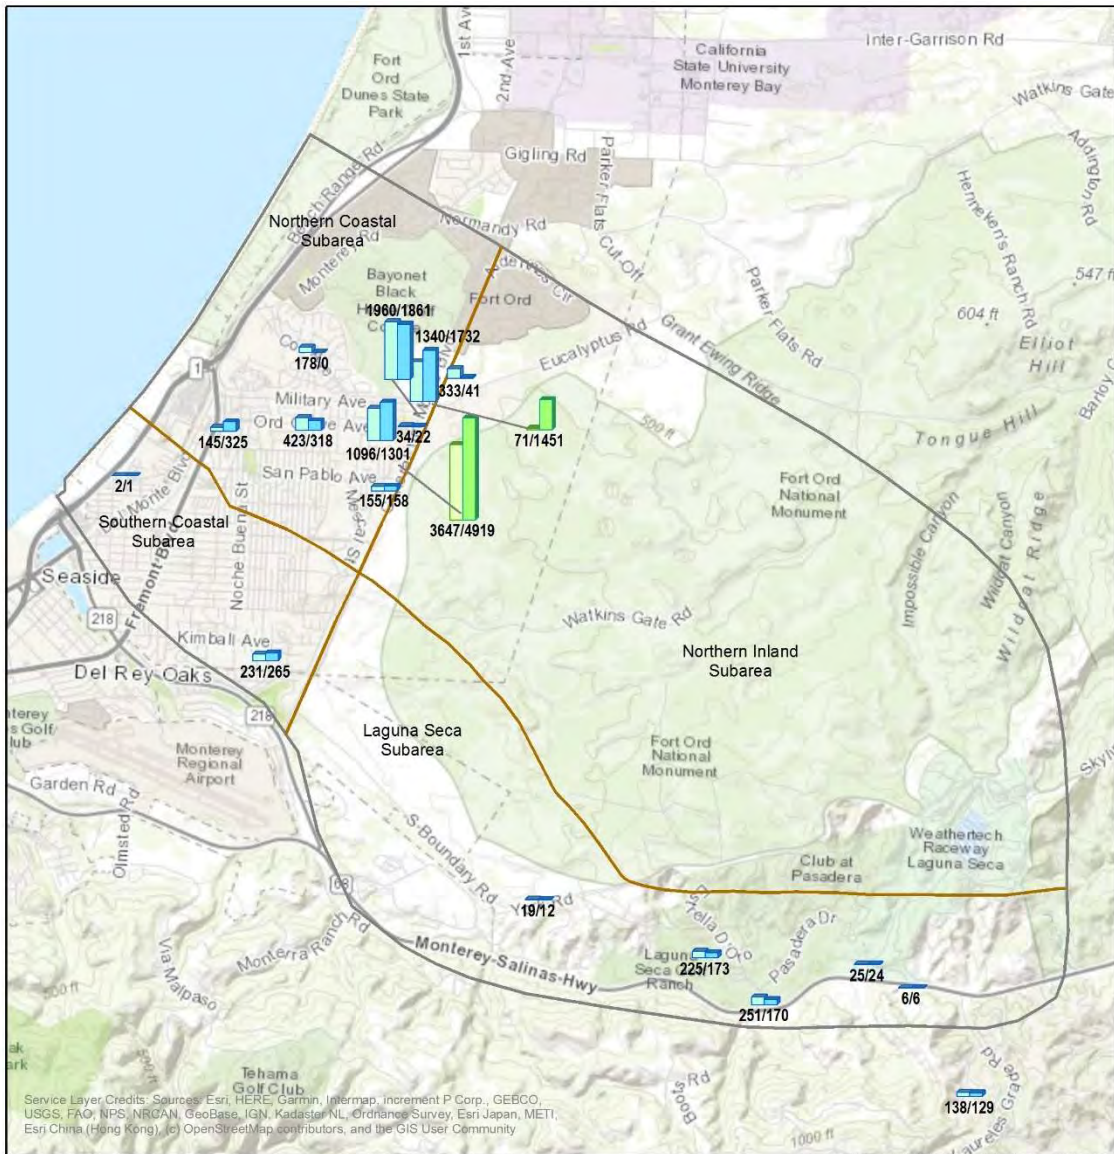
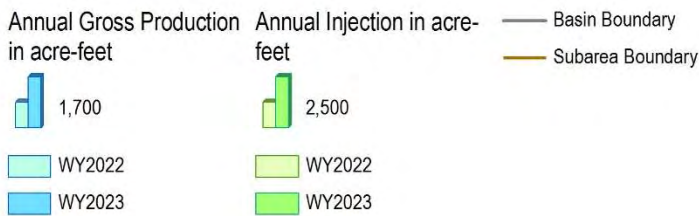
Figure 49. Watermaster Producers' Pumping Distribution for Water Years 2022 and 2023

Figure 49 shows the distribution of pumping through the Basin and the volumes pumped at each production well for the past 2 years. The blue bar charts on Figure 49 reflect the actual or gross amounts pumped from each well and the green bar charts reflects the volume of ASR or PWM injection. In WY 2023, the majority of pumping in the Basin occurred at CAWC's Ord Grove No. 2, Santa Margarita #1, Santa Margarita #3, and Paralta production wells.
